**Docket No. 272 – Development and Management Plan Inspection**

**Segment 4b Underground Line**

**Date:** May 8, 2008

**Location:** Westport Avenue to the Norwalk Substation in the City of Norwalk

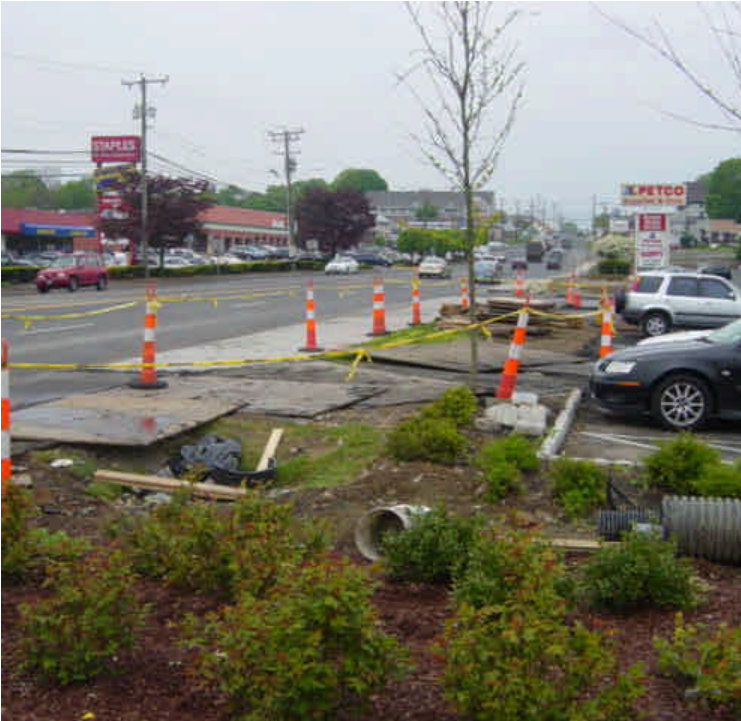
**Trenching and vault tie-in work continues near sta. #148-149. The area was covered with steel plates at the time of the inspection.**

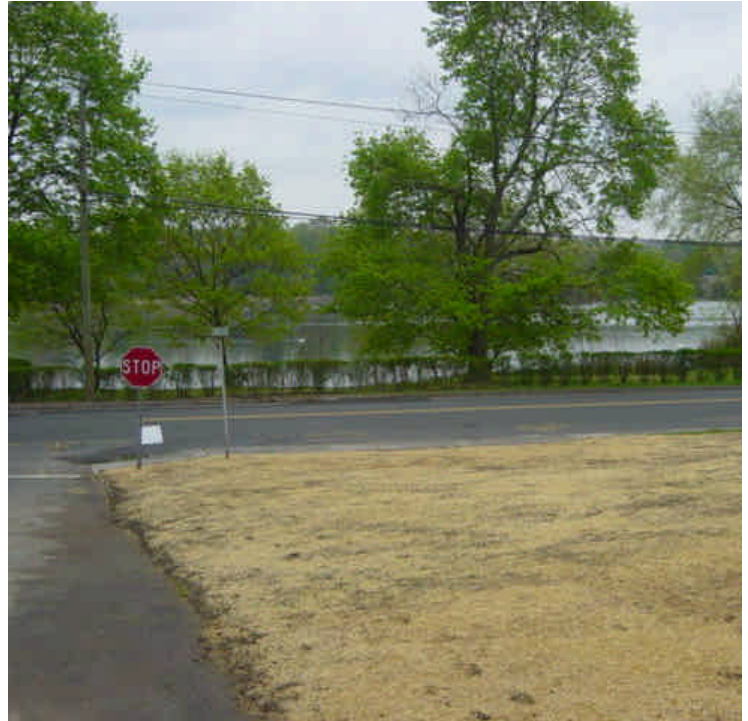
**Area of exposed soil near sta. #231 was previously seeded and grass cover was beginning to establish.**

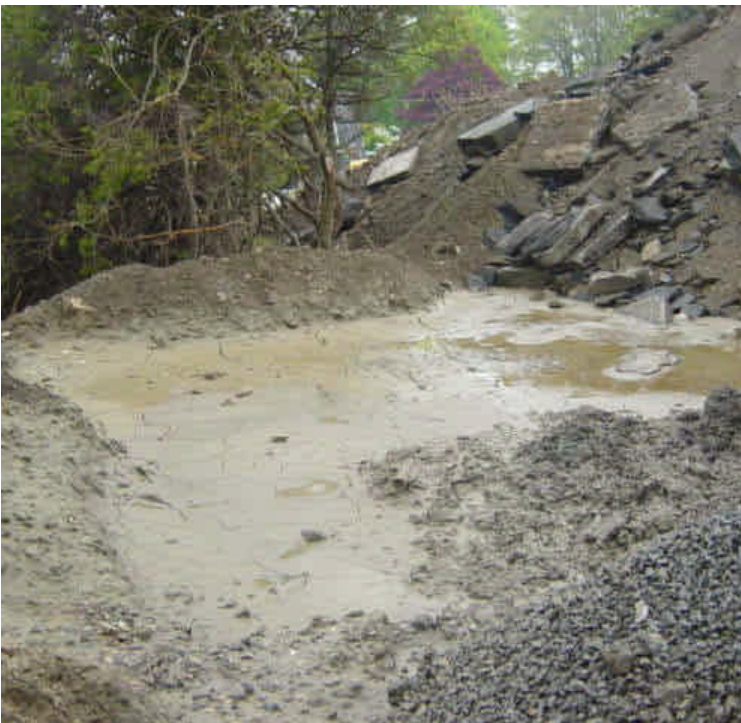
**Frac tank washout water has been mixed with the material stockpile in the Sherwood Island yard to bind the material for disposal.**

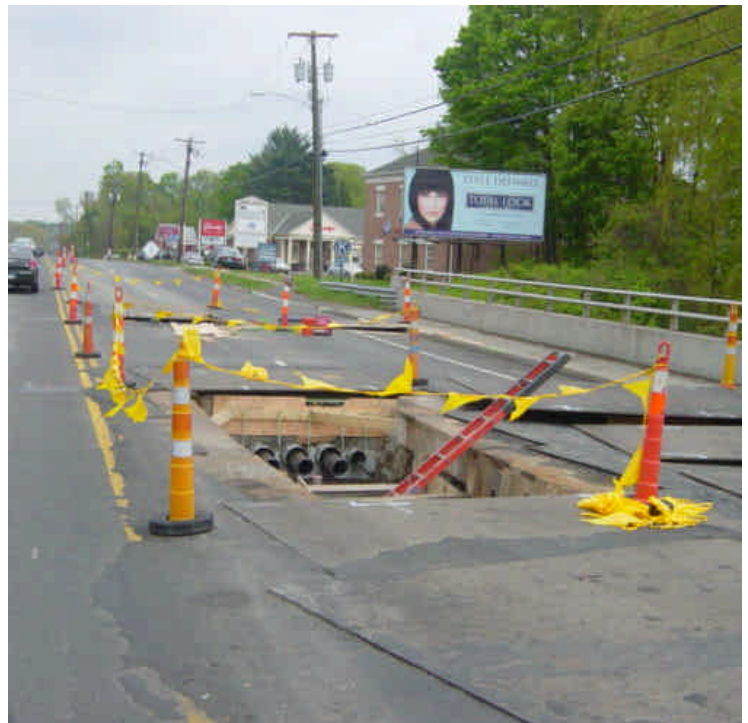
**Work continues on both sides of the bridge over Sasco creek near sta. #435 in preparation for hanging the conduit from the bridge deck.**
