Docket No. 272 – Development and Management Plan Inspection

Segment 4b Underground Line

Date: May 15, 2008

Location: Westport Avenue to the Norwalk Substation in the City of Norwalk

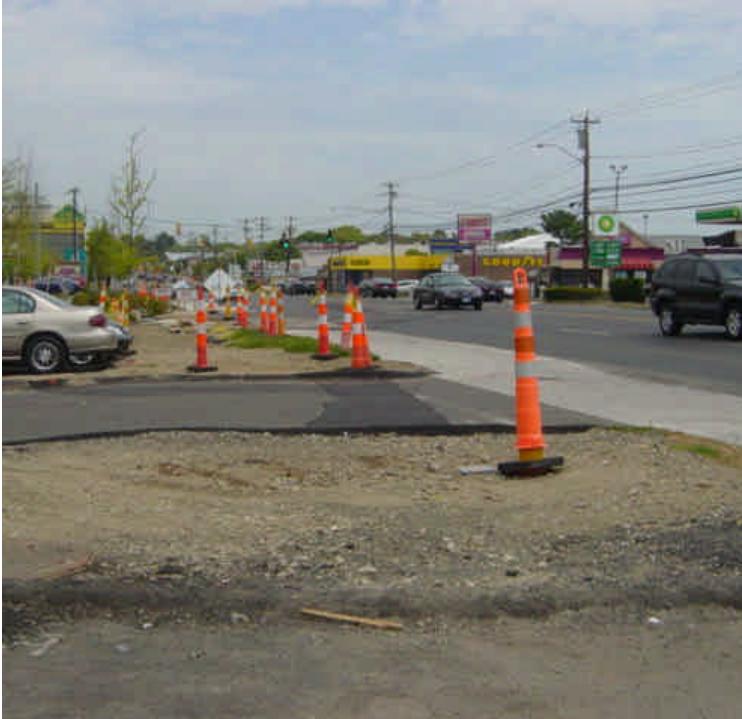
Trenching and vault tie-in work continues near sta. #148-149.

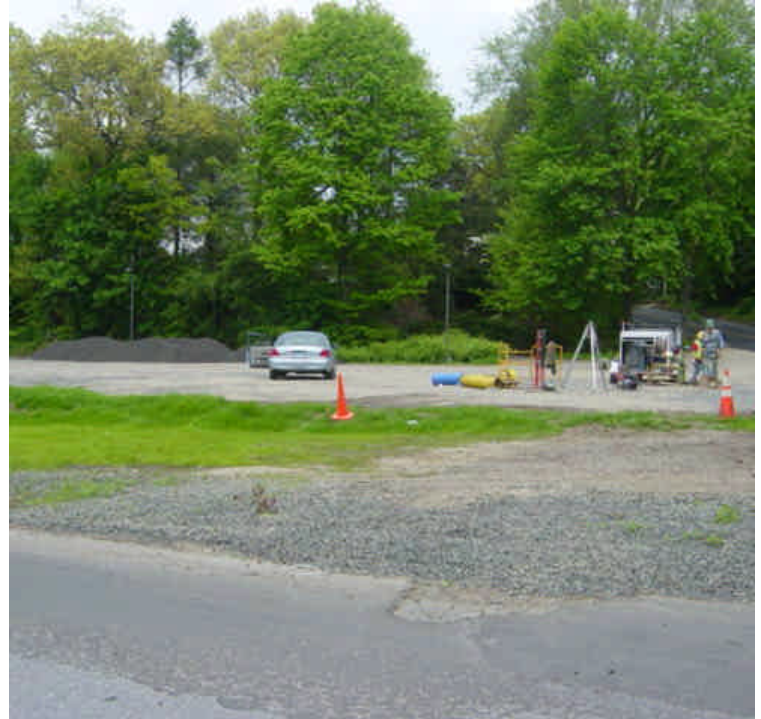
The staging area on the east side of the Saugatuck River has been restored. Electrical contractors were on site proofing the lines.

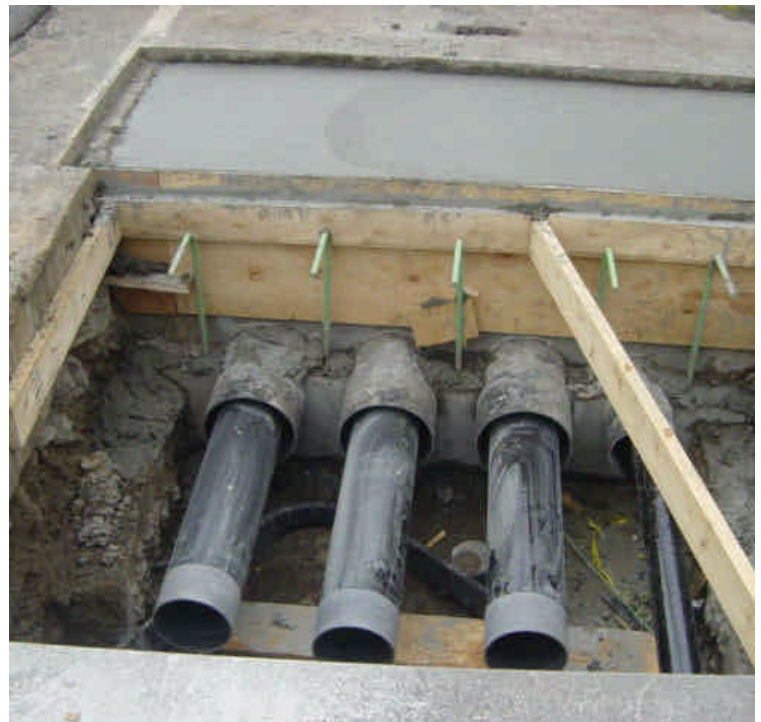
Work continues on the bridge over Sasco Creek continues near near sta. #434 as conduit sleeves were being installed under the bridge deck.
