**Docket No. 272 – Development and Management Plan Inspection**

**Segment 4b Underground Line**

**Date:** May 29, 2008

**Location:** Westport Avenue to the Norwalk Substation in the City of Norwalk

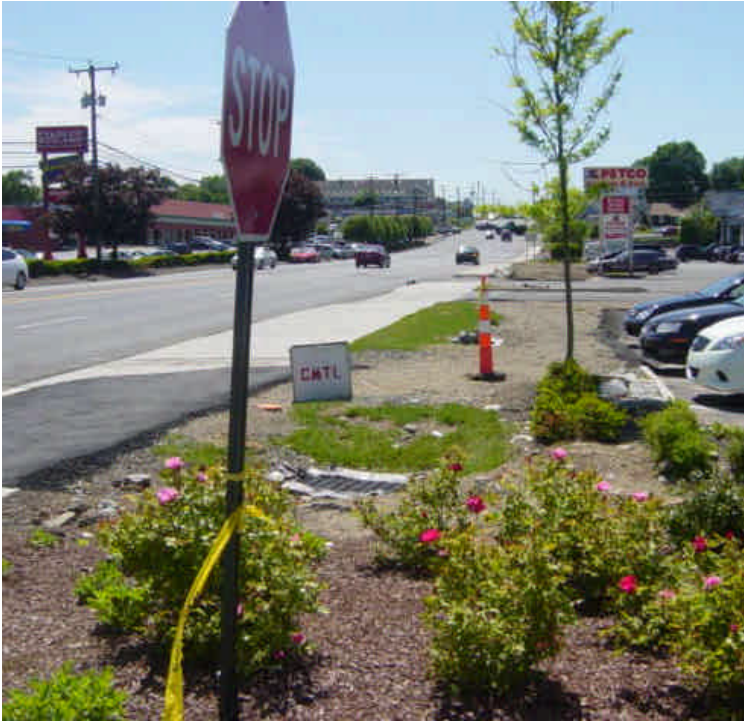
Areas of Inspection	Observation	Recommended Action	Corrected Action
	<p>Two trees have previously been removed near sta. #145 per the D&amp;M plan. 5/29/08</p> <p>Trenchwork appears complete near sta #148. Restore grass cover here and other similar areas when feasible. 5/29/08</p>	<p>Cleared trees have been removed in accordance with the D&amp;M plan. Restore as required by the D&amp;M plan when feasible. 5/29/08</p> <p>Work out restoration plans along all sidewalk/business areas. Restore grass or original cover. 5/29/08</p>	<p>NA</p> <p>Needs evaluation and attention when feasible.</p>
Dewatering	Dewatering was not observed during this week's inspection. 5/29/08	Continue to ensure that material is contained appropriately and treated according to the ground-water handling plan as referenced in the D&M. 5/29/08	NA
Spills and Material Storage	<p>Spill cleanup materials/kits were observed in the storage yard. 5/29/08</p> <p>A light post and associated concrete footings were being stored at sta. #148. Materials appear to be project related. 10/4/07-5/29/08</p> <p>The small soil stockpile near sta. #433+65 that appeared to have migrated into the adjacent parking lot area (since 5/15) has been removed. 5/29/08</p>	<p>Ensure that spill kits are also present with each vehicle during active construction. 5/29/08</p> <p>Remove or attend to materials when feasible. 10/4/07-5/29/08</p> <p>Sweep parking lot if necessary to remove any residual material. 5/29/08</p>	<p>NA</p> <p>Needs attention when feasible.</p> <p>Stockpile has been removed.</p>

**Work appears to be complete near sta. #148. The sidewalk has been temporarily restored with bituminous pavement. Restore grass cover over the trench when feasible.**

<p>Trench work has been completed near sta. #147. Some catch basins have been protected. 5/29/08</p>	<p>Restore grass cover over the area of the trench when feasible. 5/29/08</p>	<p>Needs restoration when feasible.</p>
	<p>Steel plates remain in place in a parking lot over trenched areas near sta. #163-164. The gravel/ cold-mix material that had accumulated in the parking lot area has been swept. 5/29/08</p>	<p>Sweep area as necessary to remove granular material. 5/29/08</p>	<p>Some areas have been swept.</p>
<p><b>Westport</b></p>	<p>Portions of the erosion controls are deteriorating between the hard- pack material and Stony Brook at sta. #217 and don't provide complete coverage. Some areas of process material and soil appear to have the potential to run-off (since 1/24). 5/29/08</p>	<p>Continue to monitor and maintain controls as necessary. Ensure that all material remains contained. See Inland Wetlands section for more details. 1/24-5/29/08</p>	<p>Continue to monitor.</p>

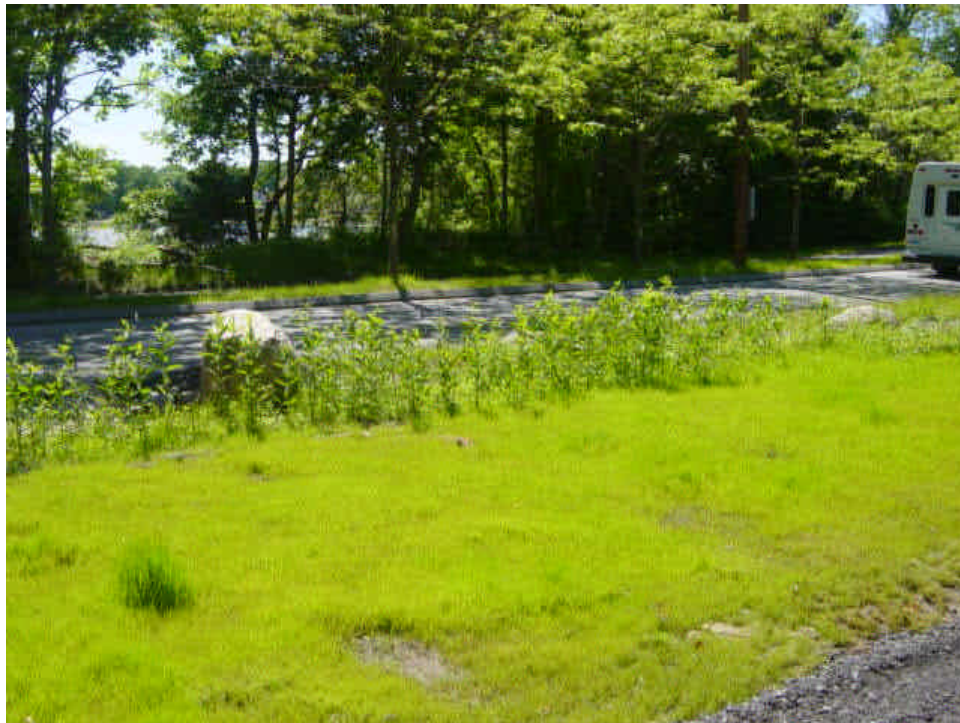
Additional Observations	<p>Sidewalk has been restored near sta. #94-96. 5/29/08</p> <p>Previously restored area near sta. #251 has been partially regraded to remove the berm and additional gravel was added to the parking area. This work appeared</p>	<p>None. 5/29/08</p> <p>None. 5/29/08</p>	<p>NA</p> <p>NA</p>

**The area near sta. #252 was previously restored and a berm was constructed and vegetated along the entrance drive. The berm has been removed and additional gravel material spread in some areas. This work appears to have been completed by the town.**
