**Docket No. 272 – Development and Management Plan Inspection**

**The Connecticut Light and Power Company Certificate of Environmental Compatibility and Public Need for the construction of a new 345-kV electric transmission line and associated facilities between Scovill Rock Switching Station in Middletown and Norwalk Substation in Norwalk, Connecticut, including reconstruction of portions of existing 115-kV and 345-kV electric transmission line, the construction of Beseck Switching Station in Wallingford, East Devon Substation in Milford, (and Singer Substation in Bridgeport), modifications at Scovill Rock Switching Station and Norwalk Substation, and the reconfiguration of certain interconnections.**

**Segment 4b Underground Line**

**Date:** June 6, 2008

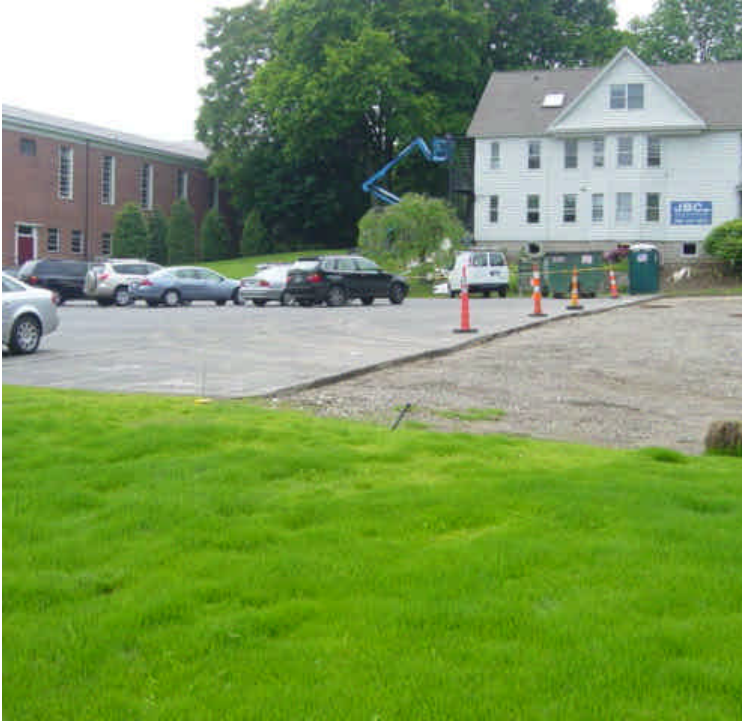
**Vehicles are traveling through the exposed soil near sta. #234 and tracking sediment onto Lincoln St. as well as the adjacent parking lot area. This area has been scheduled for paving for some time.**

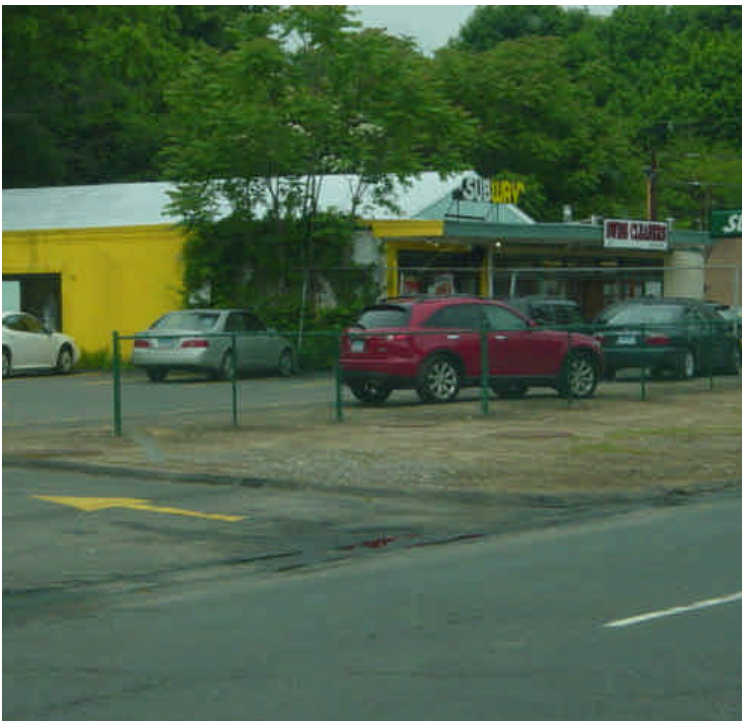
**A chain link fence has been installed near sta. #334 by others, to reduce the amount of vehicle traffic driving through this area. Vehicles continue to park in this area. Contractors should attempt to establish grass cover if final work is complete here.**

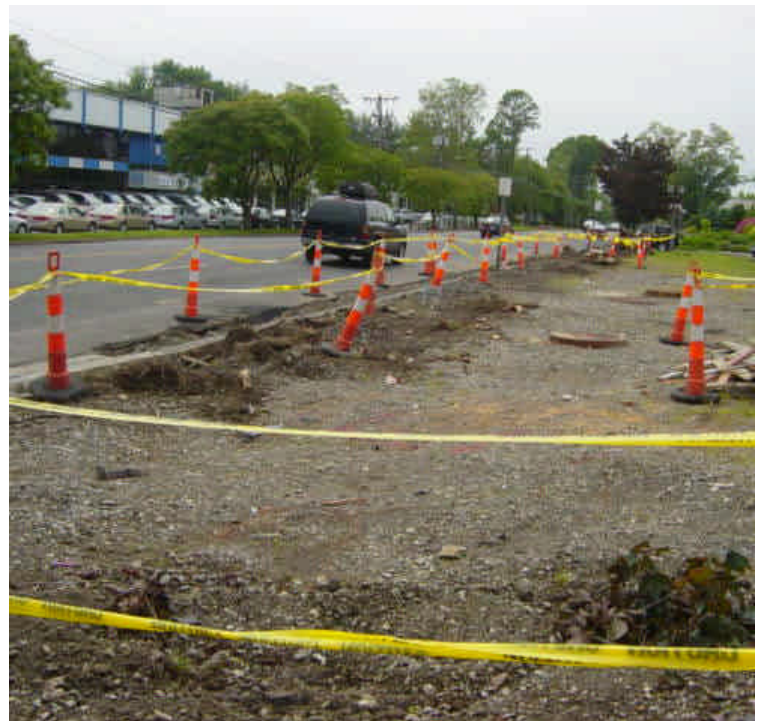
**Restoration work is underway near sta. #382. Concrete formwork is in place for new sections of curbing.**
