Docket No. 272 – Development and Management Plan Inspection

Segment 4b Underground Line

Date: June 20, 2008

Location: Westport Avenue to the Norwalk Substation in the City of Norwalk

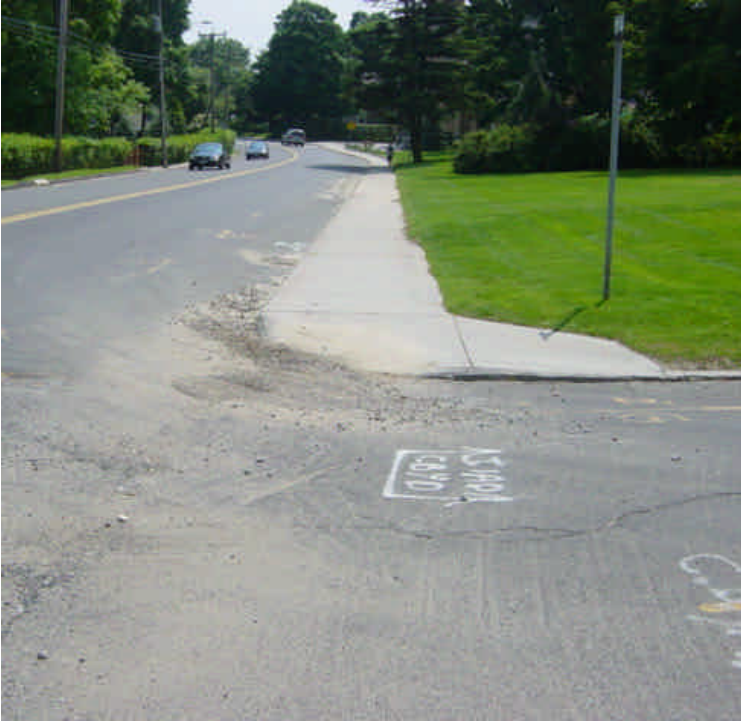
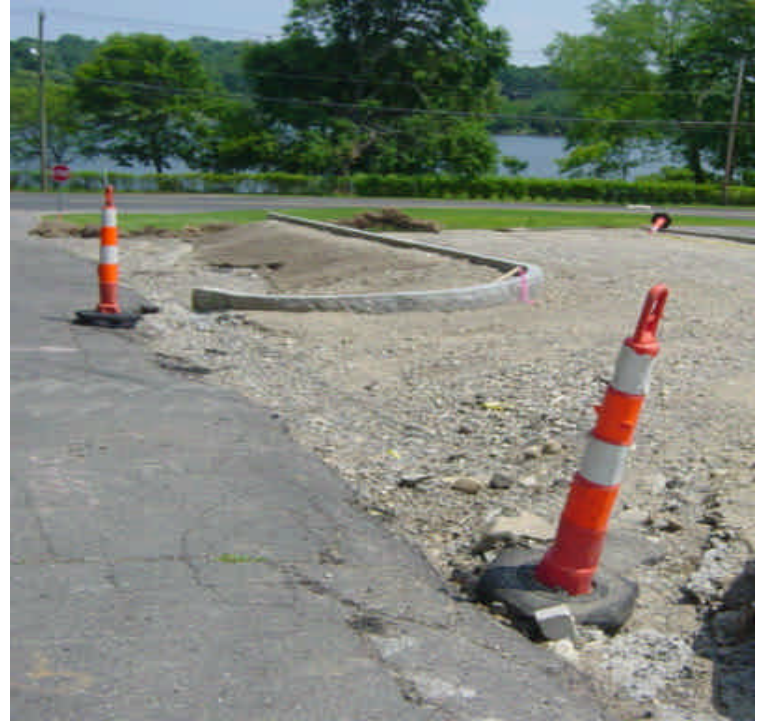
Stone curbing has been set near sta. #234. The adjacent areas have been partially re-graded and some of the material had eroded and accumulated at the intersection of Lincoln St. and Riverside Ave.

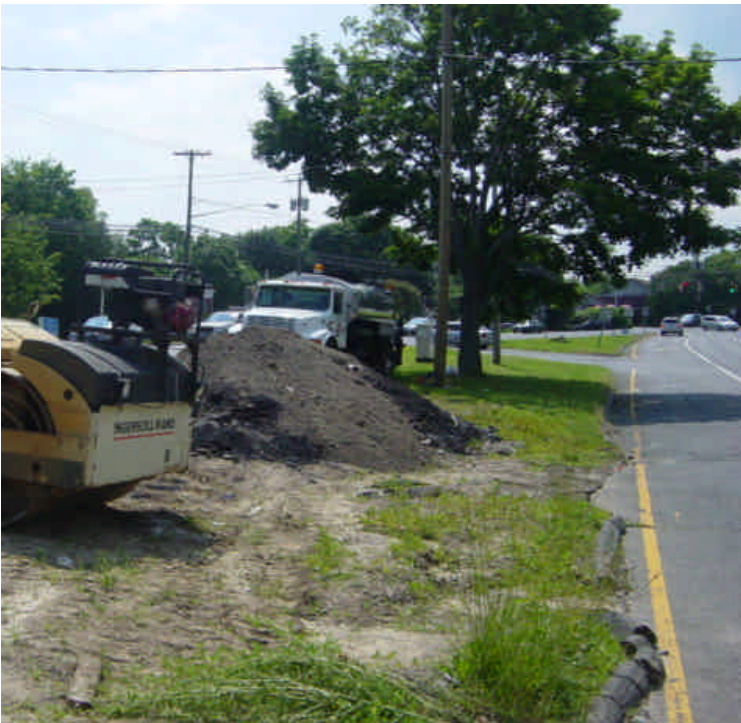
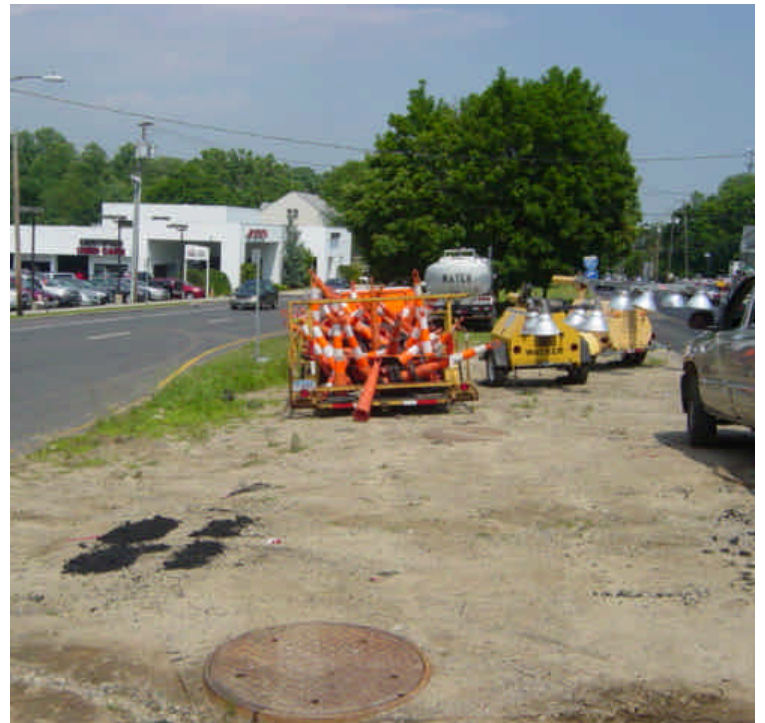
Areas of Inspection	Observation	Recommended Action	Corrected Action
<p>Kings Highway Lay-down Yard (Fairfield) (Currently being used for Segment 4a and 4b operations.)</p>	<p>3/20). 6/20/08</p> <p>Sediment tracking and heavy rutting was observed in the island near sta. #316-318 (since 11/21) as a result of access by electrical contractors. Active work has been complete for several months (since 2/21) and stabilization is needed. Currently, the paving contractor has begun parking equipment in this area. 6/20/08</p>	<p>Remove the accumulated sediment along the curb and sweep the roadway as necessary. Temporarily stabilize any portions where active work/access is no longer required. The remainder of this area needs to be sufficiently stabilized. 12/31- 6/6/08 Coordinate between contractors as needed. 6/20/08</p>	<p>Needs attention.</p> <p><i>Contractors are currently working out responsibility for this area.</i></p>

Sediment tracking and heavy rutting remains in the island near sta. #316-318. Paving contractor has begun parking equipment in this area. Active work has been complete for several months and restoration is needed. If material stockpiles are to be stored longer than one work day, controls should be installed.
