**Docket No. 272 – Development and Management Plan Inspection**

**Segment 4b Underground Line**

**Date:** July 2, 2008

**Location:** Westport Avenue to the Norwalk Substation in the City of Norwalk

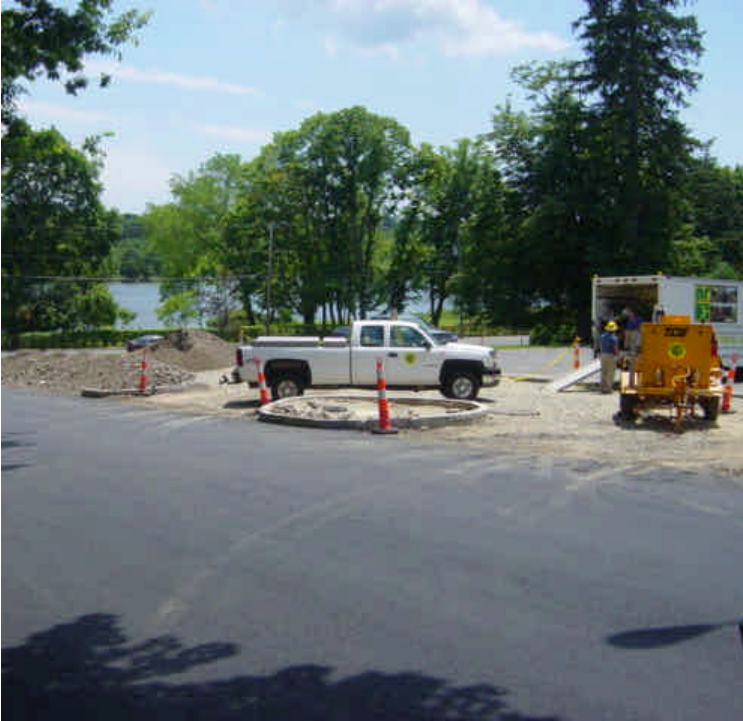
**On the west side of the Saugatuck River, the staging area is still waiting to be paved. Stone curbing has been set and soil has been stockpiled in these areas. Minor tracking was observed on Lincoln St. New River Electric was on-site.**

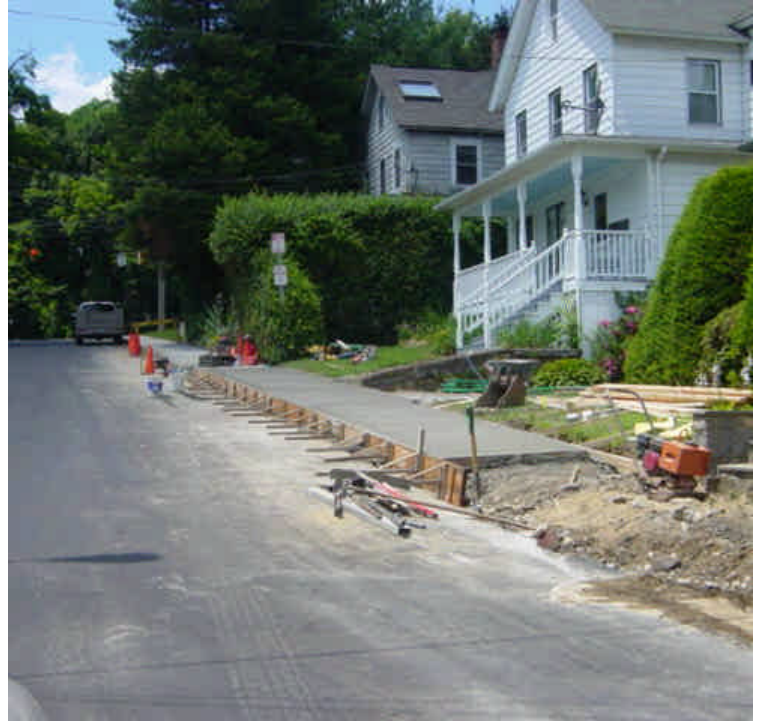
**Sidewalk restoration was observed near sta. #230. This work was not project related.**

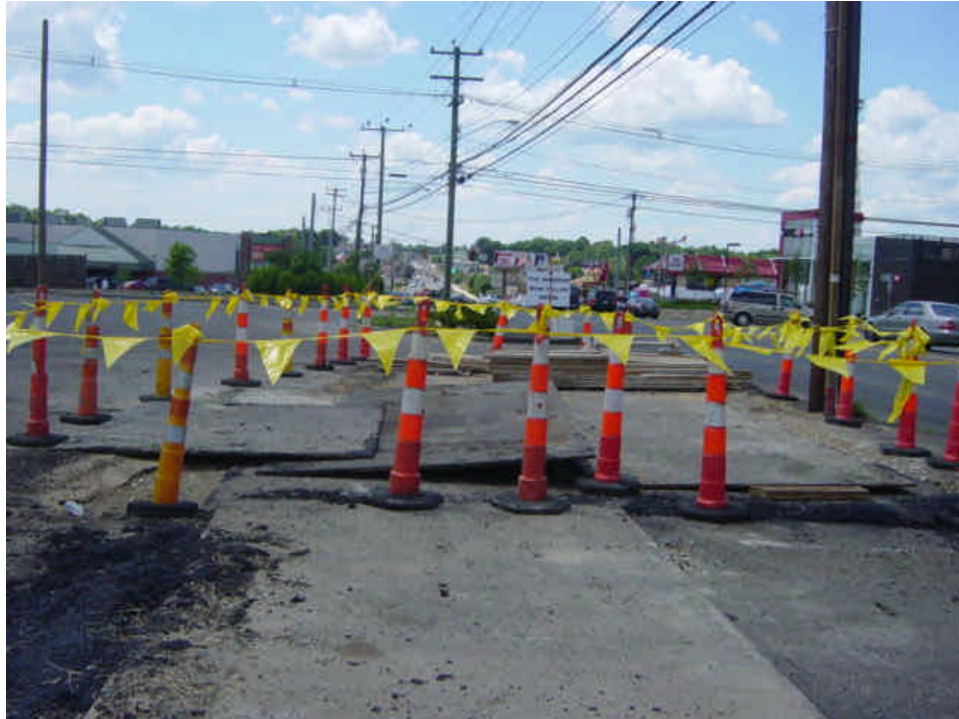
**Steel plates remain in the parking lot near sta. #162-164. A minor amount of loose cold mix and sediment has accumulated along the edge of the plates.**
