Docket No. 272 – Development and Management Plan Inspection

Segment 4b Underground Line

Date: August 14, 2008

Location: Fairfield/Westport Town Line to Westport Avenue in Norwalk

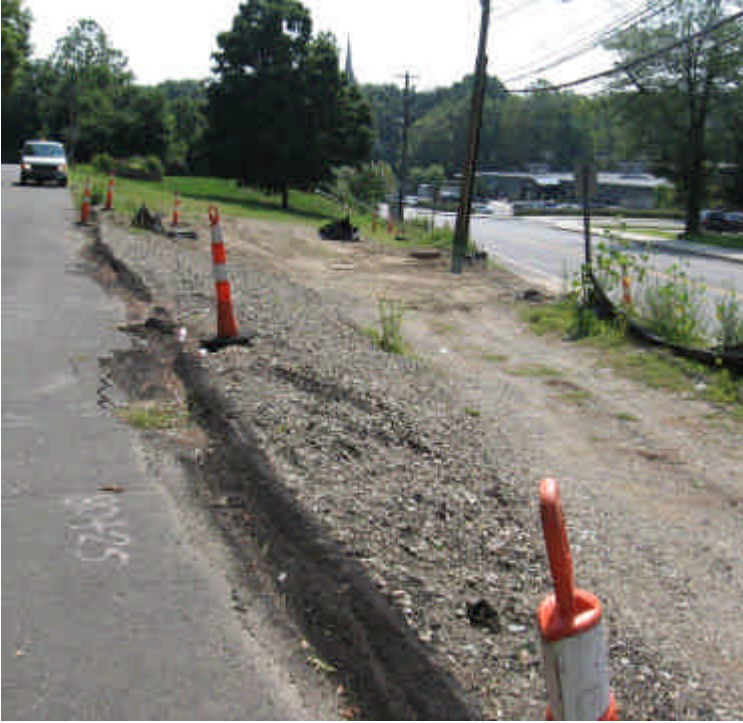
Temporary curbing remains along Westport Ave. near sta. #81 (vault #5) but is beginning to deteriorate. Area has been backfilled with process material but remains exposed. Work towards final stabilization/surfacing in the area.

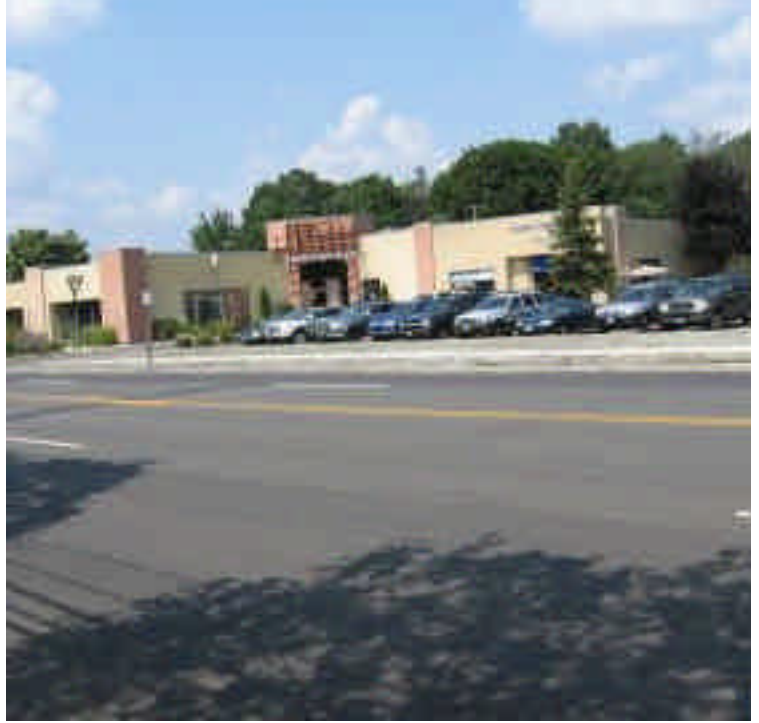
The area near vault #26 has been restored. Topsoil has been spread and the area has been hydro-seeded.

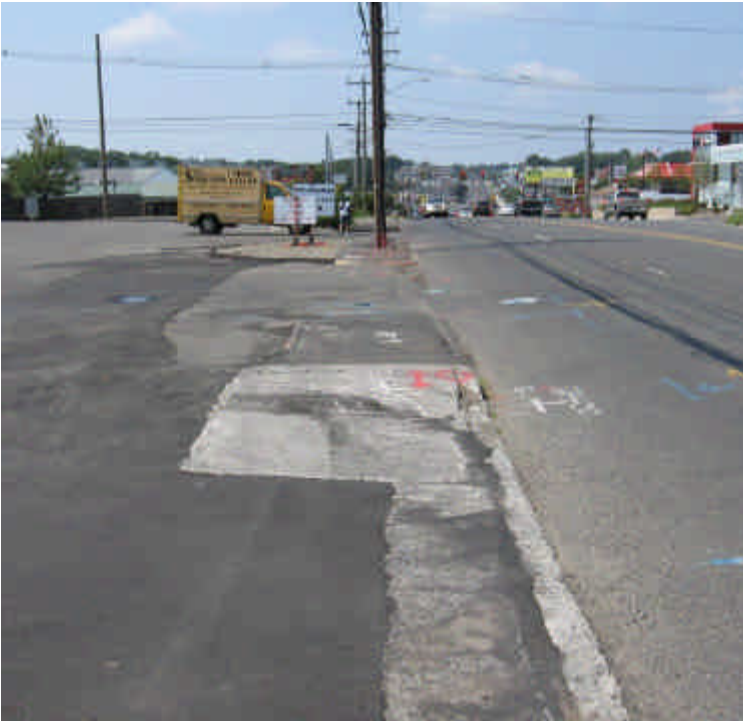
Tie-in work appears to have been completed at vault #10.

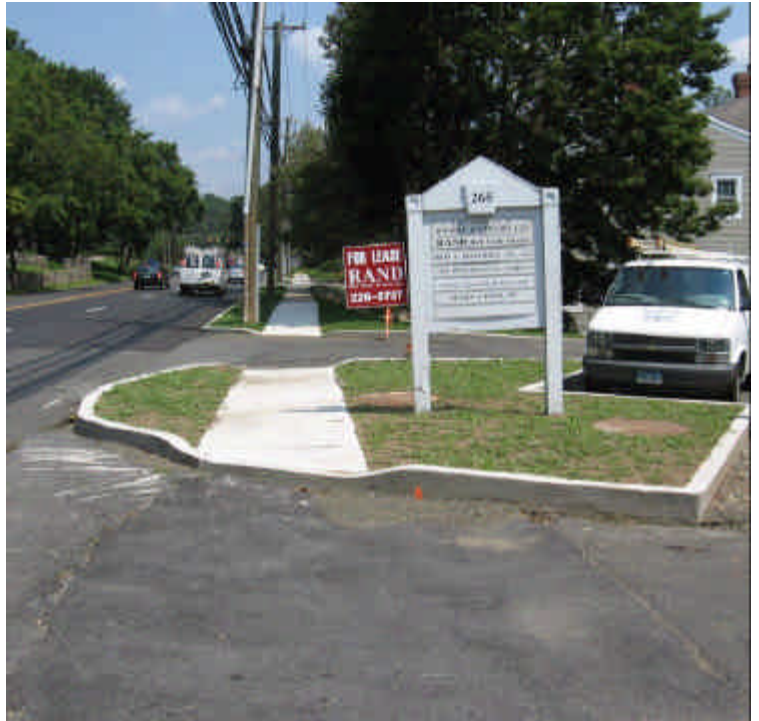
A minor amount of debris/sediment was observed along the edge of the curb near vault #12, where restorations efforts are underway.
