Docket No. 272 – Development and Management Plan Inspection

Segment 4b Underground Line

Date: August 21, 2008

Location: Fairfield/Westport Town Line to Westport Avenue in Norwalk

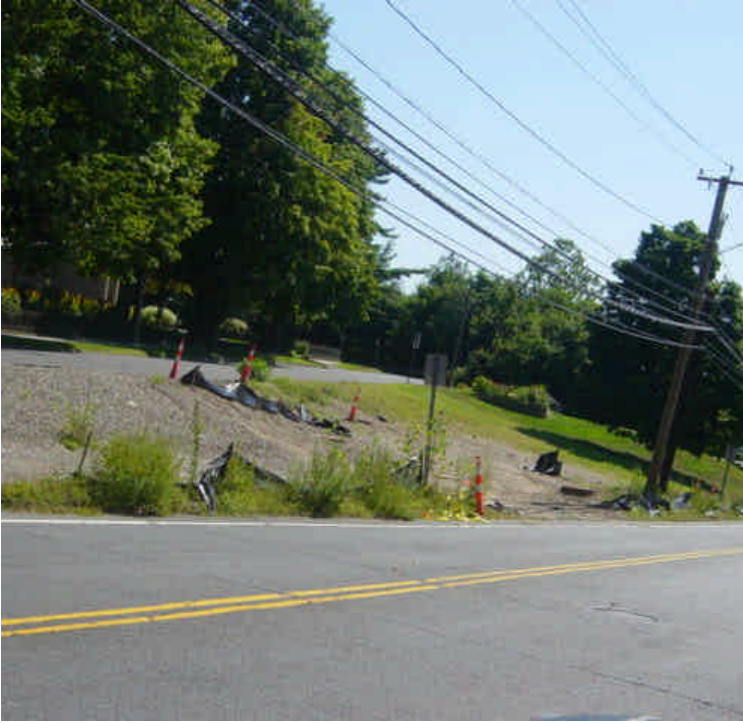
Temporary curbing remains along Westport Ave. near sta. #81 (vault #5) but is beginning to deteriorate. Silt fence needs repair.

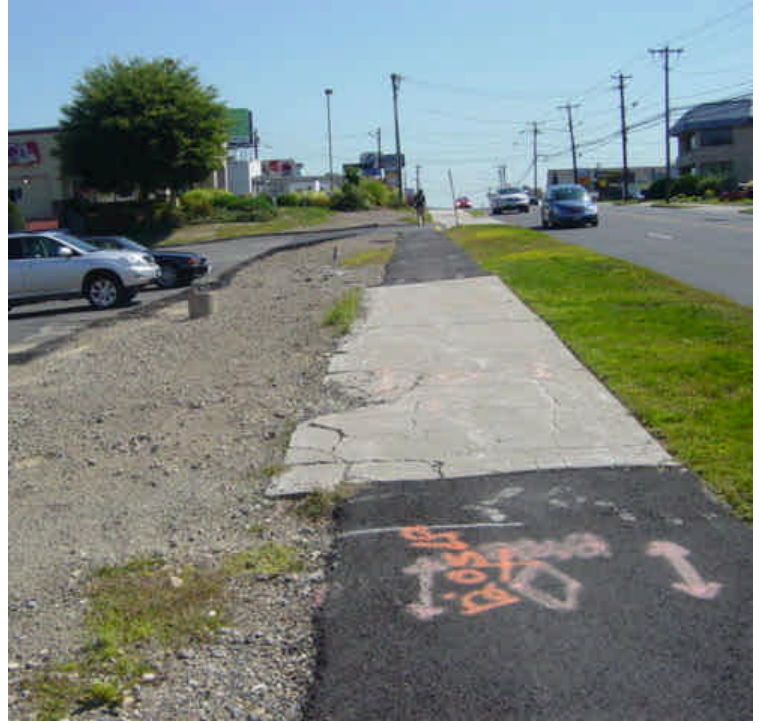
The area near sta. #130 remains backfilled with process material. Final restoration is needed in this area.

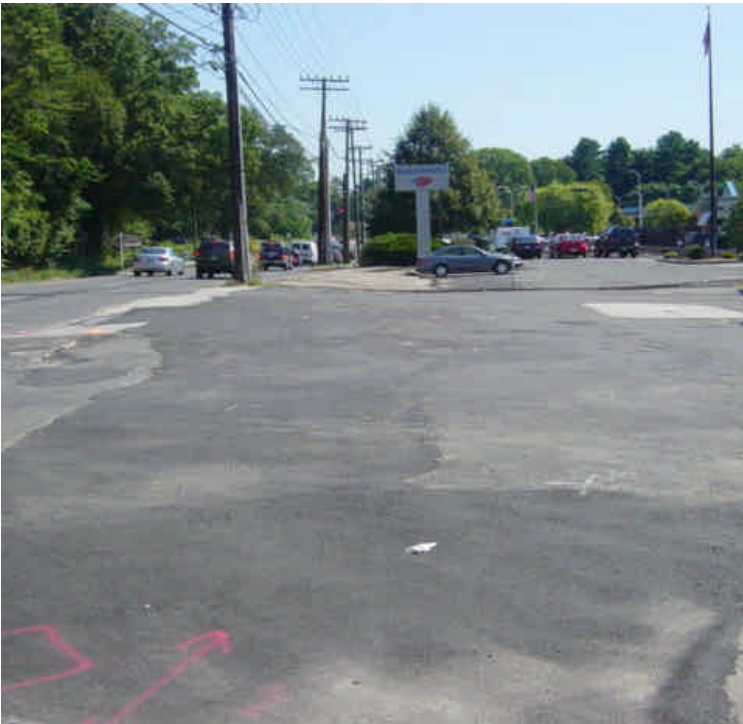
Tie-in work appears to have been completed at vault #10.

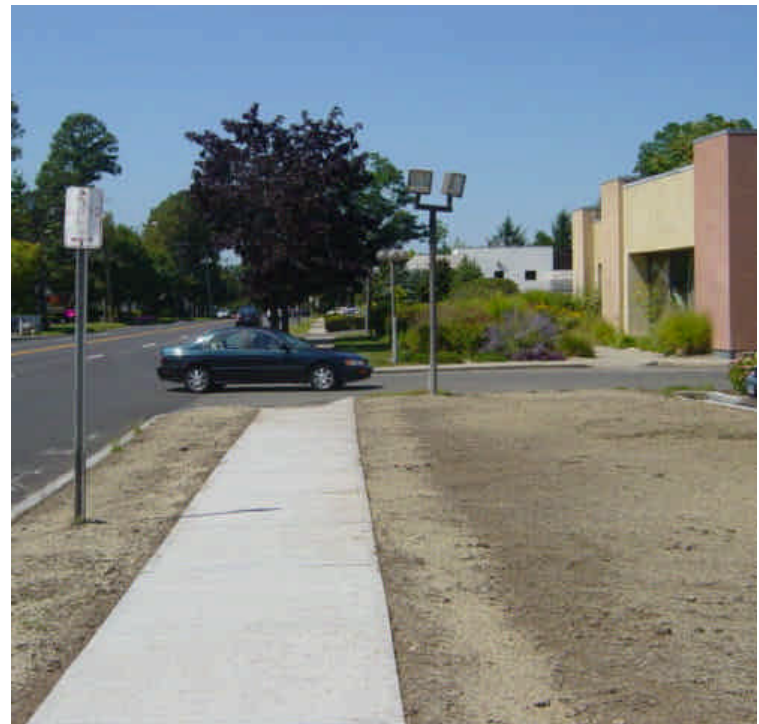
Topsoil has been spread near sta. #381-383. The exposed soil needs to be seeded and stabilized. Efforts are underway.
