Docket No. 272 – Development and Management Plan Inspection

Segment 4b Underground Line

Date: August 29, 2008

Location: Fairfield/Westport Town Line to Westport Avenue in Norwalk

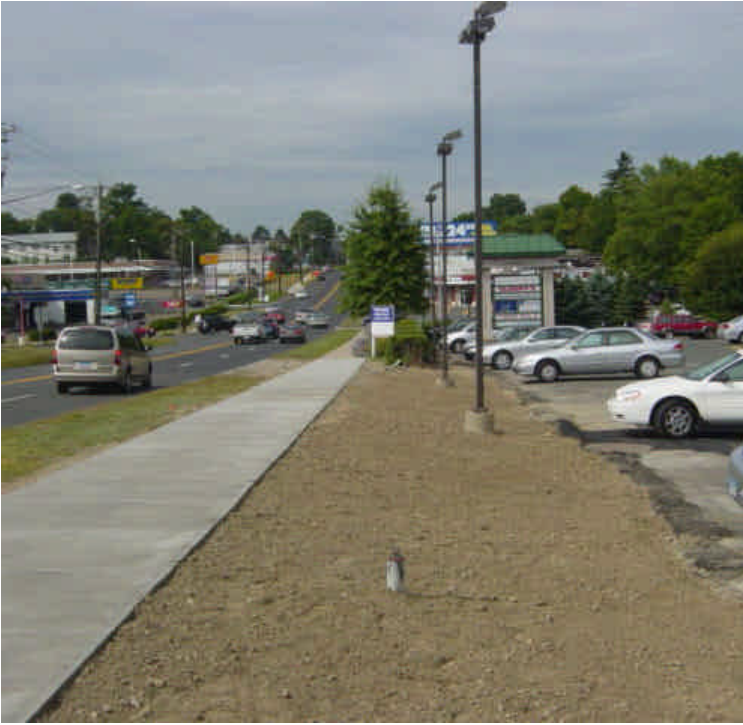
Topsoil has been spread in the area near sta. #130. Light poles and sidewalk have also been restored. Continue to stabilize with mulch and vegetation.

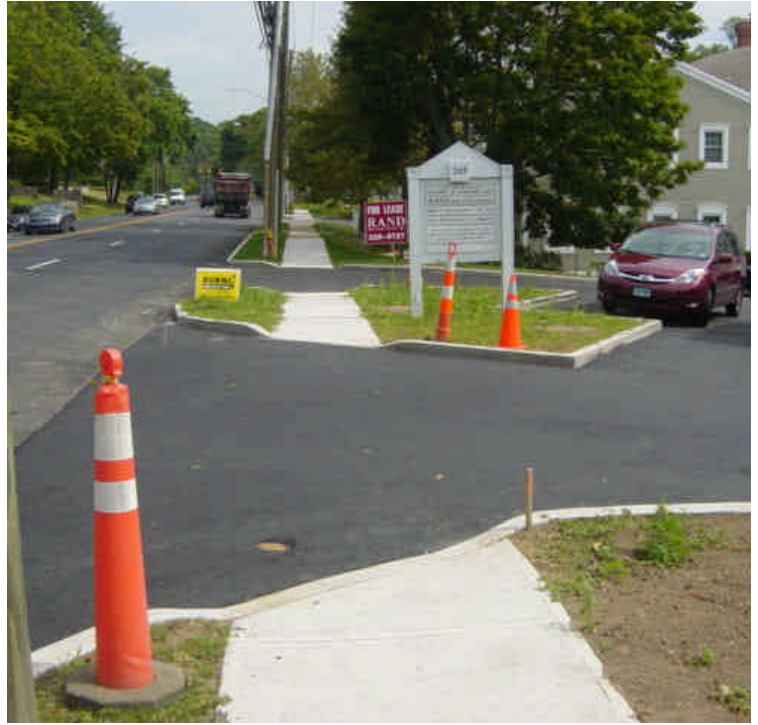
The area near vault #12 has been restored.

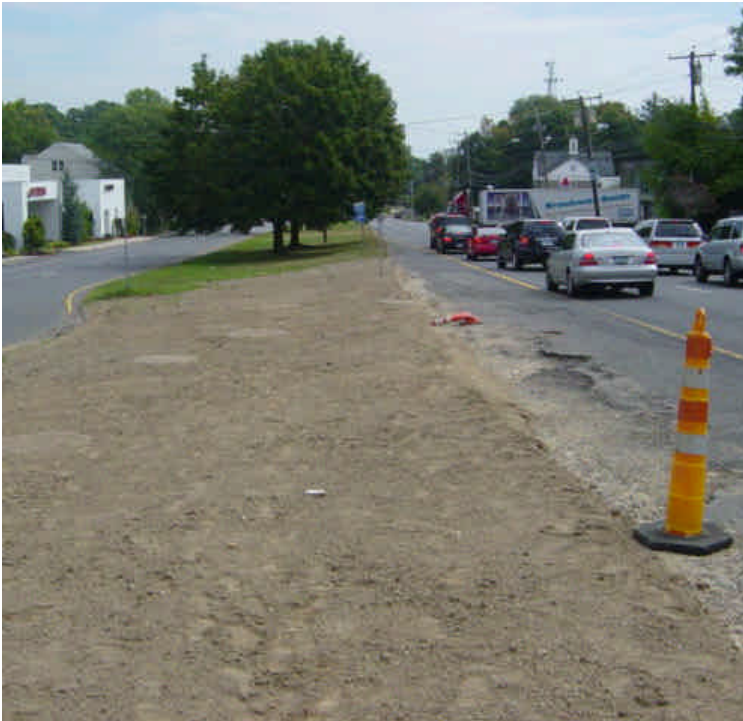
Topsoil remains over the area near sta. #316-318. The area has not yet been seeded or mulched and the bituminous curbing has not yet been replaced.

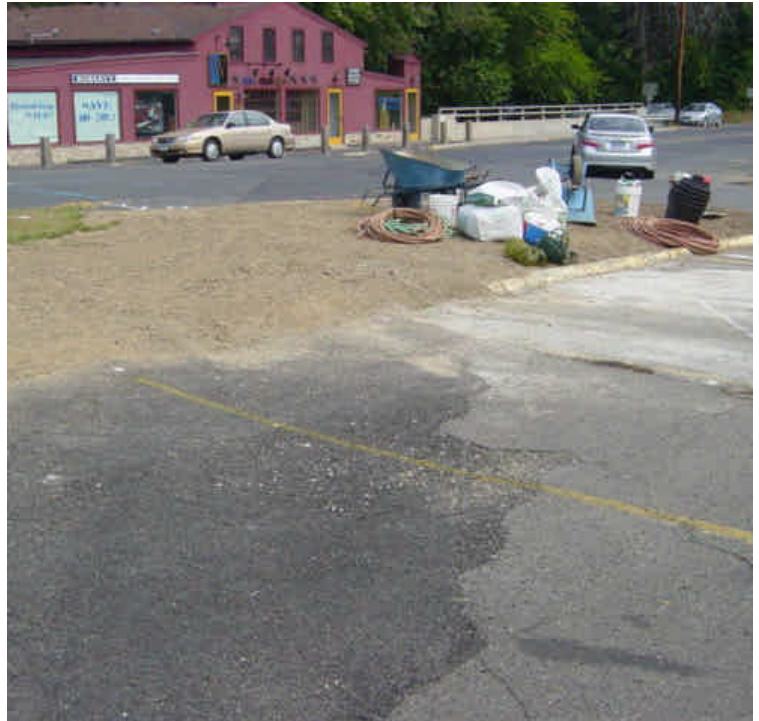
Restoration efforts were on going near sta. #433-434 and vault #26. Sweep adjacent roadways and parking areas as needed.
