Docket No. 272 – Development and Management Plan Inspection

The Connecticut Light and Power Company Certificate of Environmental Compatibility and Public Need for the construction of a new 345-kV electric transmission line and associated facilities between Scovill Rock Switching Station in Middletown and Norwalk Substation in Norwalk, Connecticut, including reconstruction of portions of existing 115-kV and 345-kV electric transmission line, the construction of Beseck Switching Station in Wallingford, East Devon Substation in Milford, (and Singer Substation in Bridgeport), modifications at Scovill Rock Switching Station and Norwalk Substation, and the reconfiguration of certain interconnections.

Segment 4b Underground Line

Date: September 5, 2008

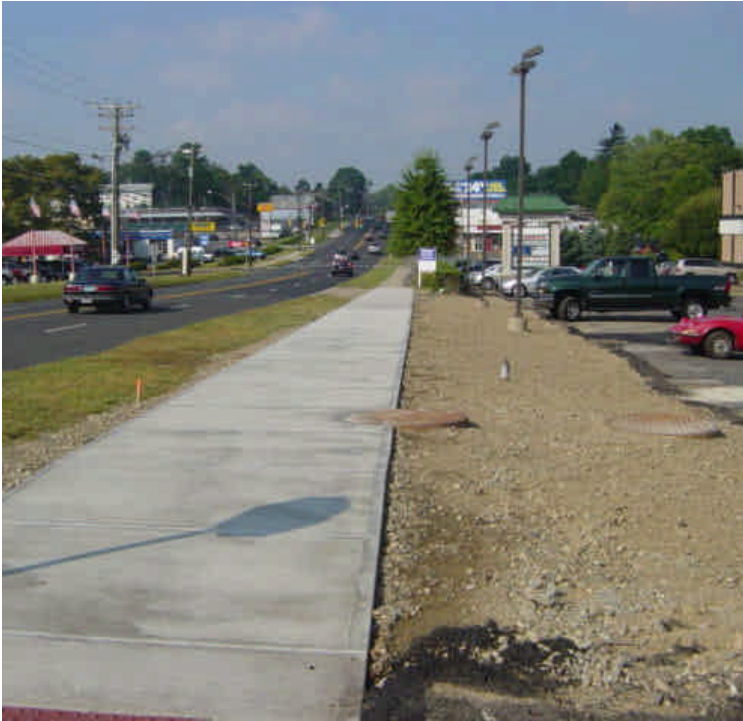
Topsoil has been spread in the area near sta. #130. Light poles and sidewalk have also been restored. Stabilize the exposed soil with mulch and seed as soon as possible.

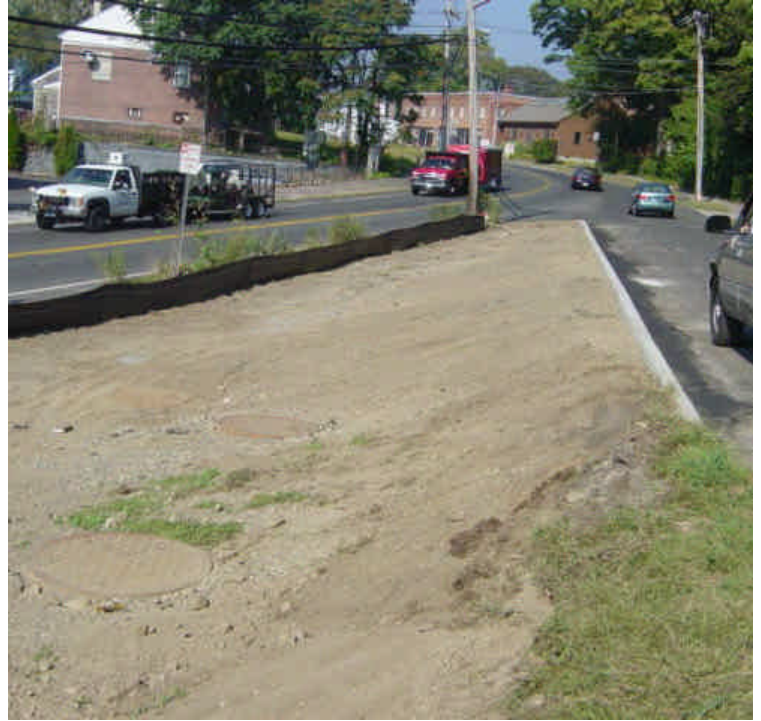
Stone curb has been reset near sta. #81 and topsoil has been spread. Provide stabilization for the exposed soil as soon as feasible.

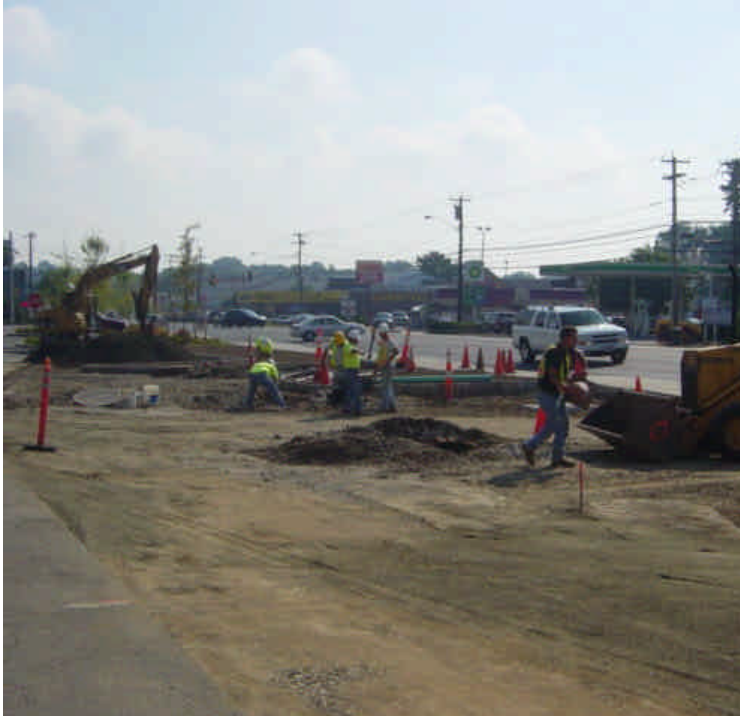
Restorations efforts were ongoing at sta. #146-148. Manhole rims were being adjusted and the area was being re-graded. Topsoil was spread in some areas. Provide mulch and seed to stabilize the soils.
