Docket No. 272 – Development and Management Plan Inspection

Segment 4b Underground Line

Date: September 12, 2008

Location: Westport Avenue to the Norwalk Substation in the City of Norwalk

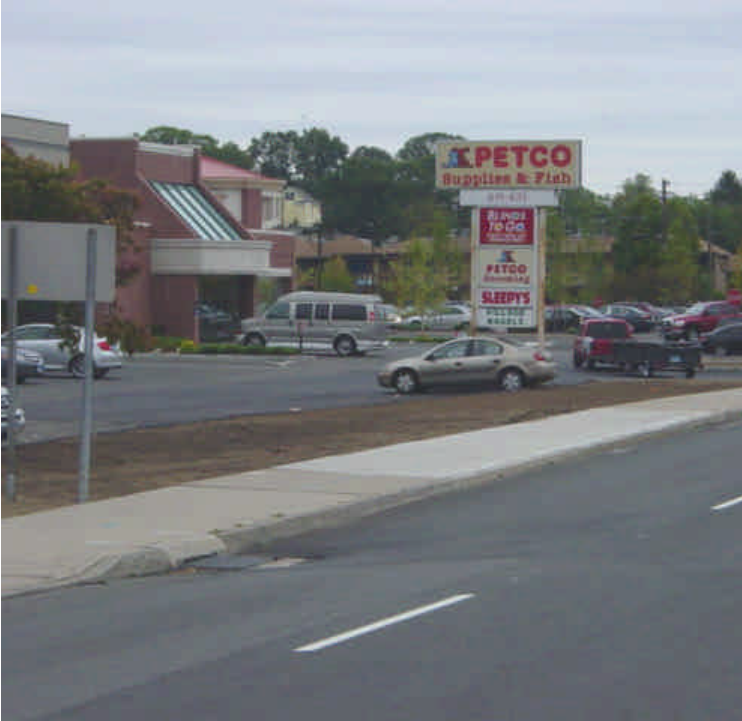
Topsoil has been spread in the area near sta. #146 and the area is partially restored. Continue to mulch/stabilize exposed soils.

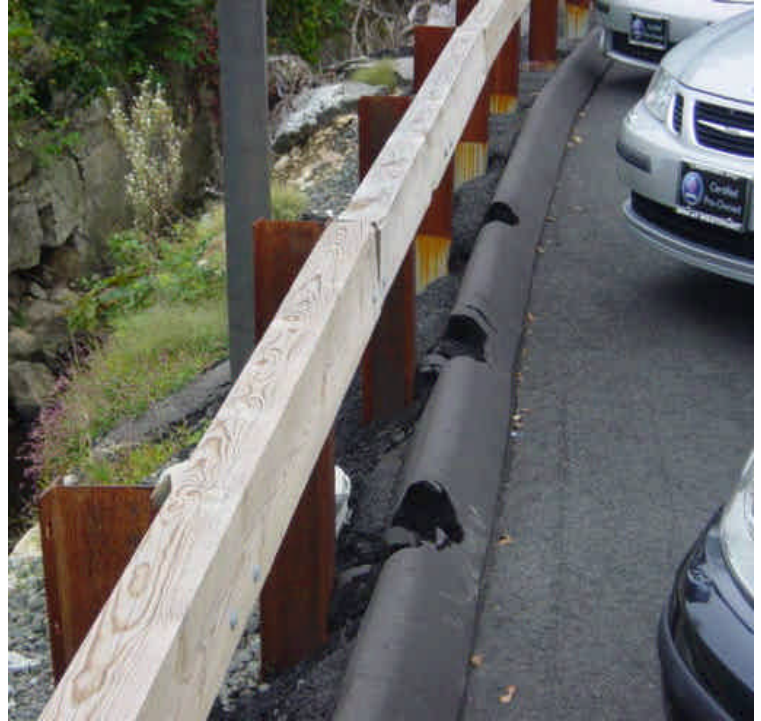
Bituminous curb was previously restored near sta. #217, but several areas have been damaged.

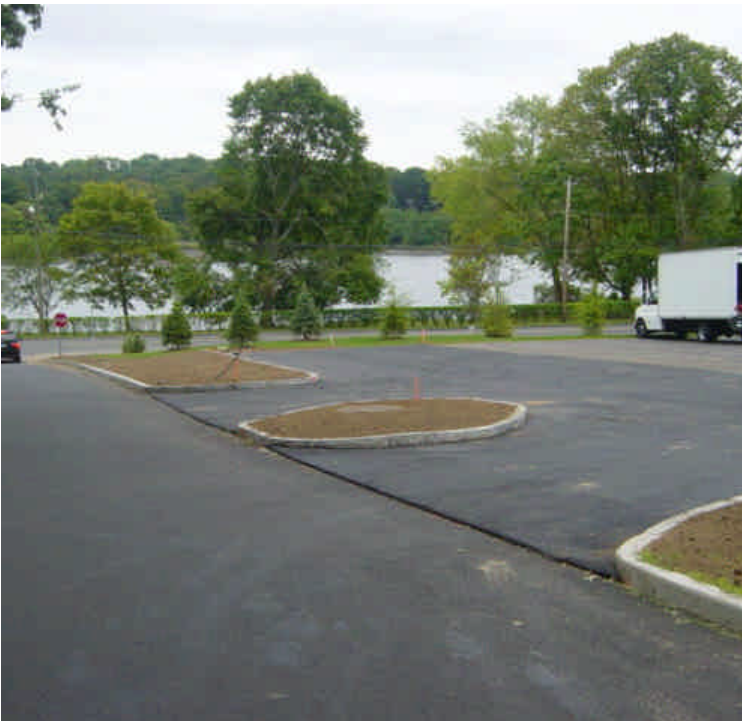
Parking lot near sta. #234 has been repaved and the island areas have been seeded. Mulch should be added to further stabilize.

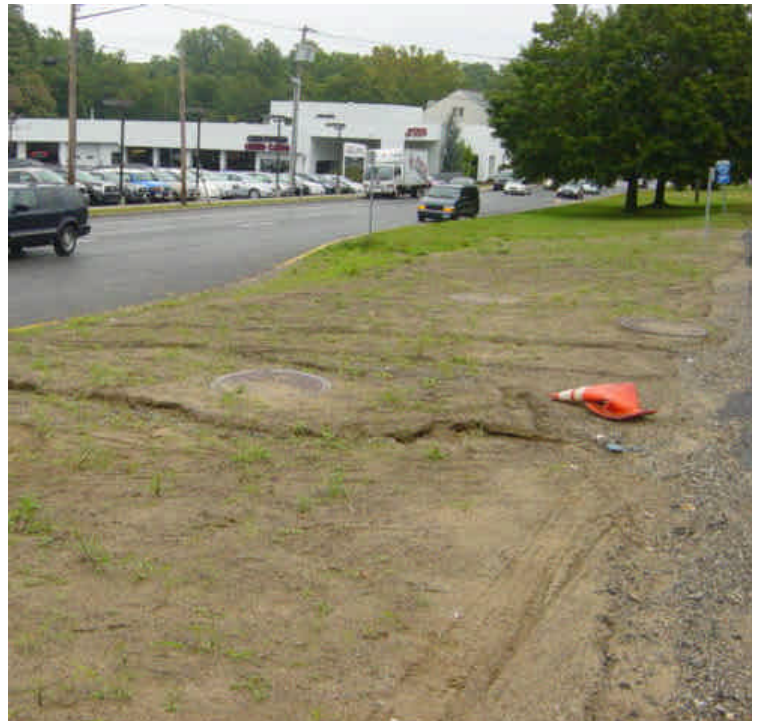
The area near sta. #316-318 was previously graded and seeded. However, heavy rain has caused portions of the exposed soil to erode and gullies were present. The area will need to be repaired and mulch should be applied.
