Docket No. 272 – Development and Management Plan Inspection

Segment 4b Underground Line

Date: September 19, 2008

Location: Westport Avenue to the Norwalk Substation in the City of Norwalk

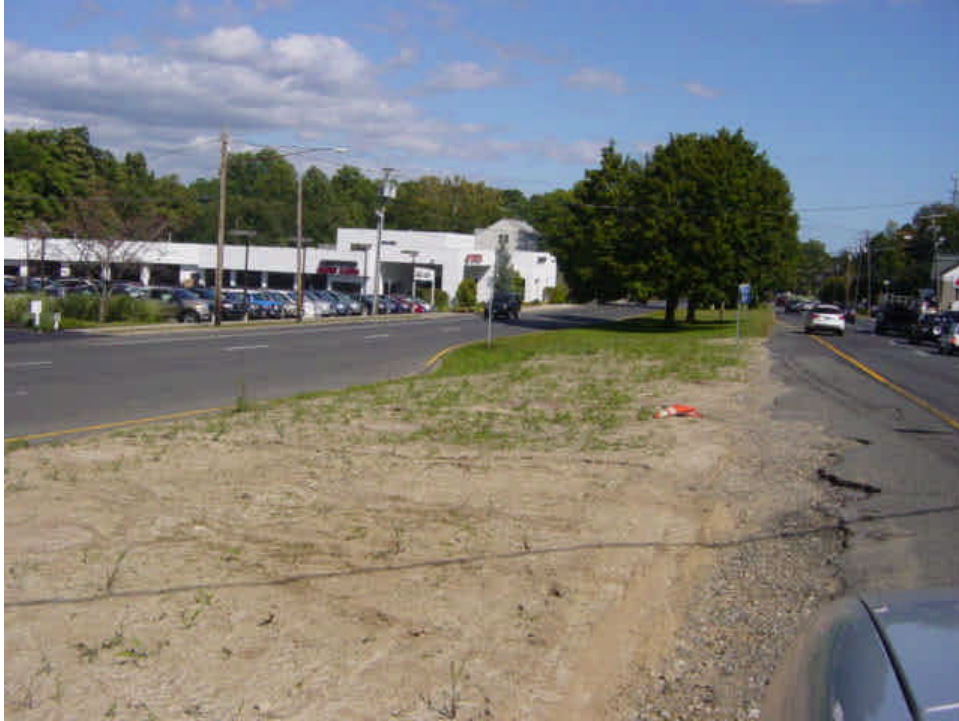
Topsoil has been spread in the area near sta. #316-318 but was not mulched. Minor gullies have formed in some locations due to heavy rains. Repair the erosion and apply mulch over the entire area.
