Docket No. 272 – Development and Management Plan Inspection

Segment 4b Underground Line

Date: October 3, 2008

Location: Fairfield/Westport Town Line to Westport Avenue in Norwalk

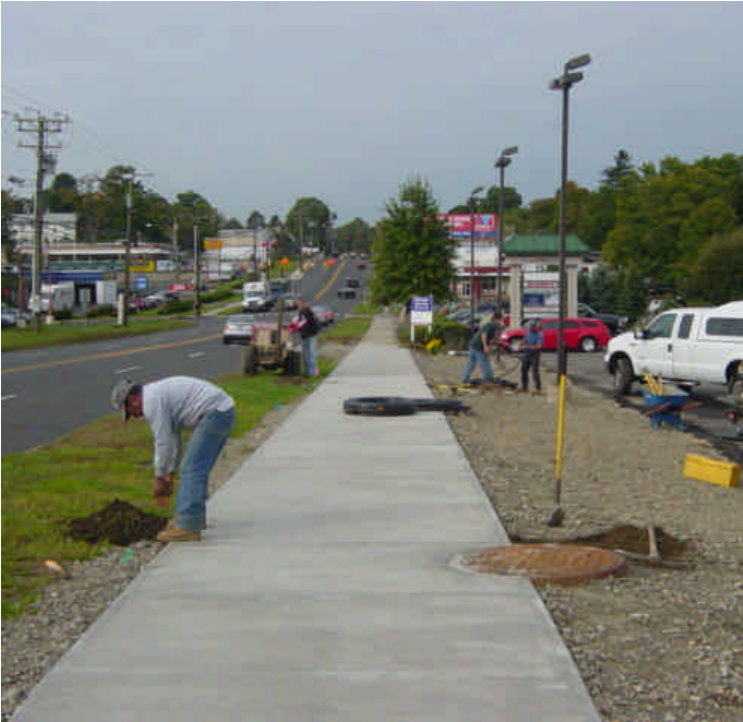
Restoration work was underway near sta. #129-131 and vault # 8.

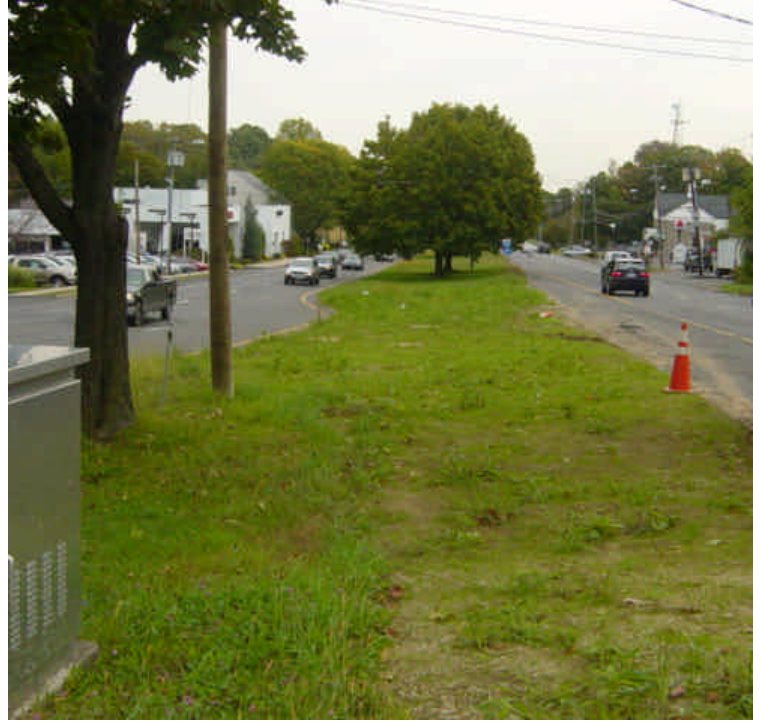
The area near sta. #316-318 has vegetated with weedy growth. Bituminous curbing still needs to be restored.

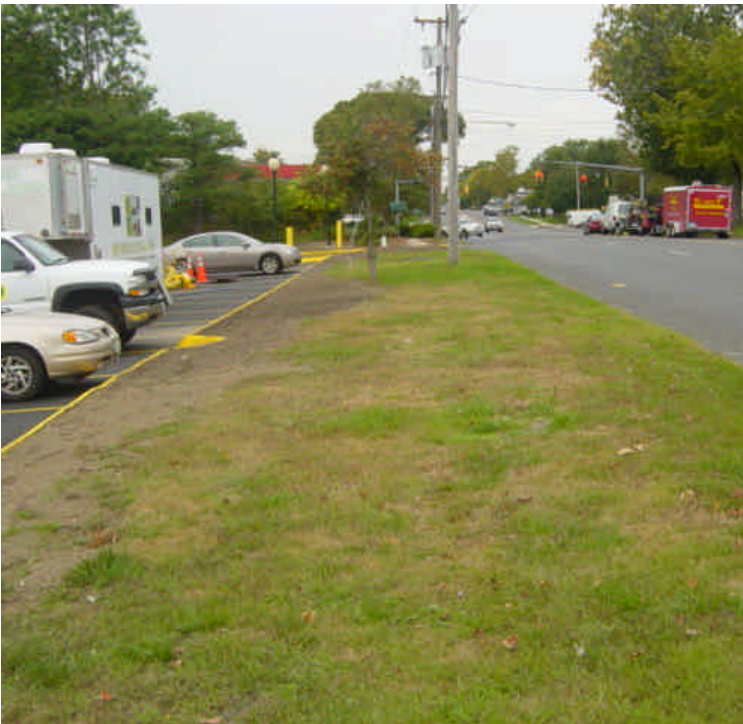
New River Electric was on site at vault #26.

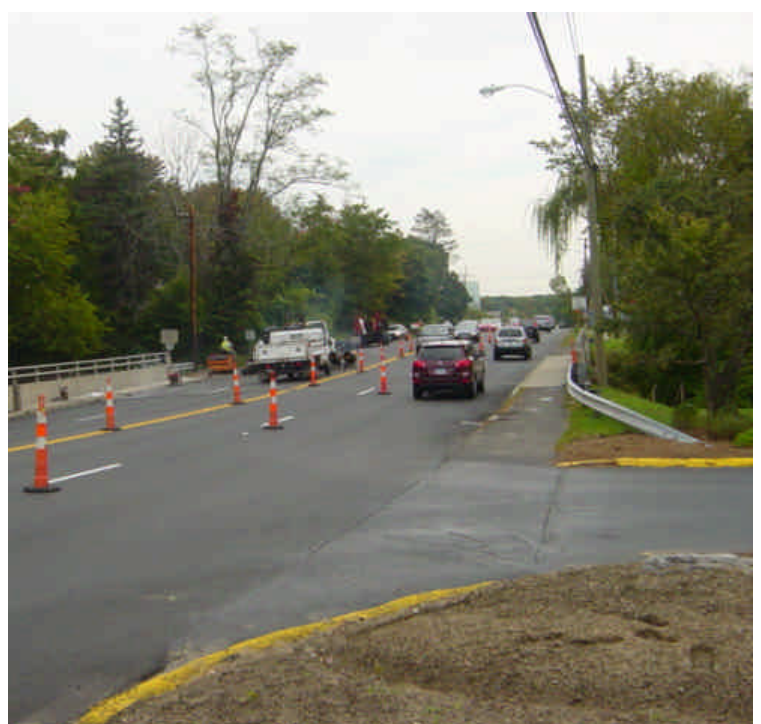
Asphalt road work was observed near sta. #435 at the Sasco Creek bridge crossing.
