**Docket No. 272 – Development and Management Plan Inspection**

**Segment 4b Underground Line**

**Date:** October 16, 2008

**Location:** Westport Avenue to the Norwalk Substation in the City of Norwalk

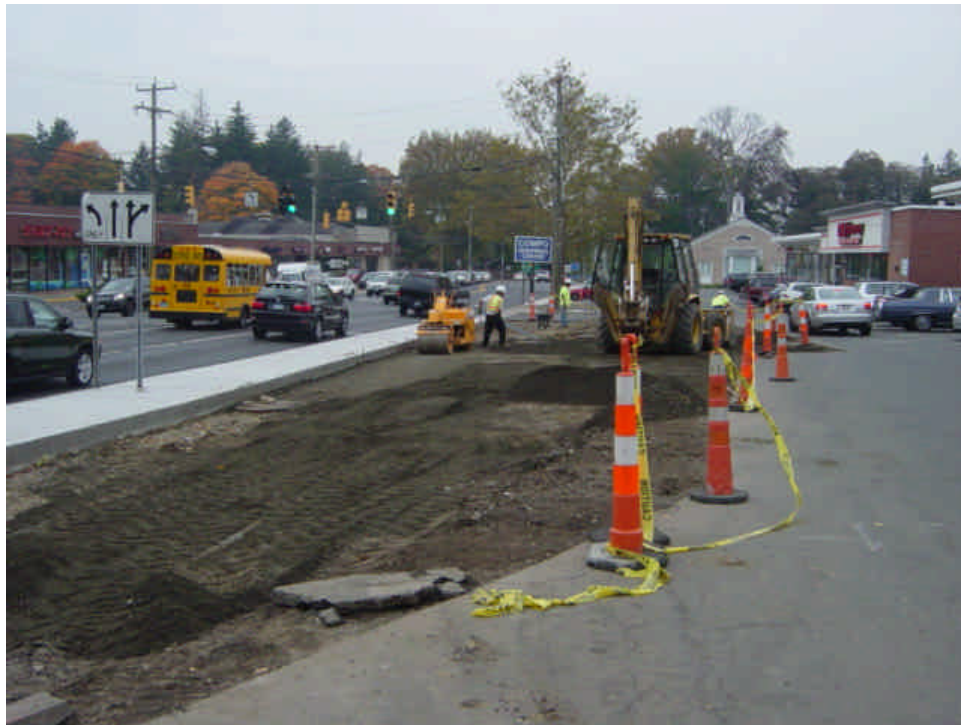
**Restoration efforts were underway near sta. #283-284 at vault #17.**

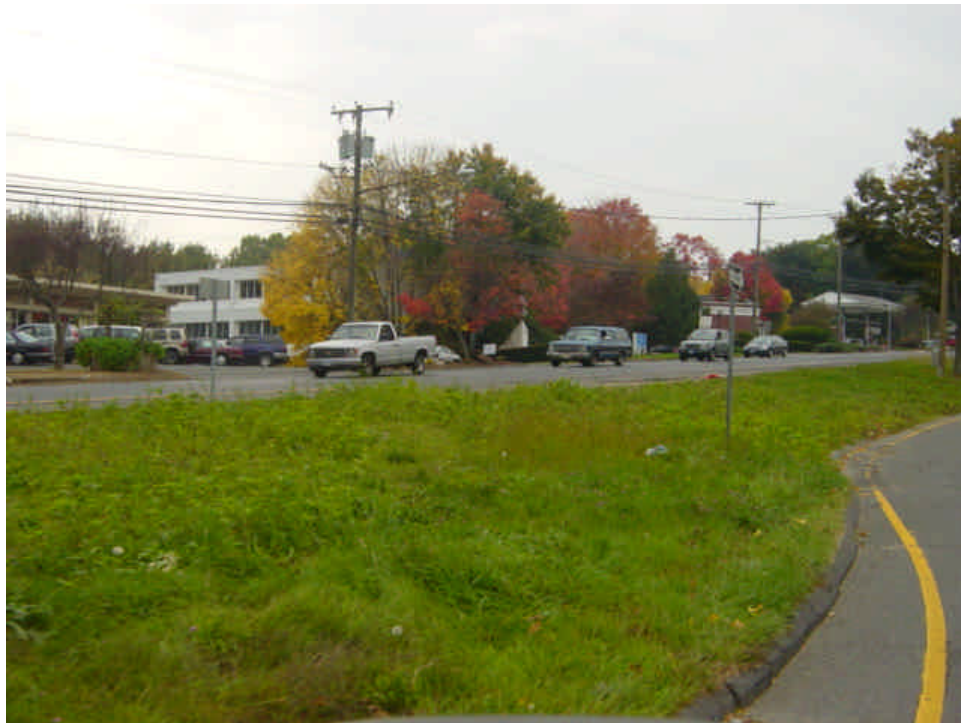
**The area near sta. #316-318 has vegetated with weedy growth and grass cover. Bituminous curbing still needs to be restored in this area.**
