Docket No. 272 – Development and Management Plan Inspection

Segment 4b Underground Line

Date: October 24, 2008

Location: Westport Avenue to the Norwalk Substation in the City of Norwalk

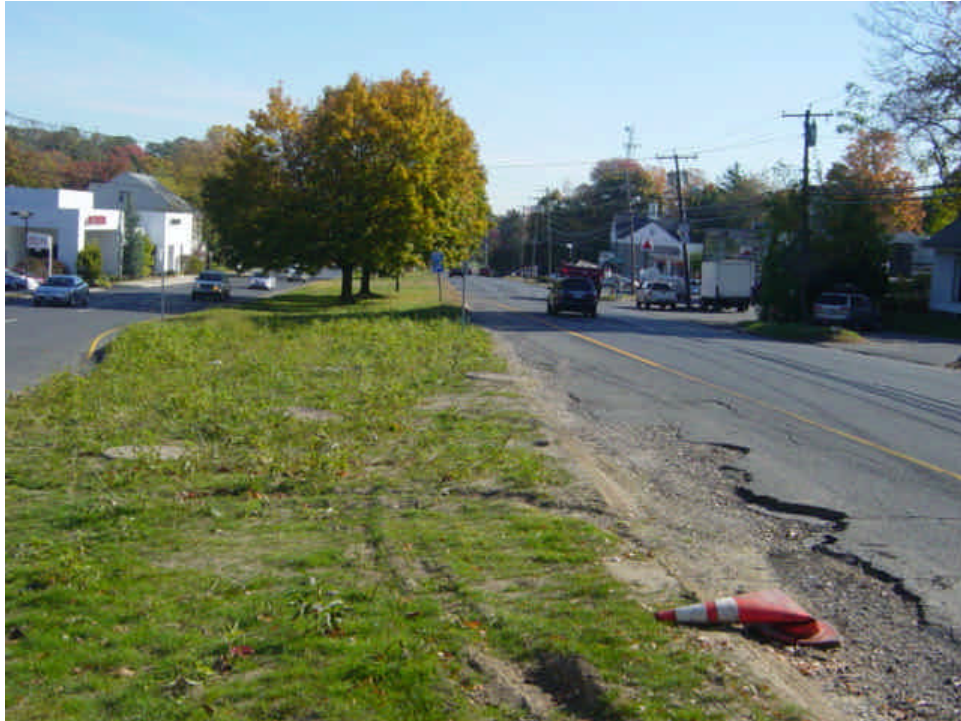
The area near sta. #316-318 has vegetated with weedy growth. Ruts and eroded gullies were observed in a few locations. Bituminous curbing and edge of pavement still need to be restored.

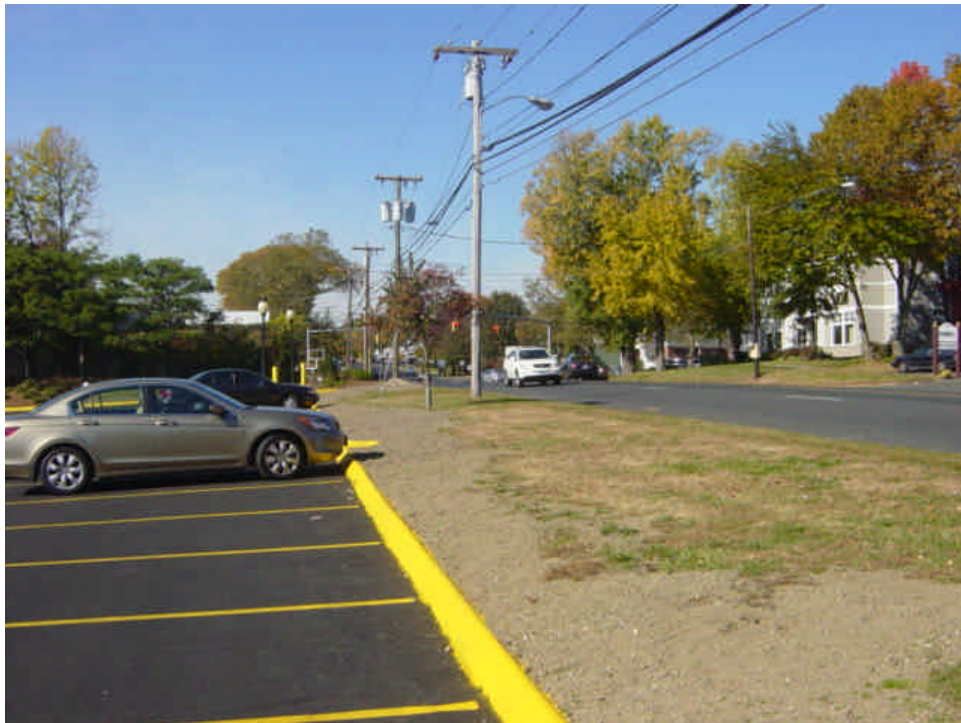
Area near vault #26 has been restored and portions of the area are beginning to revegetate. Ensure areas of exposed soil are stable prior to the winter.
