Docket No. 272 – Development and Management Plan Inspection

Segment 4b Underground Line

Date: November 7, 2008

Location: Westport Avenue to the Norwalk Substation in the City of Norwalk

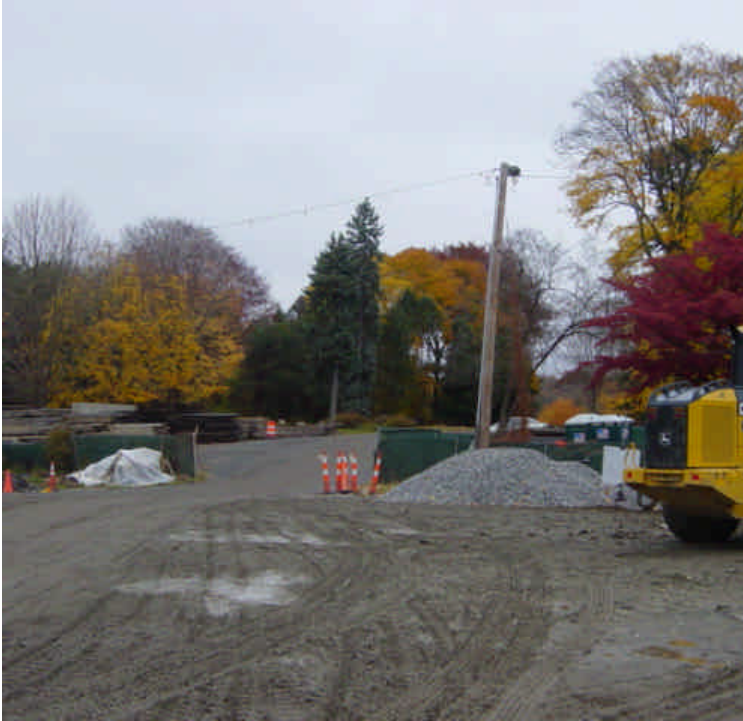
No tracking or dust issues were observed at the Sherwood Island lay-down yard.

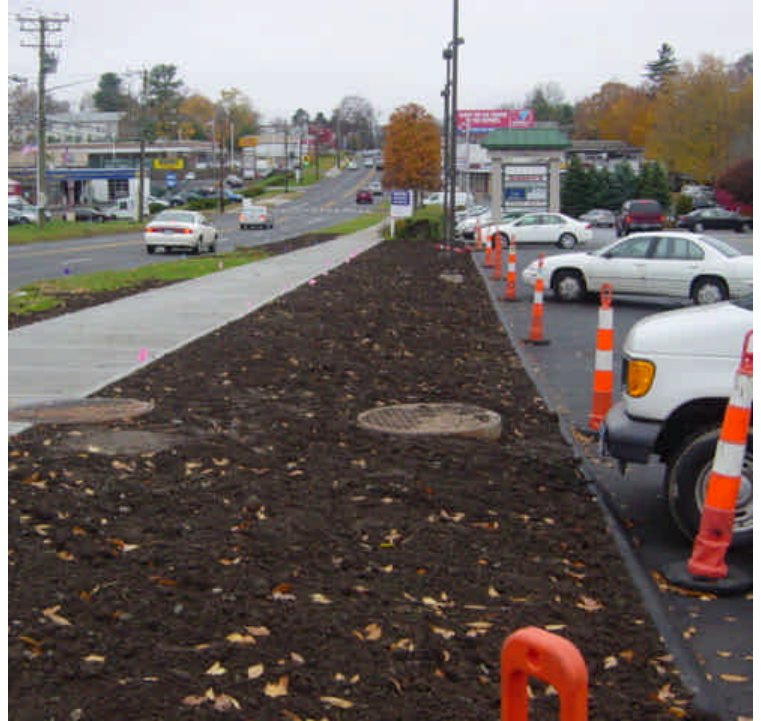
Area near sta. #129-130 has been partially restored. Topsoil has been spread but remains exposed and needs to be stabilized/winterized with mulch.

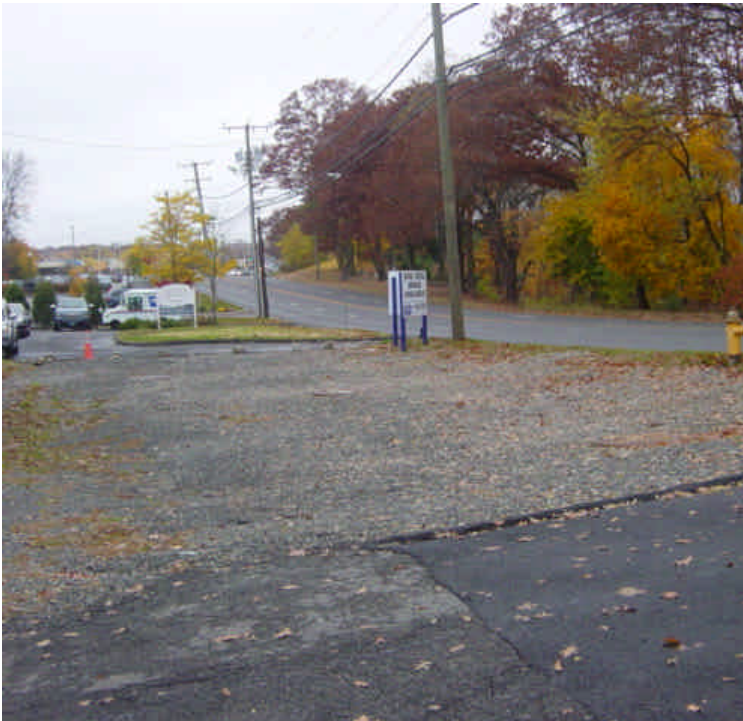
The area near vault #11 has been partially restored.

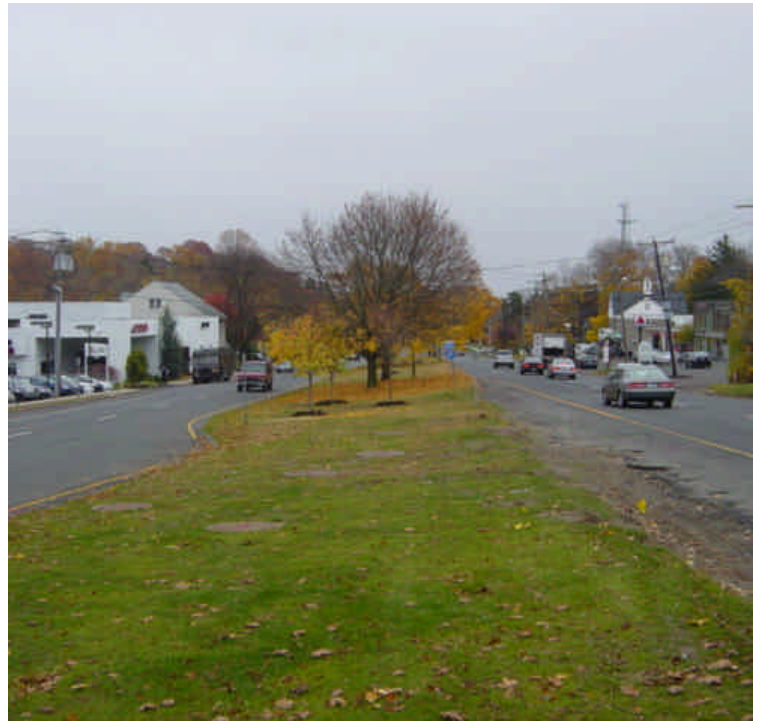
The area near sta. #316-318 has been partially restored. Trees have been planted in the median area. Some ruts remain in a few locations and bituminous curbing still needs to be restored. Damage along the edge of the roadway also needs repair.
