**Docket No. 272 – Development and Management Plan Inspection**

**Segment 4c Underground Line**

**Date:** January 11, 2008

**Location:** Westport Avenue to the Norwalk Substation in the City of Norwalk

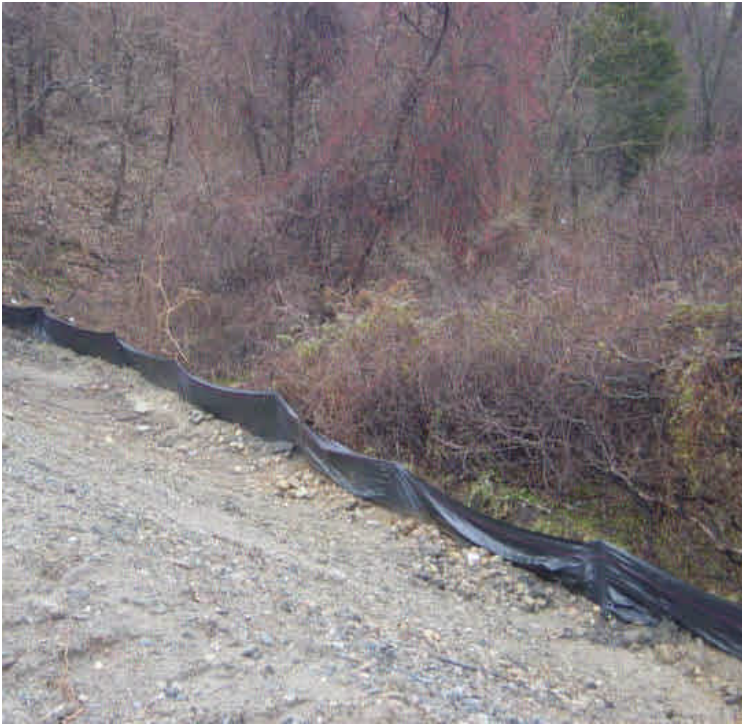
**Silt fence was repaired appropriately at station #15-16. Exposed soil should be temporarily stabilized for the winter.**

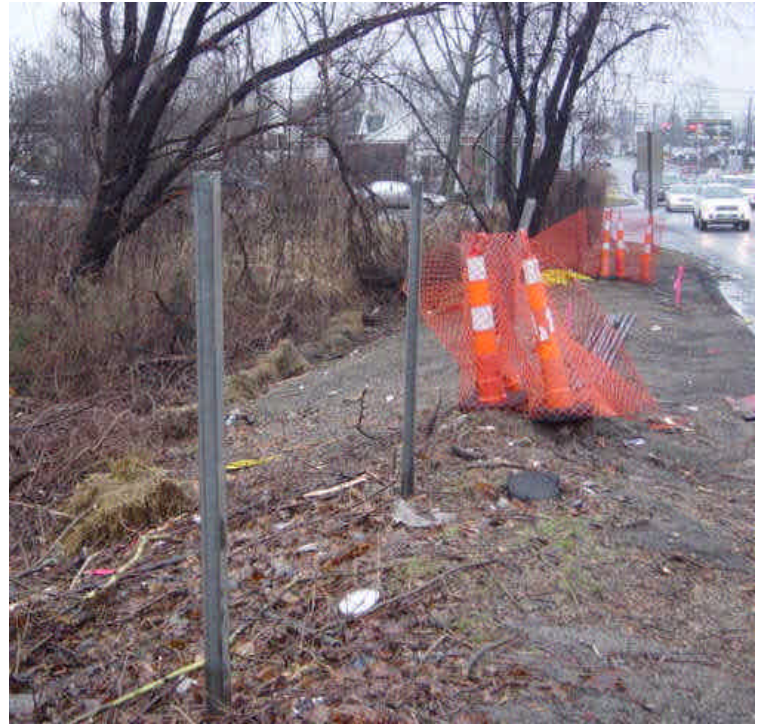
Areas of Inspection	Observation	Recommended Action	Corrected Action
	<p>repaired. 1/11/08</p> <p>Haybales previously placed along the down gradient side of the slope near sta. #18 have been moved, no longer forming a continuous barrier (since 12/5/07). Soils remain exposed (since 11/21/07). Lumber materials and a trench box that were previously piled here have been removed. 1/11/08</p> <p>A drainage inlet near sta. #9+50 remains protected with silt fence and hay bales. Accumulated sediment remains in the inlet. 12/5-1/11/08 Hay bales are also beginning to deteriorate. 1/11/08</p> <p>The inlet at #9+50 was associated with a pre-construction drainage swale. Trench work has modified the grades in the area (removing the swale) and the inlet no longer appears to function. 11/28/07-1/11/08</p> <p>Backfilled soil remains exposed between sta. #6-10 along the shoulder of the Rt. 7 off-ramp since 11/28/07. Active work was occurring between sta. #5-7. Silt fence and a hay berm were installed at sta. #6 on 12/12/07. At sta. #8, erosion is causing soil to wash under the fence into the substation. 1/11/08</p>	<p>Reset haybales along the base of the slope and stake bales in place. Controls are needed as there is no barrier between work and what appears to be a resource area down gradient. 12/21-1/11/08</p> <p>Remove accumulated sediment from the drainage inlet. Continue to monitor controls and refresh as necessary. From past observations during the Bethel- Norwalk project, this inlet receives high velocity run-off. 12/5-1/11/08</p> <p>Contractors have stated they plan to restore the drainage swale to pre-construction conditions when work is complete. Continue to ensure that drainage does not cause issues on the roadway. 1/11/08</p> <p>Temporarily stabilize areas of exposed, inactive soils in a way that is sufficient for winter months. Attend to this within timelines approved by the D&amp;M. 12/21-1/11/08          From past experience with Bethel-Norwalk, this area has a high potential for erosion. 12/5-1/11/08</p>	<p>Lumber was removed, Needs additional attention.</p> <p>Needs additional attention to remove accumulated sediment and refresh hay bales.</p> <p>Continue to monitor. (See Norwalk 9S Phasing and Erosion Control Plan rev. 10/30/03 from the Bethel-Norwalk project as reference)</p> <p>Needs regular attention.</p>

**Haybales down gradient of the slope at station #18 have been moved, no longer forming a continuous barrier. Haybales need to be reset and staked to form a continuous barrier. Exposed soil should be temporarily stabilized for the winter.**
