Docket No. 272 – Development and Management Plan Inspection

Segment 4c Underground Line

Date: January 24, 2008

Location: Westport Avenue to the Norwalk Substation in the City of Norwalk

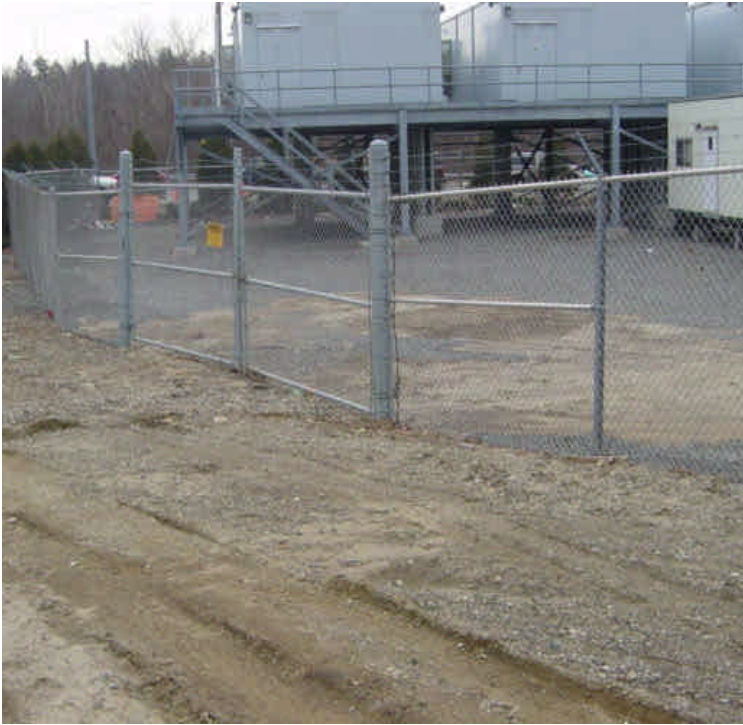
Exposed soil along the Route 7 off ramp near sta. #9 has eroded and sediment has migrated into the adjacent substation. Contractors stated that they placed additional stone here following the inspection.

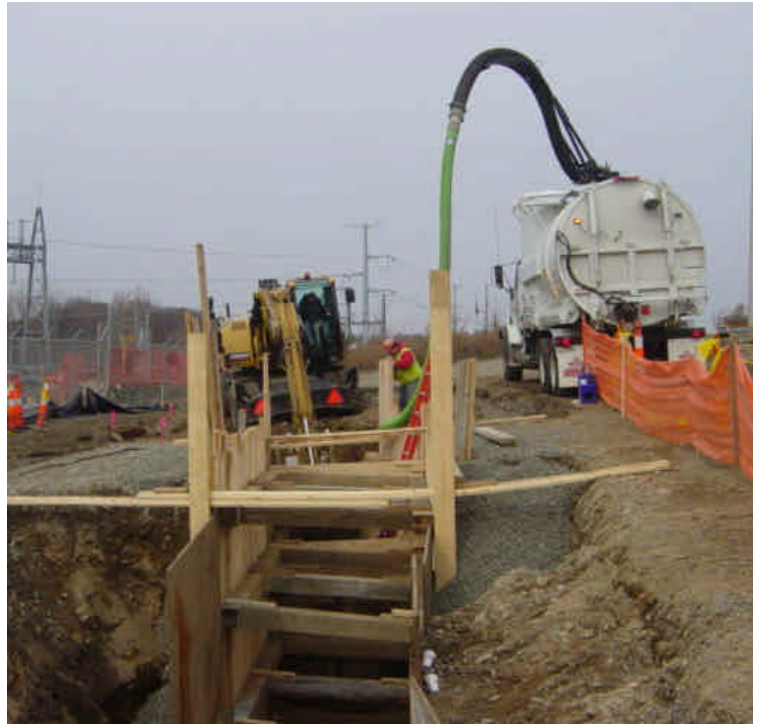
Trenchwork continues near sta. #4 along the substation fence and Rt. 7 off-ramp.

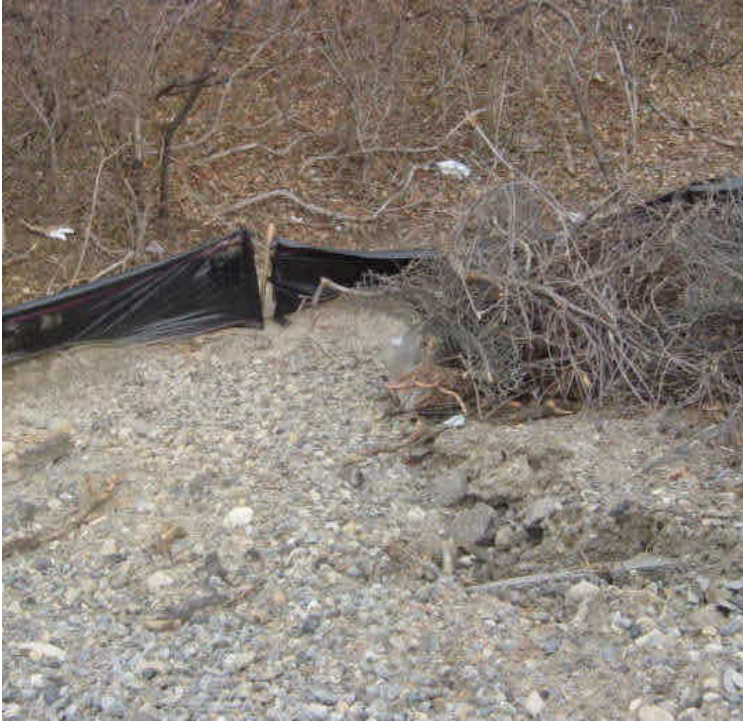
Silt fence has been repaired near sta. #15-16 but there is a small break in the fence, where a gully has formed. Sediment is eroding in this location and is beginning to migrate beyond the silt fence barrier.

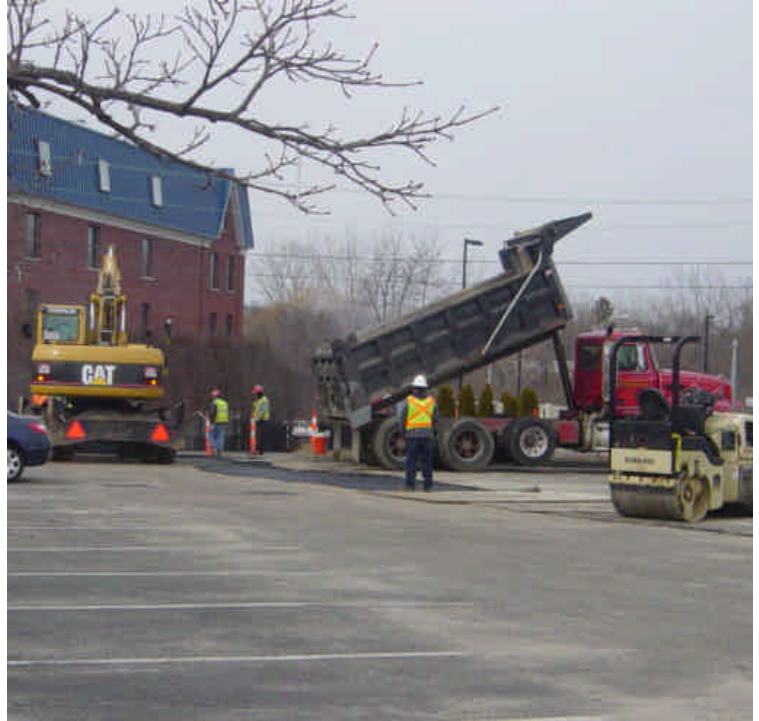
Trenching activities have been completed near sta. #23-24 and crews are re-paving the area.
