**Docket No. 272 – Development and Management Plan Inspection**

**Segment 4c Underground Line**

**Date:** January 31, 2008

**Location:** Westport Avenue to the Norwalk Substation in the City of Norwalk

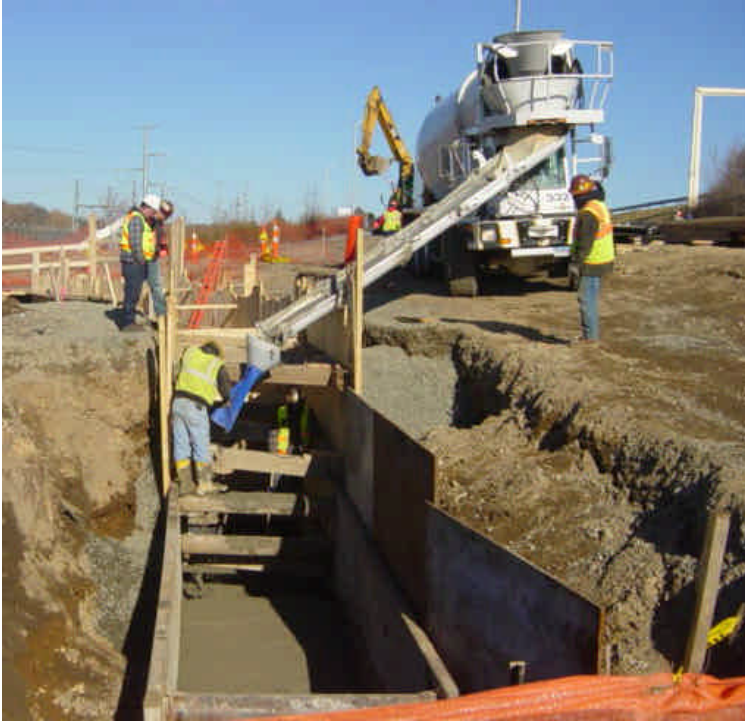
**Trenching and backfilling work continue near sta. #4 along the Norwalk substation fence and the Rt. 7 off-ramp.**

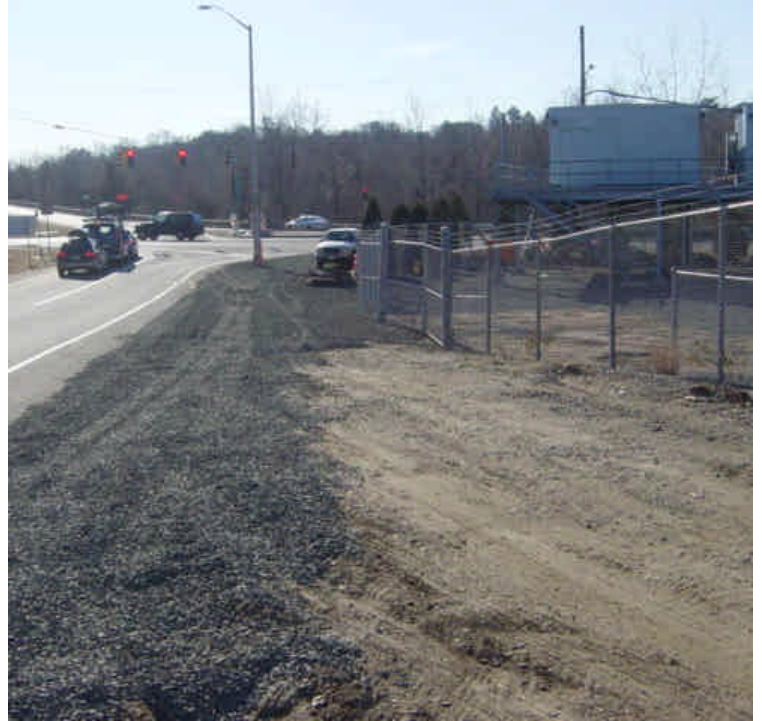
**Crushed stone has been placed over areas of exposed soil along the shoulder of the Route 7 off ramp near sta. #9. Additional erosion control measures may still be required to direct surface runoff away from the substation gate, where sedimentation has previously occurred. Permanent drainage restoration will also be needed at the conclusion of the work**

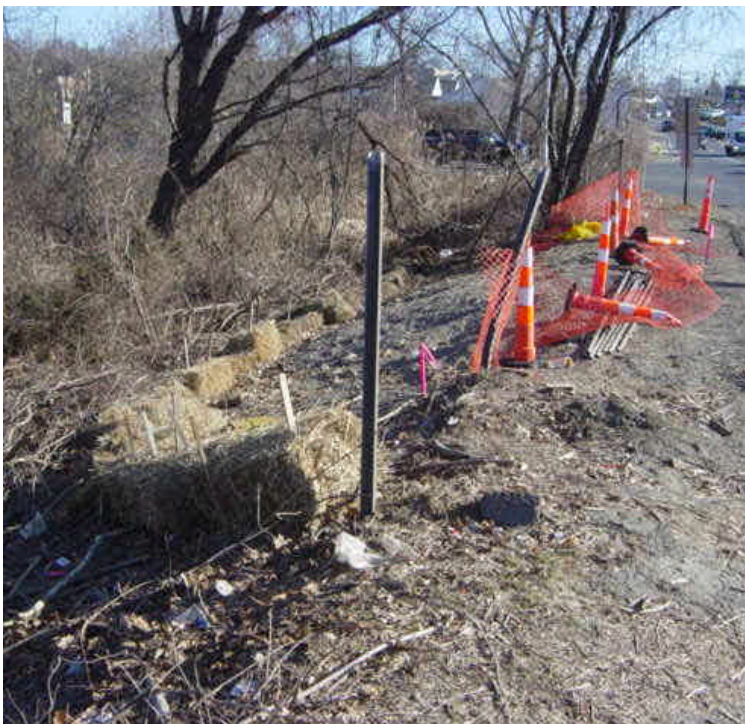
**The haybale barrier near sta. #18 has been re-established and the haybales are properly staked to the ground.**

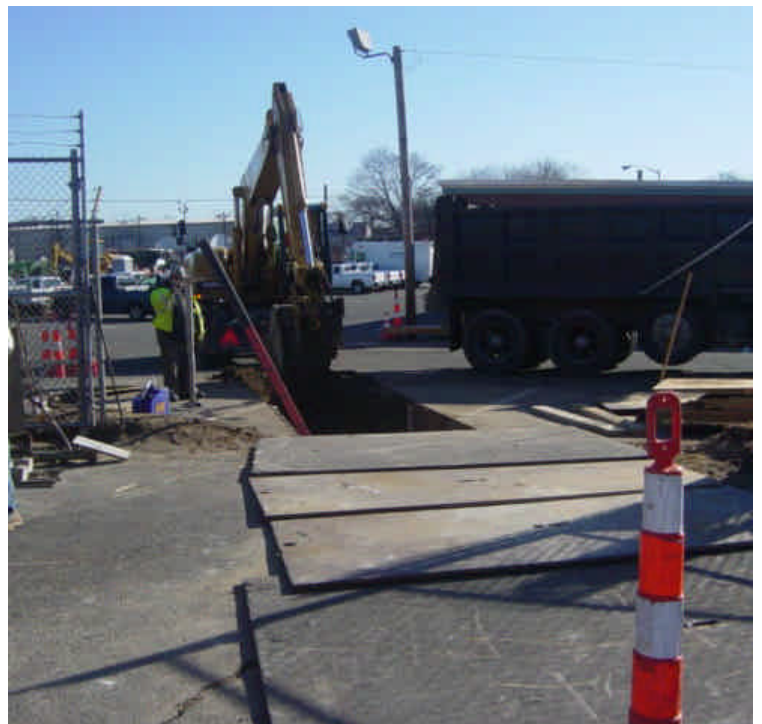
**Trenching activities continue near sta. #24-25.**
