Docket No. 272 – Development and Management Plan Inspection

Segment 4c Underground Line

Date: February 7, 2008

Location: Westport Avenue to the Norwalk Substation in the City of Norwalk

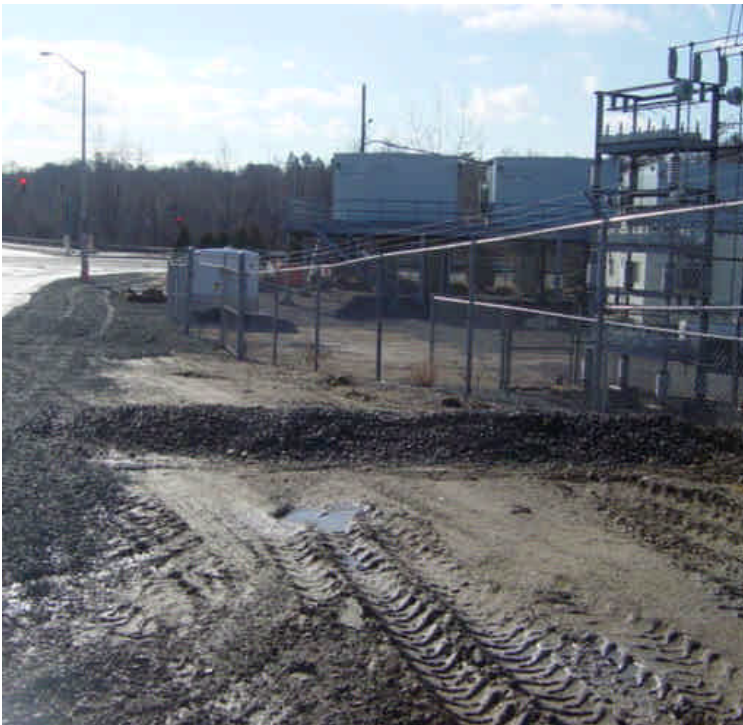
A stone berm has been placed along the shoulder of the Rte. 7 off-ramp near sta. #8 to direct run-off away from the entrance to the adjacent substation. Ensure that this solution does not result in problems to the roadway instead.

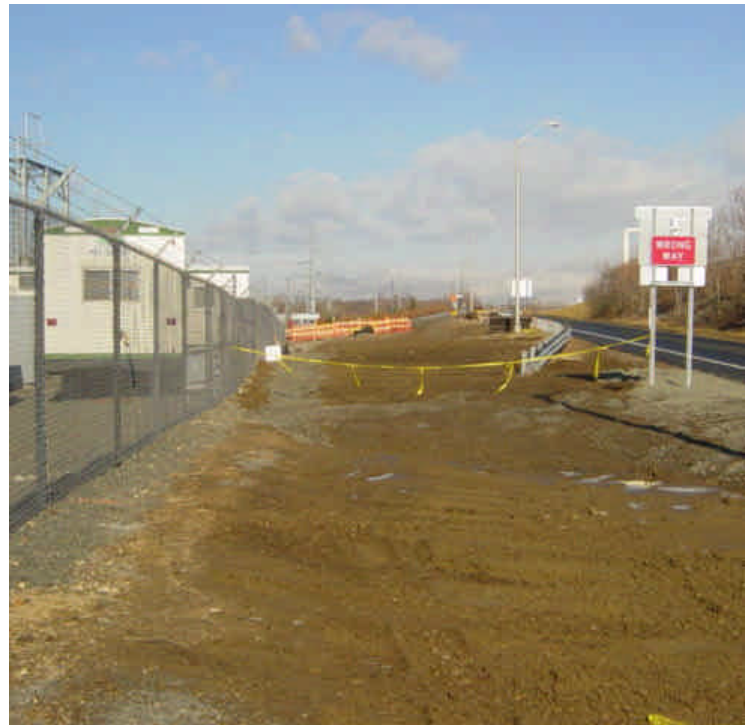
Drainage swale has been partially restored between sta. #4+50 to 6+50. Crushed stone has been placed along the swale. Surrounding areas have been temporarily backfilled with process material and graded. When conditions allow, evaluate whether landscaping and vegetation should be restored.

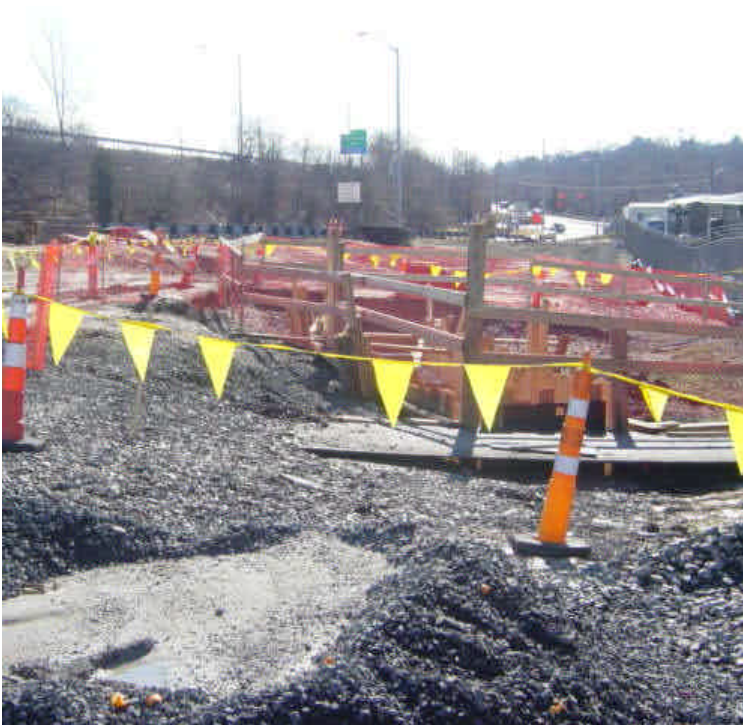
Trench between sta. #3 to 4 has been partially backfilled but remains open. A properly contained concrete washout area was established near the trench.

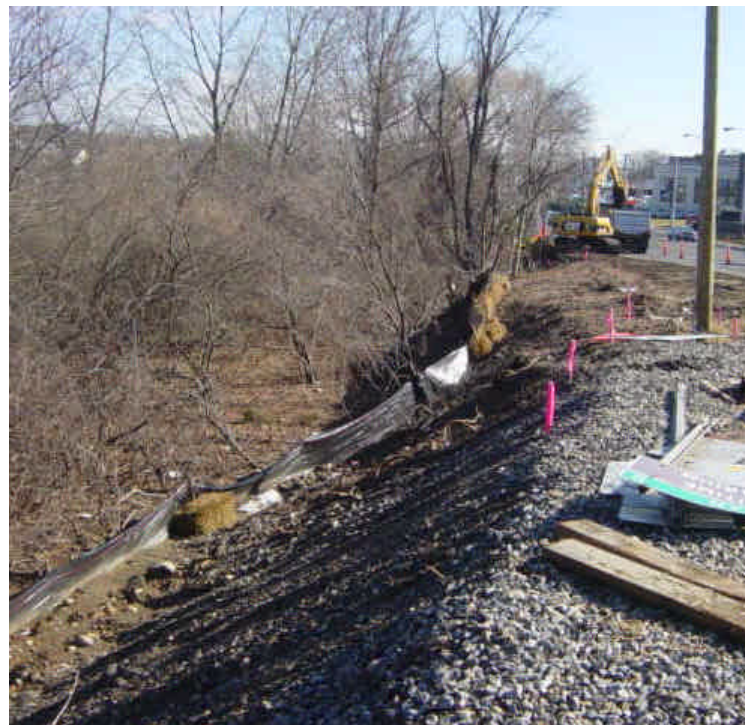
The hay bale and silt fence barrier has been extended along the slope between sta. #15 to 18. Trenching continues near sta. #18. A hay bale has also been placed between the break in the silt fence near sta. #15.
