Docket No. 272 – Development and Management Plan Inspection

Segment 4c Underground Line

Date: February 14, 2008

Location: Westport Avenue to the Norwalk Substation in the City of Norwalk

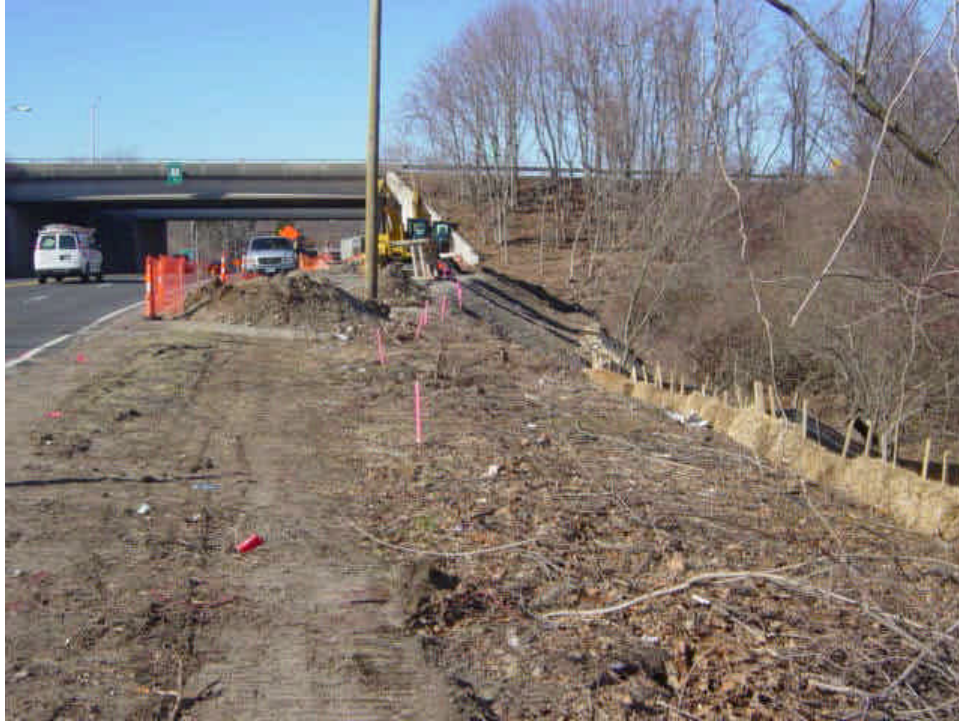
The hay bale and silt fence barrier has been extended along the slope between sta. #15 to 18. Some small stockpiles were noted in the work area.

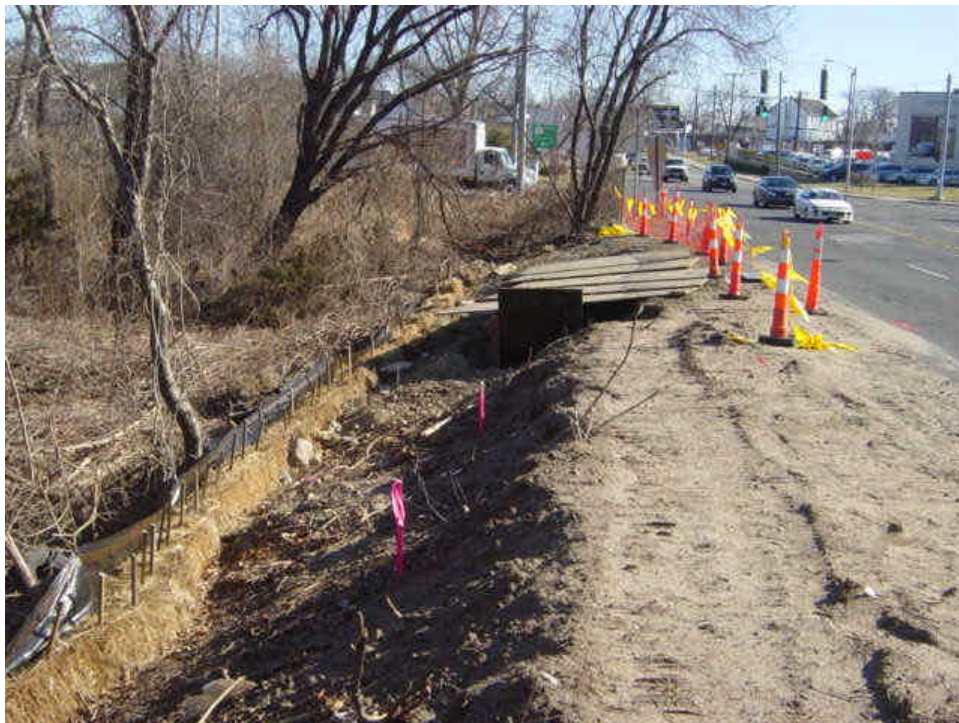
Another view of the hay bale and silt fence barrier in place along the slope between sta. #15 to 18. Controls are in good shape. No active work was occurring at the time of this week's inspection
