Docket No. 272 – Development and Management Plan Inspection

Segment 4c Underground Line

Date: February 27, 2008

Location: Westport Avenue to the Norwalk Substation in the City of Norwalk

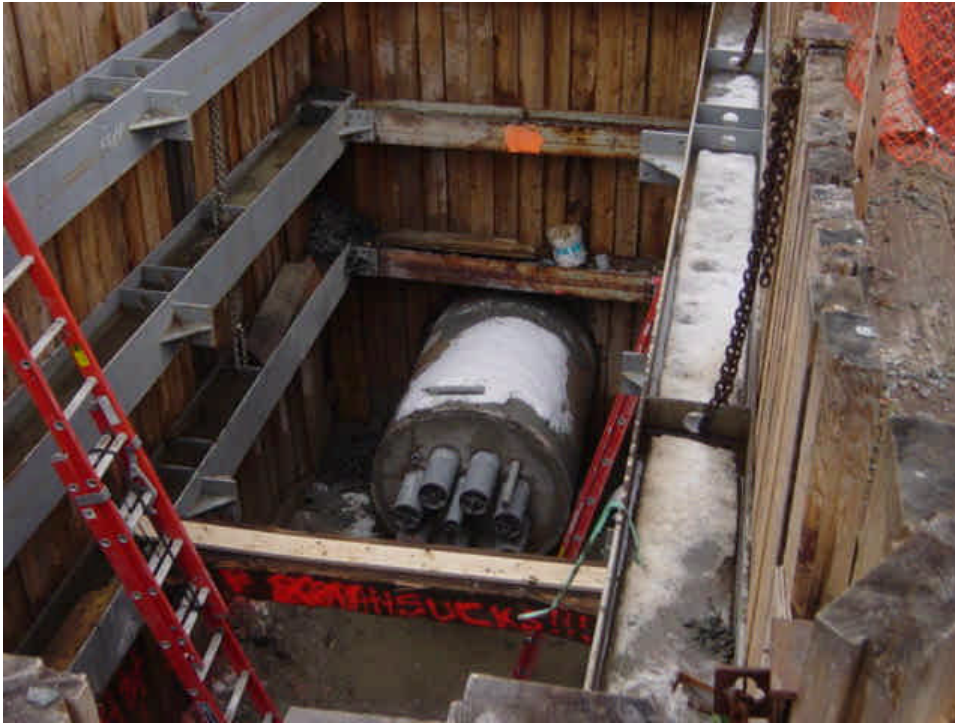
View of the conduit and casing at the jack and bore pit near station #25, where the project crosses a railroad bed.

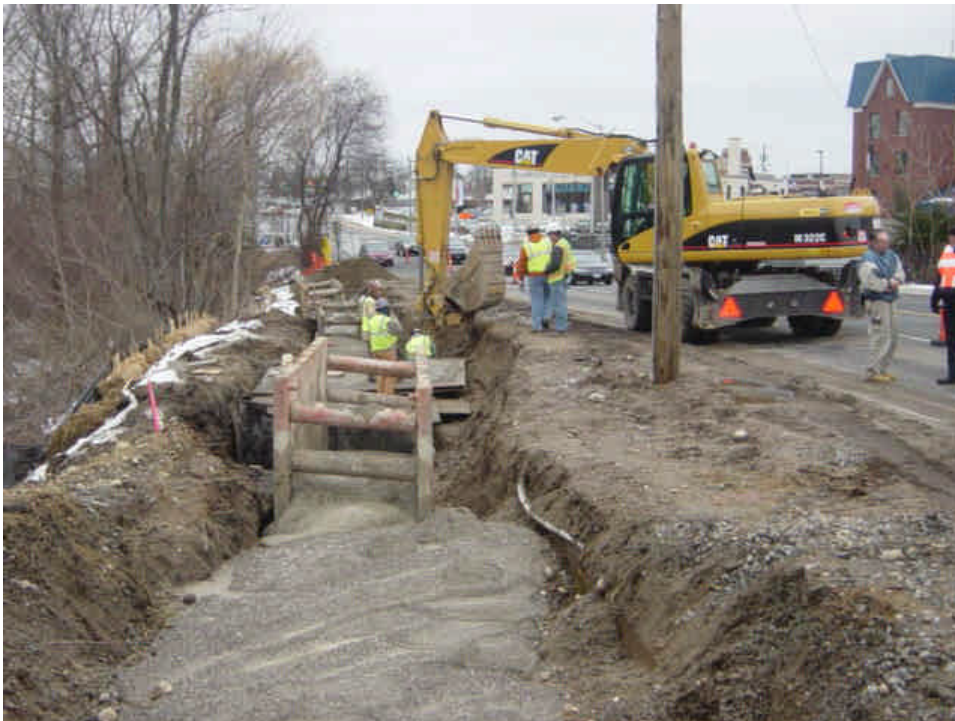
At stations #16-17, trenching and backfilling continue.
