Docket No. 272 – Development and Management Plan Inspection

Segment 4c Underground Line

Date: April 10, 2008

Location: Westport Avenue to the Norwalk Substation in the City of Norwalk

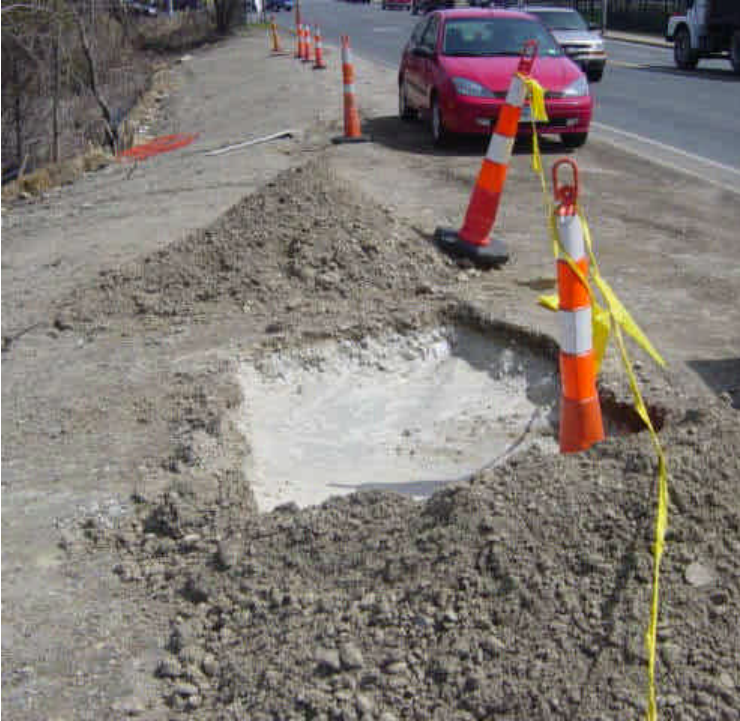
A concrete washout area was observed near sta. #16. Attempts were made to contain the area but additional controls are needed. The dirt berms should be built up if the area will be used further.

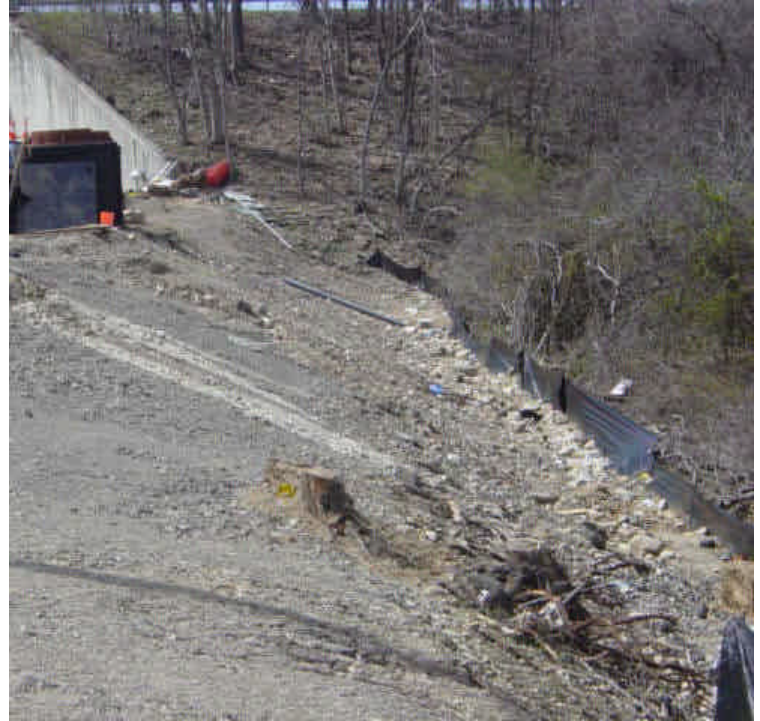
Silt fence remains in place along the slope between sta. #15-18. Sediment and debris are beginning to accumulate along the fence.

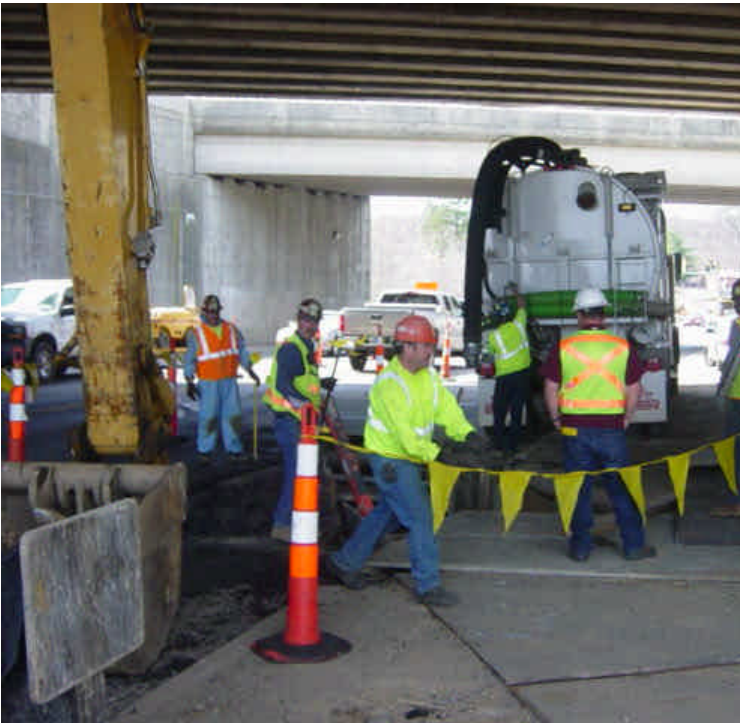
Trenching activities continue near sta. #13-14. The trench was being properly dewatered using a vac truck.

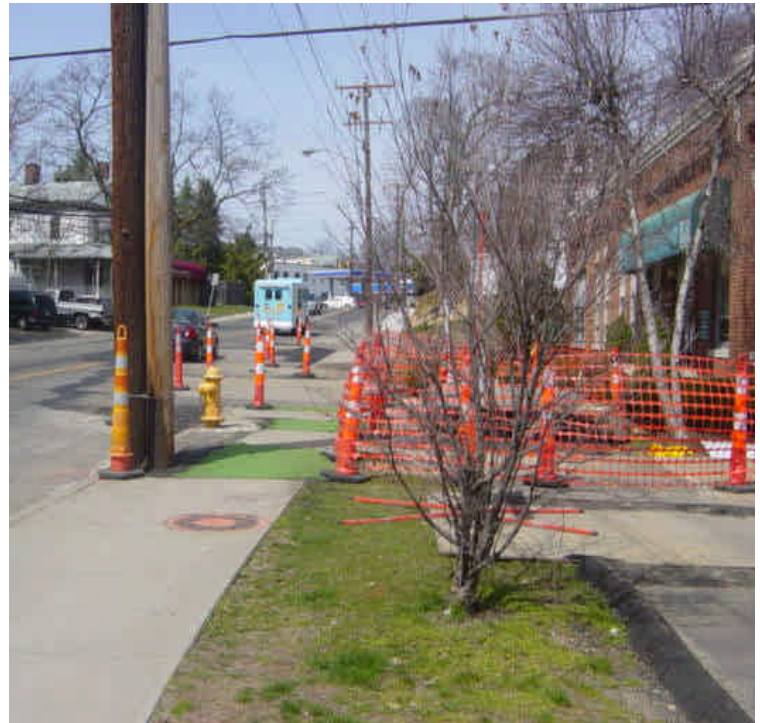
Trenching continues near sta. #50-51. Steel plates are in place in the roadway and adjacent parking lot.
