Docket No. 272 – Development and Management Plan Inspection

Segment 4c Underground Line

Date: April 17, 2008

Location: Westport Avenue to the Norwalk Substation in the City of Norwalk

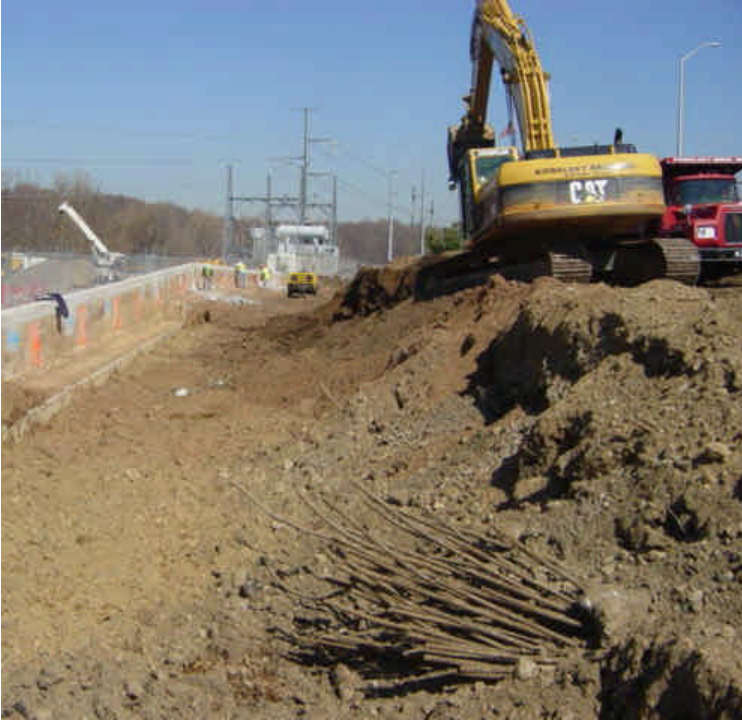
Earthwork is being performed near sta. #1-3 in preparation for final trenching to tie-in to the Norwalk Substation.

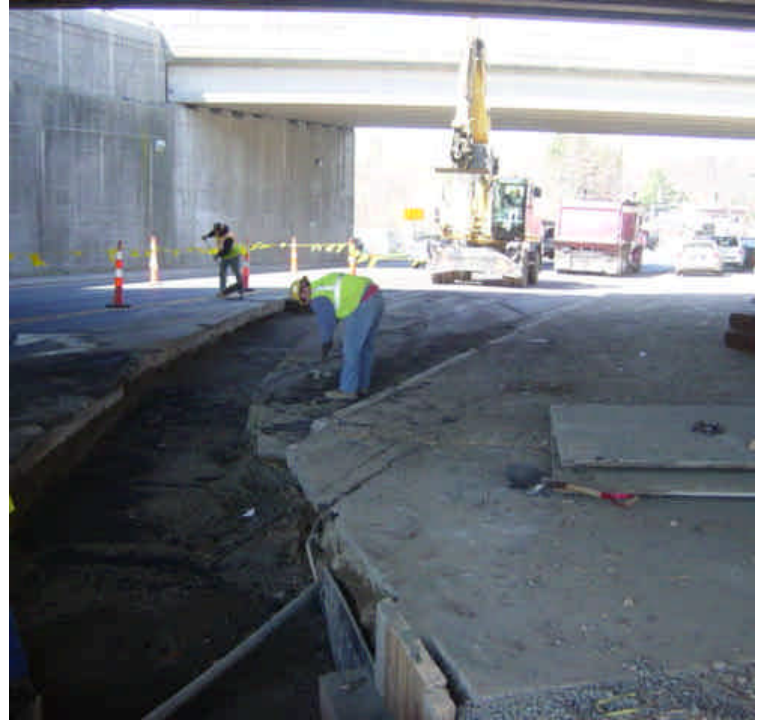
Backfilling continues between sta. #13-14. Crews were sweeping the roadway to reduce the potential for tracking.

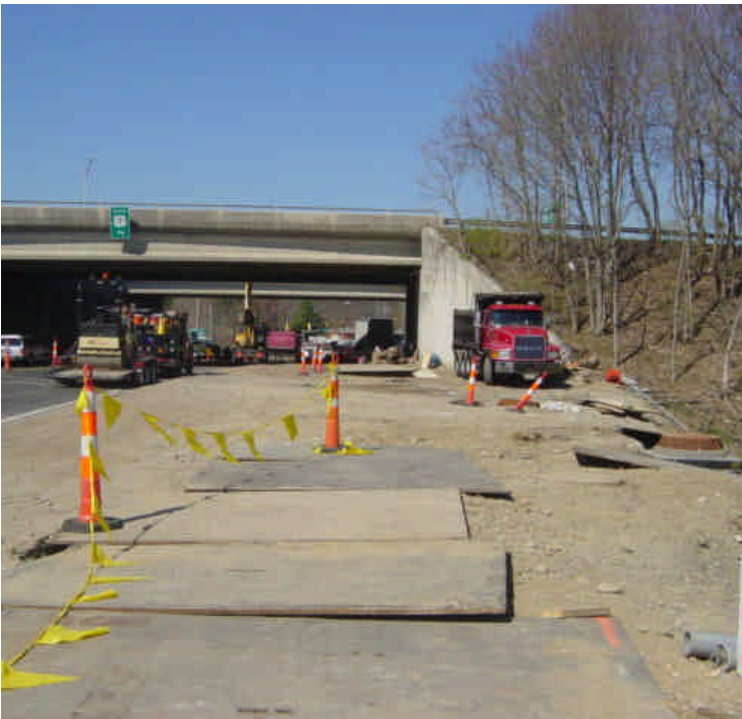
Steel plates are in place near sta. #15 and handholes are being installed. Silt fence remains in place along the toe of the slope, but sediment is beginning to accumulate here.

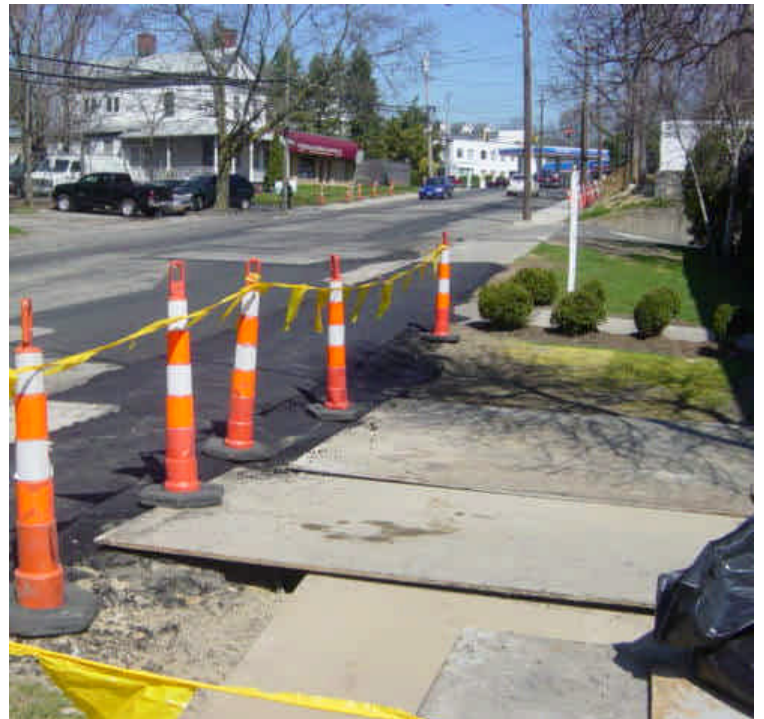
Trenching continues near sta. #50-51. Steel plates are in place along the roadway and adjacent parking lot.
