**Docket No. 272 – Development and Management Plan Inspection**

**Segment 4c Underground Line**

**Date:** May 15, 2008

**Location:** Westport Avenue to the Norwalk Substation in the City of Norwalk

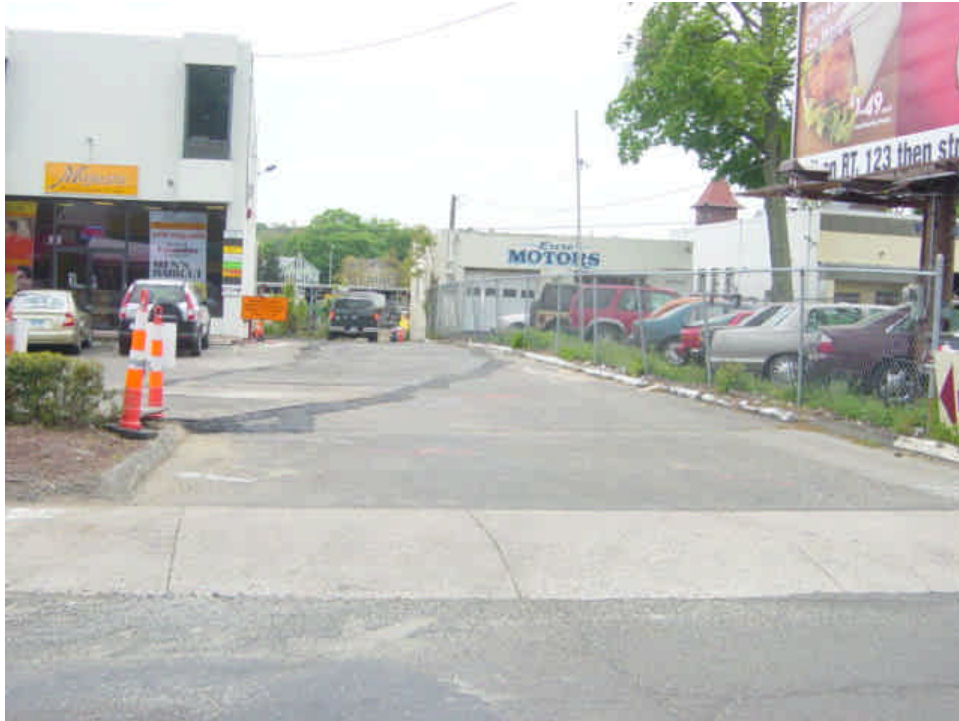
**Trenching continues between sta. #28-30. Steel plates were covering the trench at the time of the inspection.**

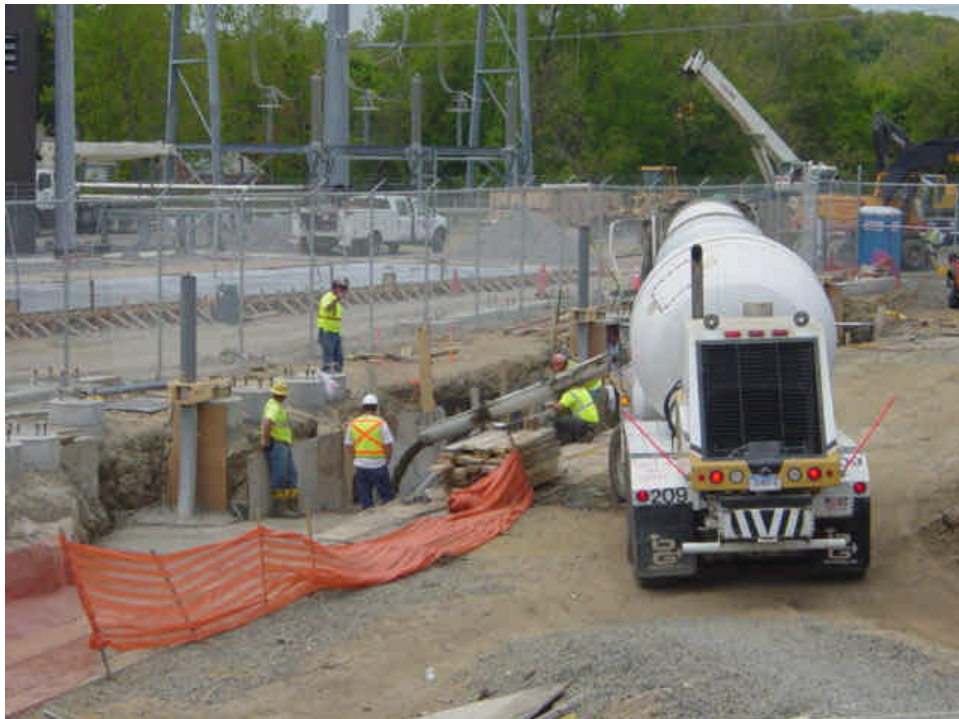
**Conduit has been installed to the bases of the previously placed foundations and the Trench between sta. #0-2 was being backfilled.**
