**Docket No. 272 – Development and Management Plan Inspection**

**The Connecticut Light and Power Company Certificate of Environmental Compatibility and Public Need for the construction of a new 345-kV electric transmission line and associated facilities between Scovill Rock Switching Station in Middletown and Norwalk Substation in Norwalk, Connecticut, including reconstruction of portions of existing 115-kV and 345-kV electric transmission line, the construction of Beseck Switching Station in Wallingford, East Devon Substation in Milford, (and Singer Substation in Bridgeport), modifications at Scovill Rock Switching Station and Norwalk Substation, and the reconfiguration of certain interconnections.**

**Segment 4c Underground Line**

**Date:** May 22, 2008

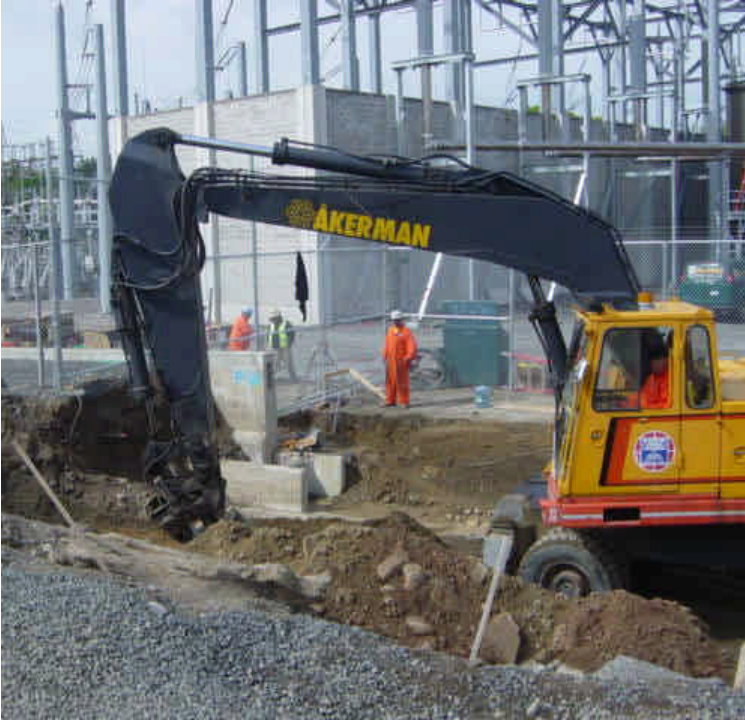
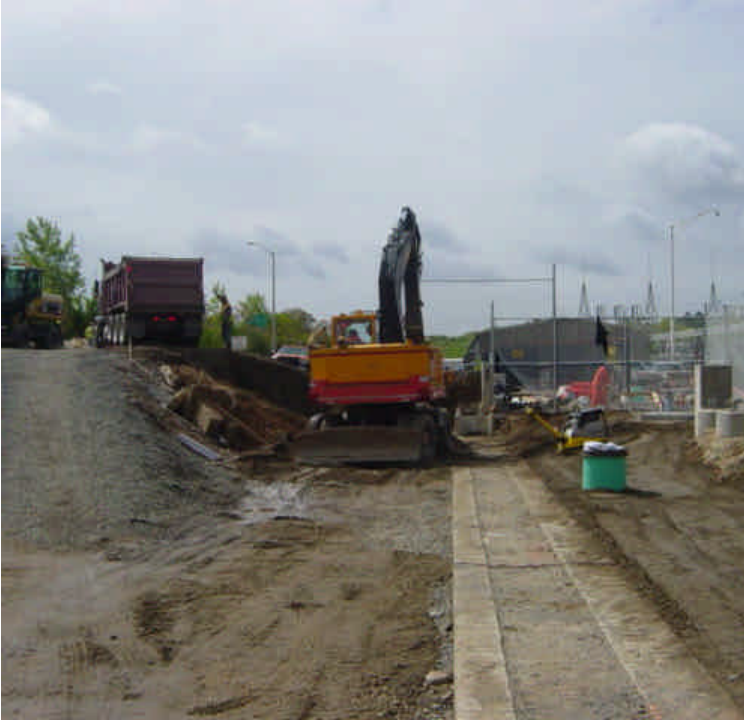
**Backfilling work was ongoing near sta. #0-2. The pre-cast concrete retaining wall was temporarily removed to facilitate trenching work.**

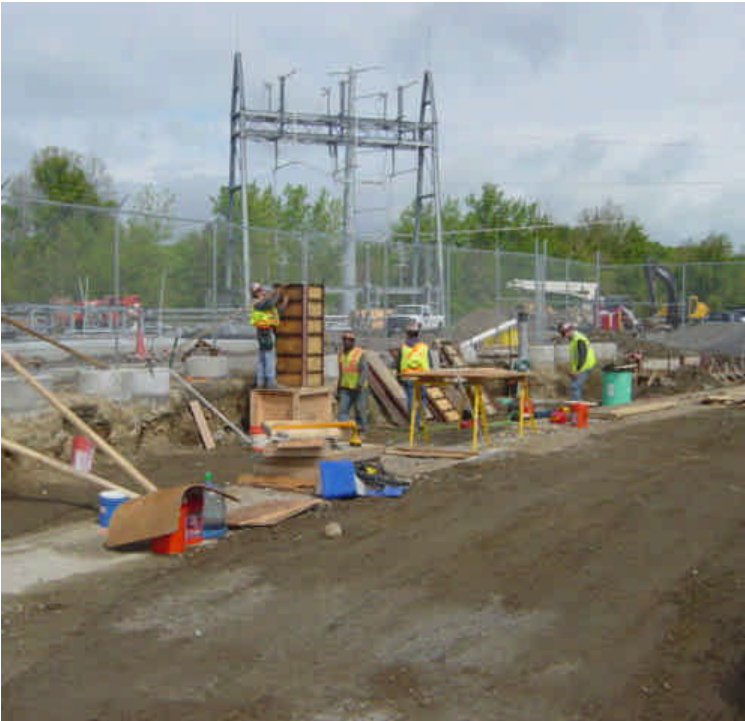
**Crews were forming foundations around the conduits to terminate each of the circuits at the Norwalk substation.**

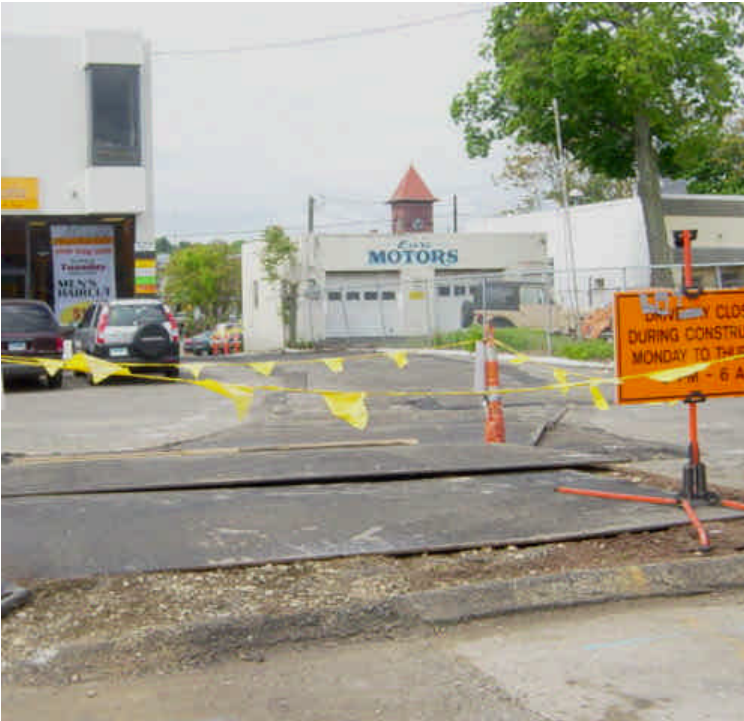
**Steel plates remain in place over the trench near sta. #28-30.**
