Docket No. 272 – Development and Management Plan Inspection

Segment 4c Underground Line

Date: June 12, 2008

Location: Westport Avenue to the Norwalk Substation in the City of Norwalk

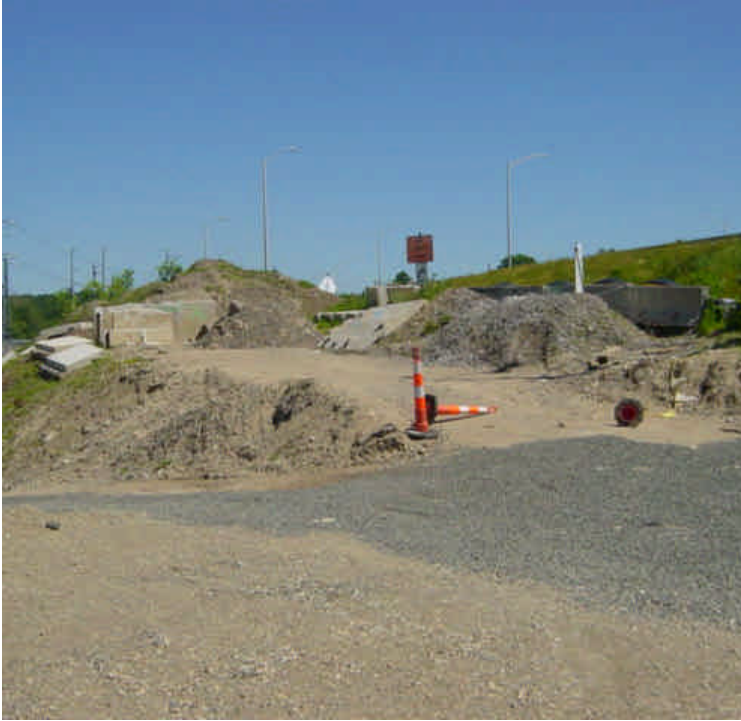
Several stockpiles of material remain along the Rt. 7 off-ramp near sta. #1. Containment has not been provided but erosion/migration issues were not observed.

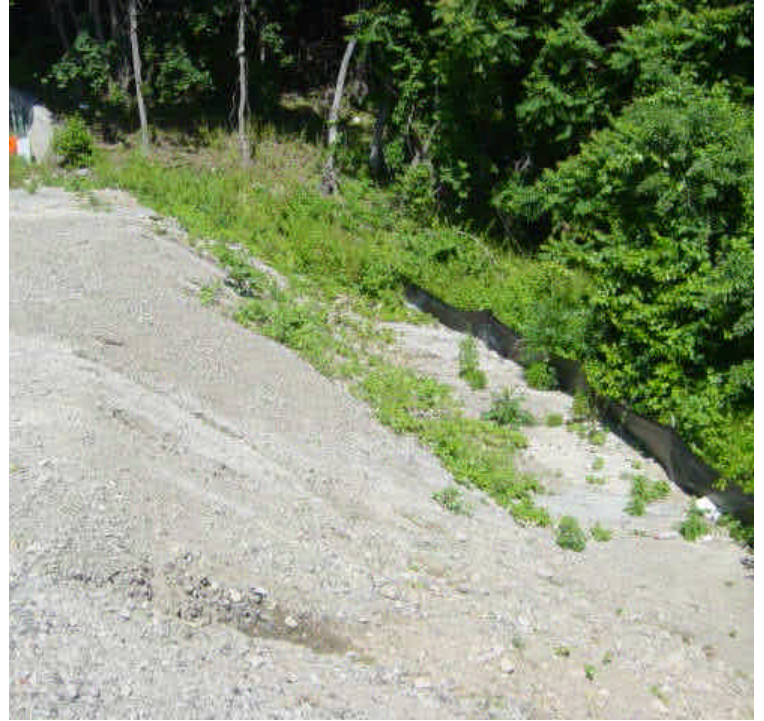
Sediment and debris continues to accumulate along the silt fence near sta. #14-16. Gullies have formed in several areas and portions of the slope are beginning to erode.

Work is complete in the area between sta. #15-18. Silt fence and hay bale barrier remains along the graded slope but portions of the silt fence need	Monitor and maintain silt fence, install additional erosion control measures as necessary. Portions of the silt fence need repair. 5/8-6/12/08	Needs attention.

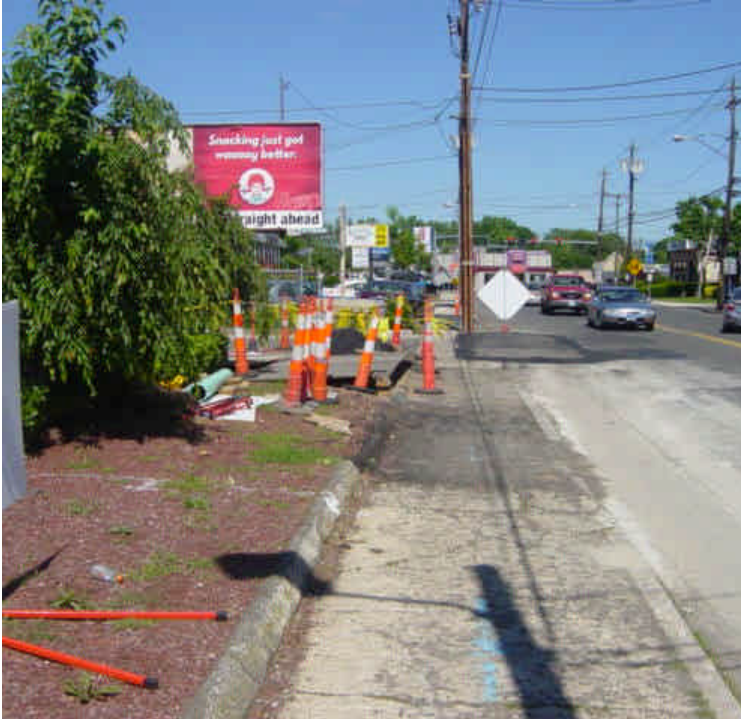
Steel plates remain in the parking lot area over the trench near sta. #31 and #36-38.
