Docket No. 272 – Development and Management Plan Inspection

Segment 4c Underground Line

Date: June 20, 2008

Location: Westport Avenue to the Norwalk Substation in the City of Norwalk

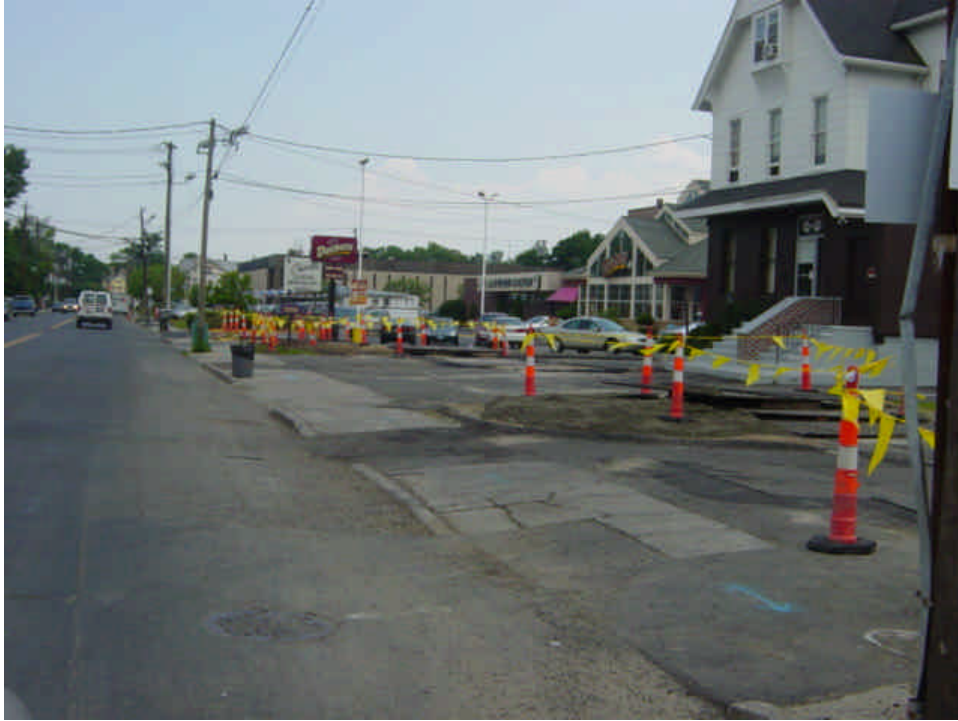
Trenching continues near sta. #36-38. Steel plates were covering the trench at the time of the inspection. Sweep roadway as needed.

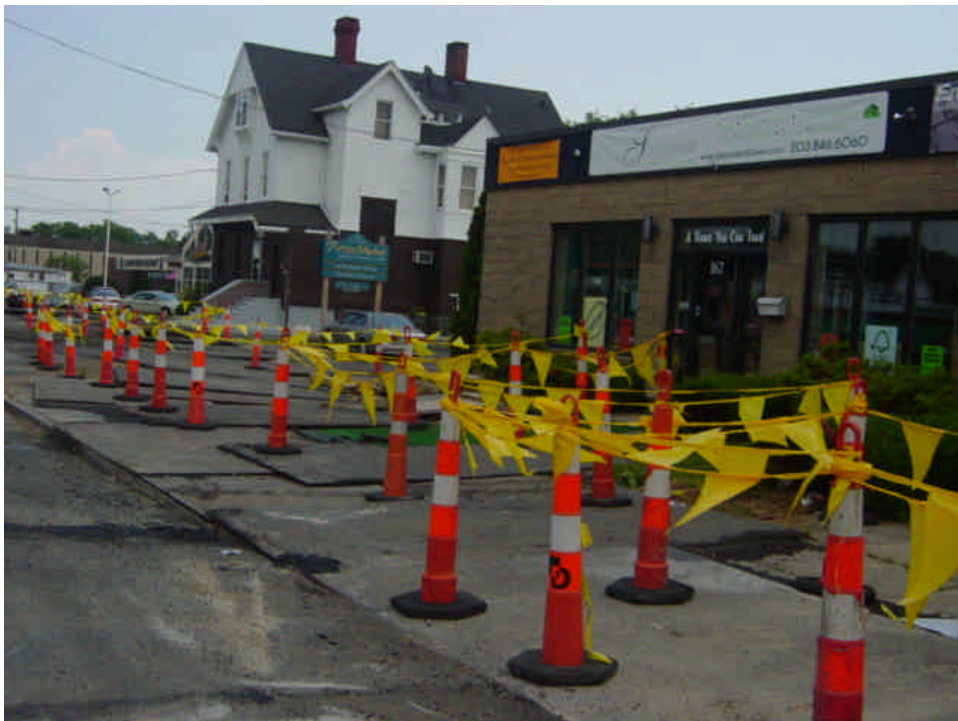
Steel plates remain in the parking lot area over the trench near sta. #36-38.
