Docket No. 272 – Development and Management Plan Inspection

Segment 4c Underground Line

Date: June 27, 2008

Location: Westport Avenue to the Norwalk Substation in the City of Norwalk

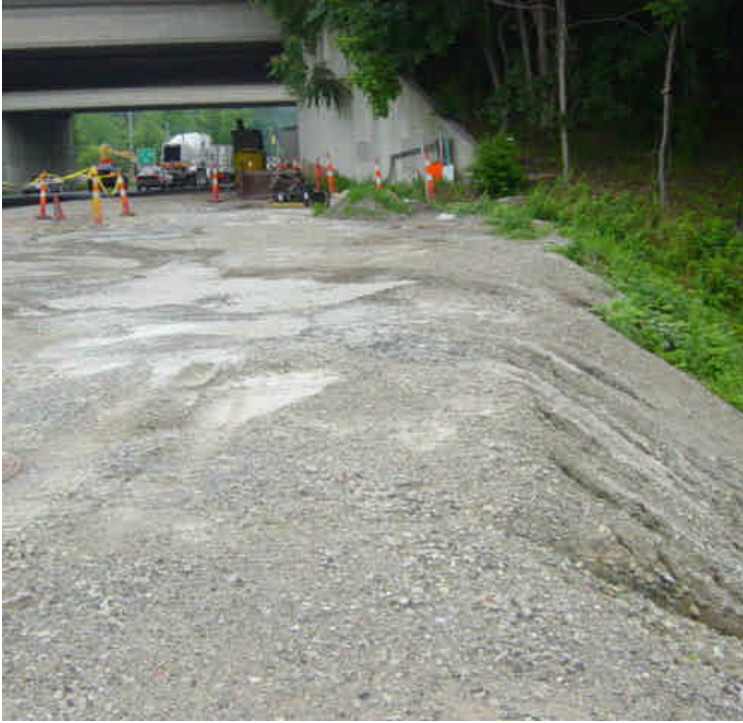
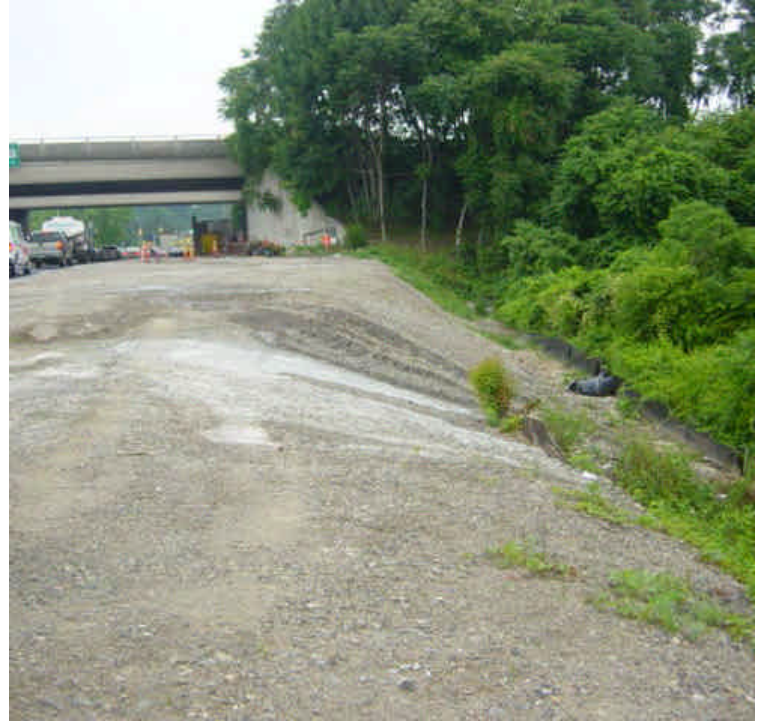
Sediment and debris continues to accumulate along the silt fence near sta. #14-16. Gullies have formed in several areas and portions of the slope are beginning to erode. Evidence of multiple concrete washouts were also observed. There is no active work in this area and it is unclear whether the washouts are project related. This area needs to be restored/stabilized per the D&M timelines.

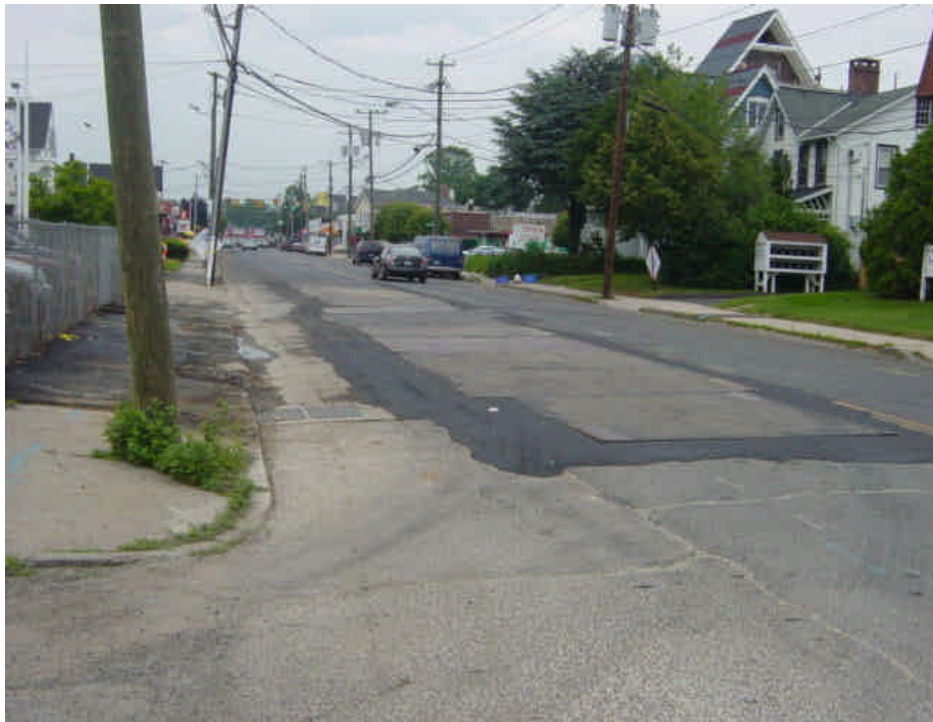
Trenching continues near sta. #40-41. Steel plates were covering the trench at the time of the inspection. A minor amount of granular material was observed along the edge of the roadway adjacent to the catch basin. Sweep as needed and clean the catch basin.
