Docket No. 272 – Development and Management Plan Inspection

Segment 4c Underground Line

Date: July 2, 2008

Location: Westport Avenue to the Norwalk Substation in the City of Norwalk

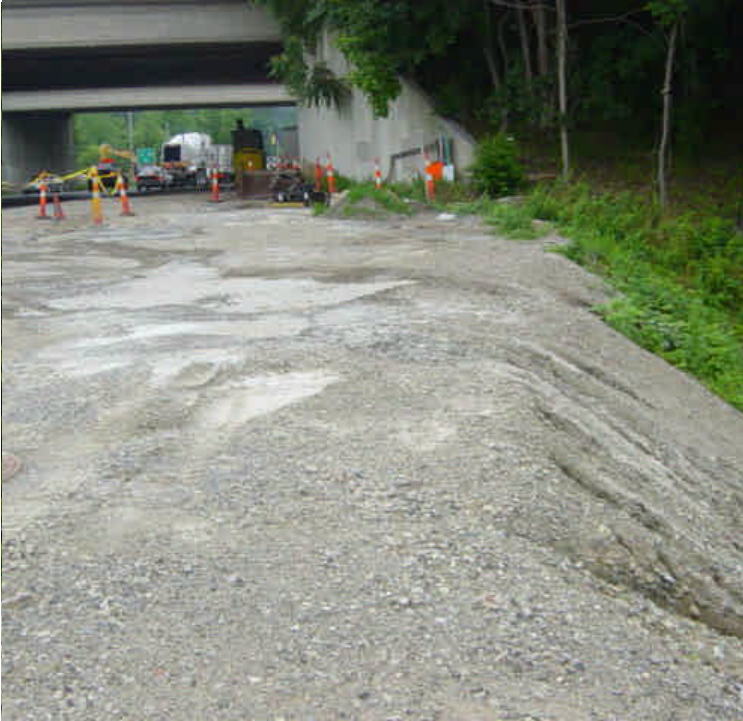
Sediment and debris continues to accumulate along the silt fence near sta. #14-16. Gullies have formed in several areas and portions of the slope are beginning to erode. Evidence of multiple concrete washouts were also observed since 6/27. There is no active work in this area and it is unclear whether the washouts are project related. This area needs to be restored/stabilized per the D&M timelines.

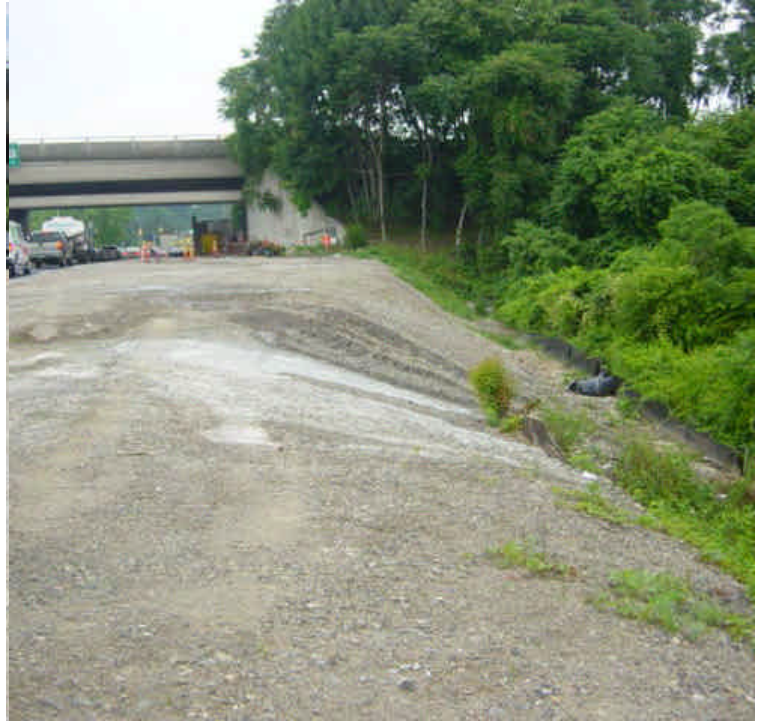
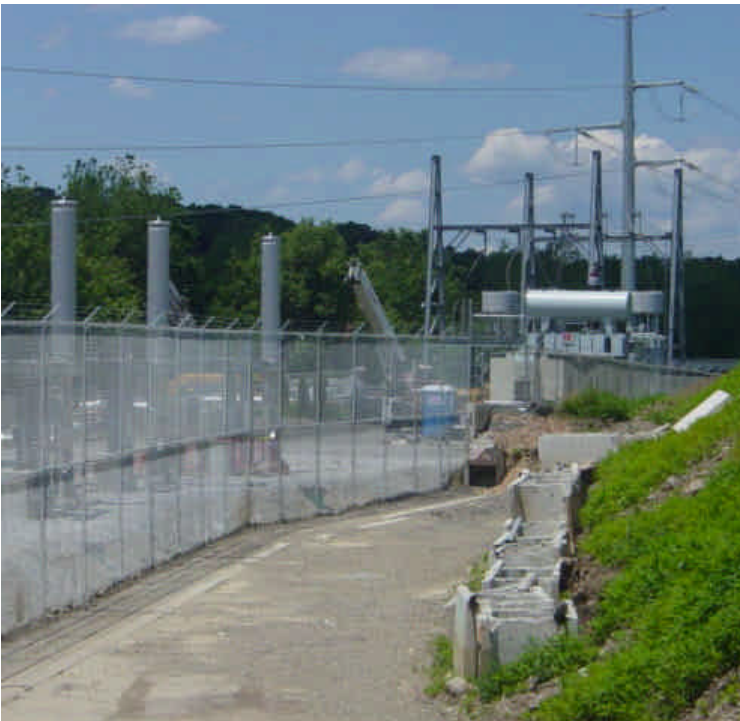
Tie-in work has been completed at the Norwalk substation. The pre-cast concrete wall needs to be restored.

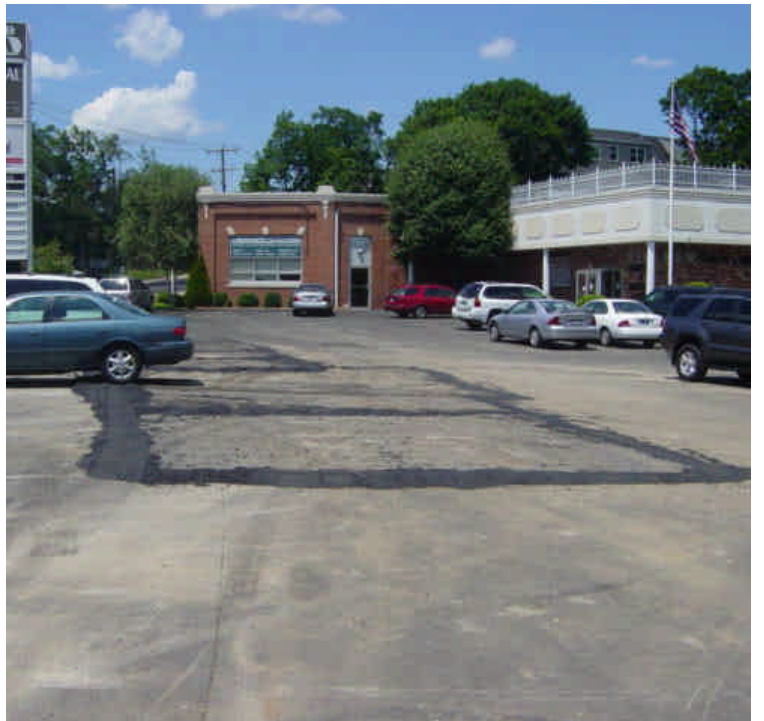
Trenching continues near sta. #52-53. Steel plates were covering the trench at the time of the inspection. A minor amount of granular material was observed along the edge of the roadway/ parking lot. Sweep as needed.
