Docket No. 272 – Development and Management Plan Inspection

Segment 4c Underground Line

Date: July 25, 2008

Location: Westport Avenue to the Norwalk Substation in the City of Norwalk

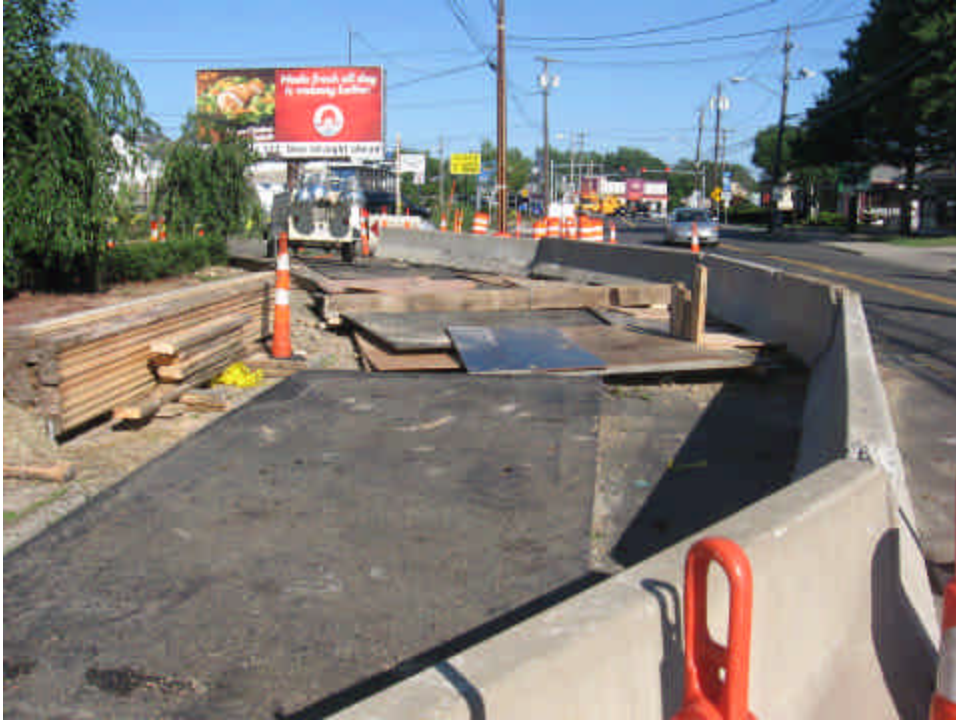
Steel plates were in place over the trench near sta. #32-33. Concrete barriers were also in place around the work area.
