Docket No. 272 – Development and Management Plan Inspection

Segment 4c Underground Line

Date: August 14, 2008

Location: Westport Avenue to the Norwalk Substation in the City of Norwalk

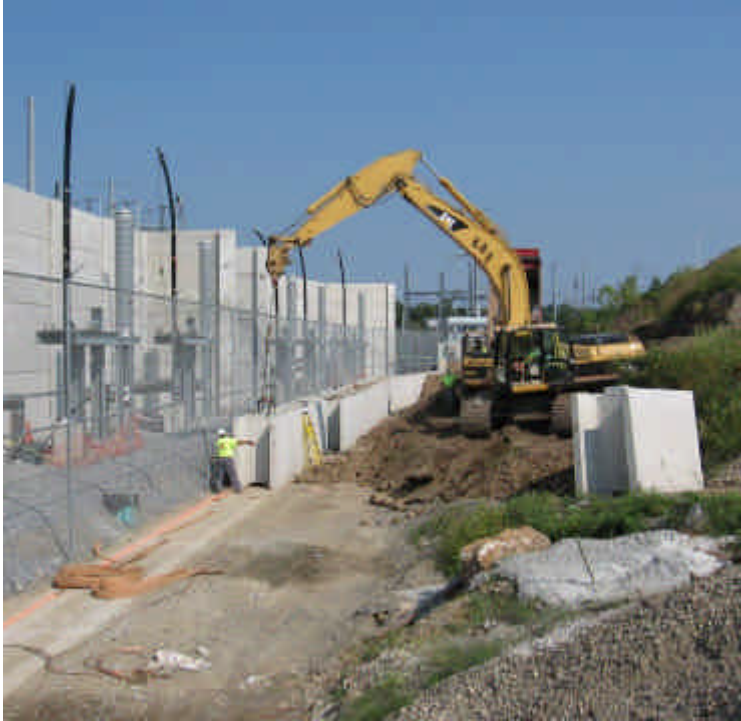
Pre-cast concrete retaining wall was being re-set outside of the Norwalk substation near sta. #0.

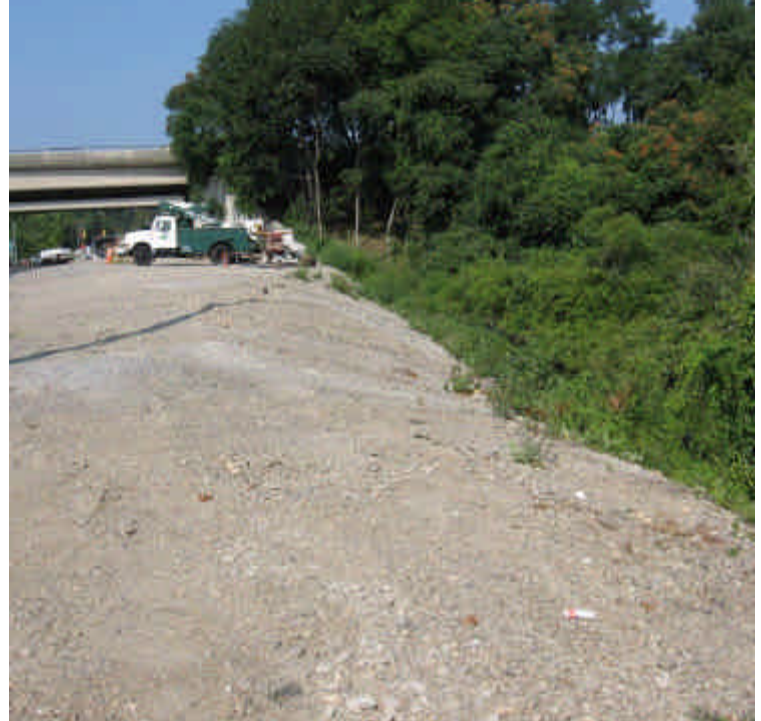
Areas of Inspection	Observation	Recommended Action	Corrected Action
	<p>Sediment and debris continues to accumulate along the silt fence near sta. #14-16 (since 5/1). Gullies have formed in several areas and portions of the slope are beginning to erode. 6/12-8/14/08</p> <p>Work is complete in the area between sta. #15-18. Silt fence and hay bale barrier remains along the graded slope but portions of the silt fence need repair. 5/8-8/14/08</p> <p>The inlet at sta. #9+50 was associated with a pre-construction drainage swale. Trench work has modified the grades in the area (removing the swale). A portion of the swale has been temporarily re-established between sta. #4+50 to 6+50 and lined with crushed stone. 8/14/08</p> <p>A stone check dam remains near sta. #8 to direct runoff away from the entrance gate. Crushed stone remains over some areas of the exposed soil between sta. #6-10 along the shoulder of the Rt. 7 off-ramp. Graded processed material remains in other areas. Tracking was not an issue. 8/14/08</p> <p>Trenching continues in various locations between sta. #31-34 & #38. Steel plates were covering the trench at the time of the inspection. A minor amount of cold mix/</p>	<p>Continue to remove the debris and stabilize the area. Install additional control measures as necessary and permanently stabilize the area. 6/12-8/14/08</p> <p>Monitor and maintain silt fence, install additional erosion control measures as necessary. Portions of the silt fence need repair. 5/8-8/14/08 The area also needs to be stabilized per D&M guidelines. 8/14/08</p> <p>Contractors plan to restore the drainage swale to pre-construction conditions when work is complete. Continue to ensure that drainage does not cause issues on the roadway. From past observations during the Bethel- Norwalk project, this inlet receives high velocity run-off. 8/14/08</p> <p>Discuss options with CL&P on how to address the material that has previously eroded into the substation. 8/14/08</p> <p>Sweep roadway as necessary. Protect catch basin during trenching operations. Clean catch basin when work is complete. 6/27-8/14/08</p>	<p>Needs attention.</p> <p>Needs attention.</p> <p>Continue to monitor. <i>(See Norwalk 9S Phasing and Erosion Control Plan rev. 10/30/03 from the Bethel-Norwalk project as reference)</i></p> <p>Discuss options with CL&P on clean-up efforts within substation.</p> <p>Needs regular attention.</p>

Evidence of multiple concrete washouts remain along the slope near sta. #14-16. There is no active work in this area and the washouts are likely not project related. However, the area remains exposed for several months and needs temporary or permanent stabilization.

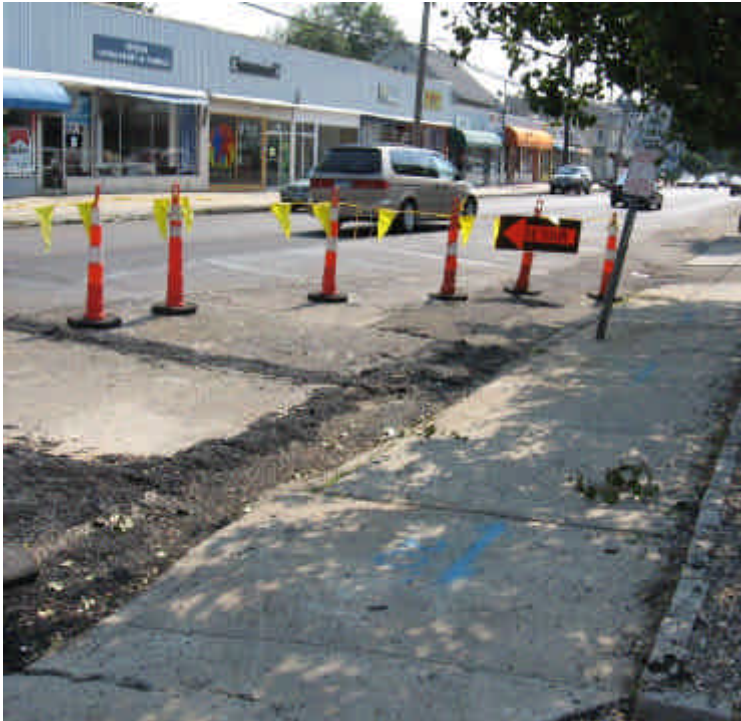
Trenching continues in various locations between sta. #31-34 & #38. Steel plates were covering the trench at the time of the inspection. A minor amount of cold mix/ granular material was observed along the edge of the roadway. Cold mix/ granular material along the roadway between sta. #38-45 appears to have been swept.
