**Docket No. 272 – Development and Management Plan Inspection**

**Segment 4c Underground Line**

**Date:** August 21, 2008

**Location:** Westport Avenue to the Norwalk Substation in the City of Norwalk

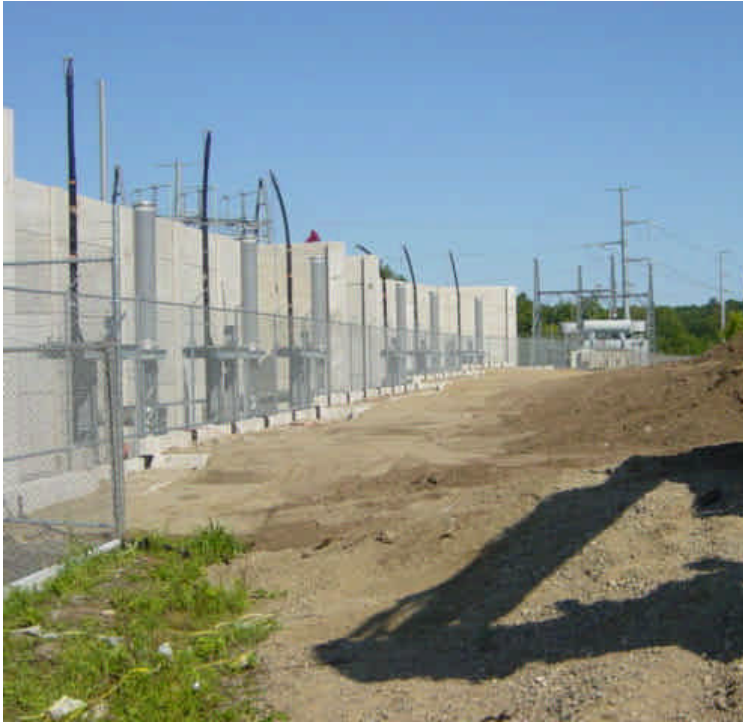
<p><b>Additional Observations</b></p>	<p><b>Pre-cast concrete retaining wall has been restored outside of the Norwalk substation near sta. #0. 8/21/08</b></p>	<p><b>None. 8/21/08</b></p>	<p><b>NA</b></p>

**Pre-cast concrete retaining wall has been restored outside of the Norwalk substation near sta. #0.**

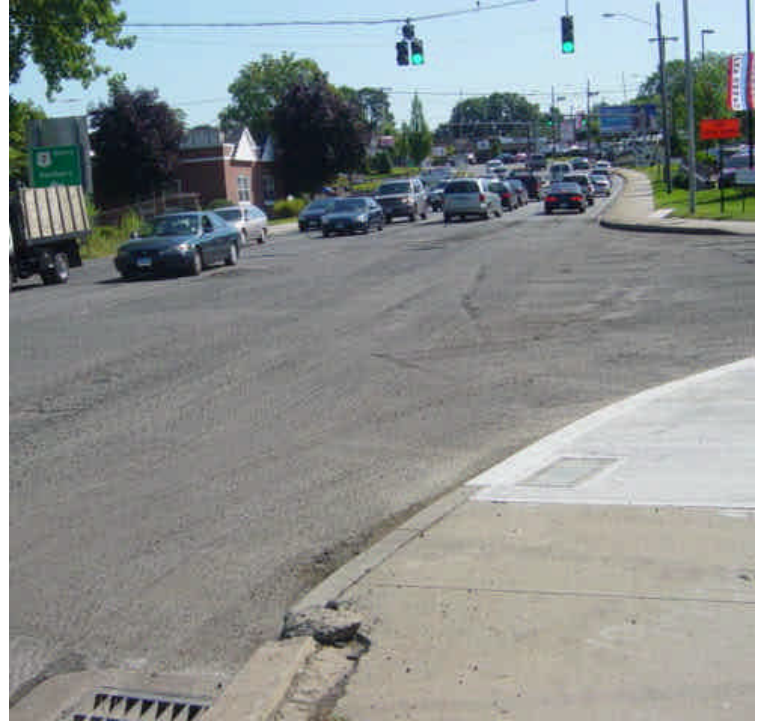
<b>Areas of Inspection</b>	<b>Observation</b>	<b>Recommended Action</b>	<b>Corrected Action</b>
	<b>Portions of Main Street and Grand Street near sta. #18-22 have been milled in preparation for paving 8/21/08</b>	<b>None. 8/21/08</b>	<b>NA</b>

**Pavement has been milled near sta. #19-21 and is ready to be paved.**

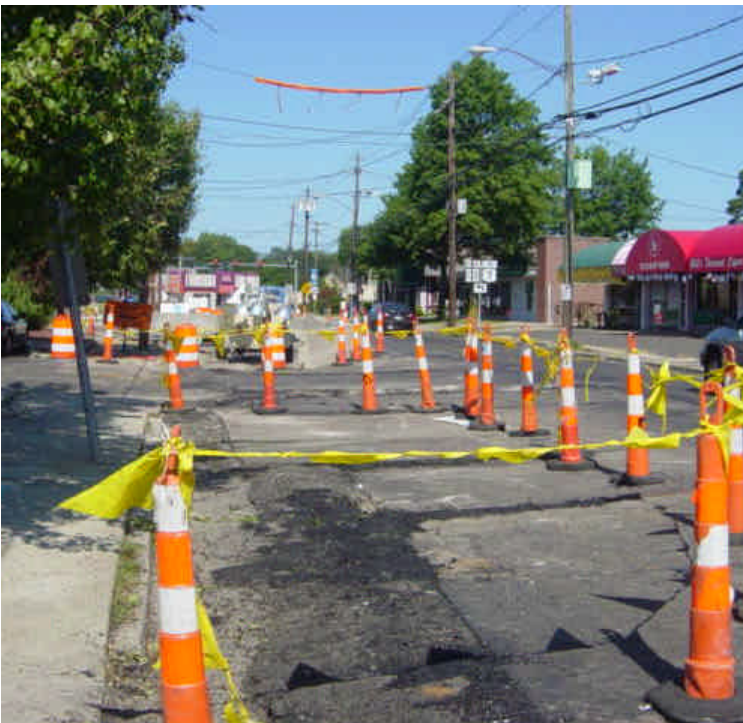
**Trenching continues in various locations between sta. #31-34 & #38. Steel plates were covering the trench at the time of the inspection. A minor amount of cold mix/ granular material was observed along the edge of the roadway. Electrical contractor was on site at vault # 3.**
