**Docket No. 272 – Development and Management Plan Inspection**

**Segment 4c Underground Line**

**Date:** September 5, 2008

**Location:** Westport Avenue to the Norwalk Substation in the City of Norwalk

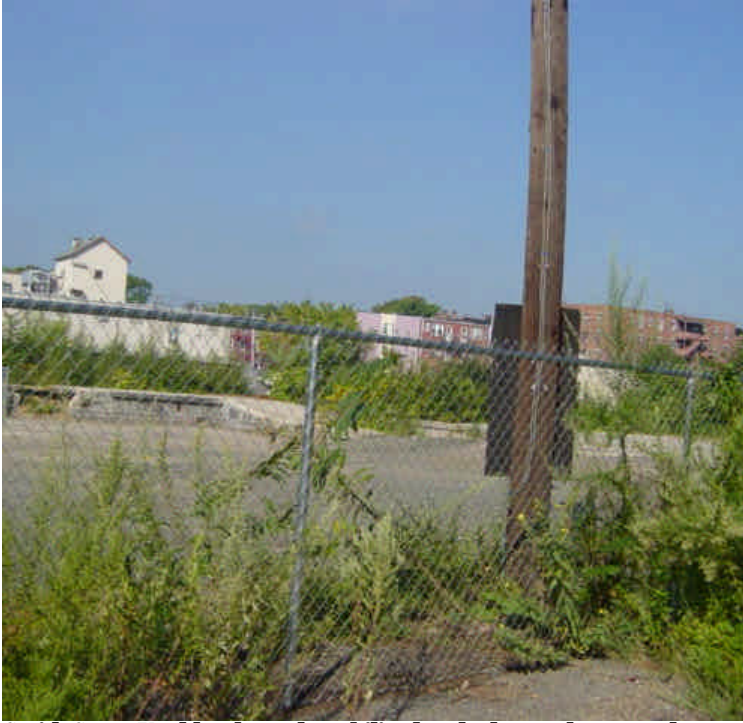
**Smith Street Yard has been demolished and adequately restored.**

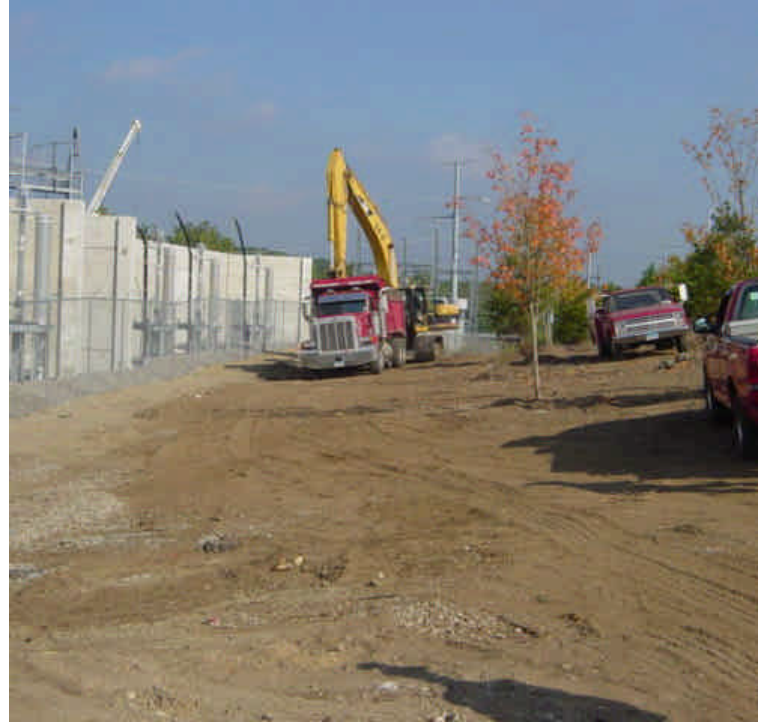
**Pre-cast concrete retaining wall has been restored outside of the Norwalk substation near sta. #0 and the area has been backfilled. Some trees and landscaping has also been restored. Exposed soil needs mulch and seed.**

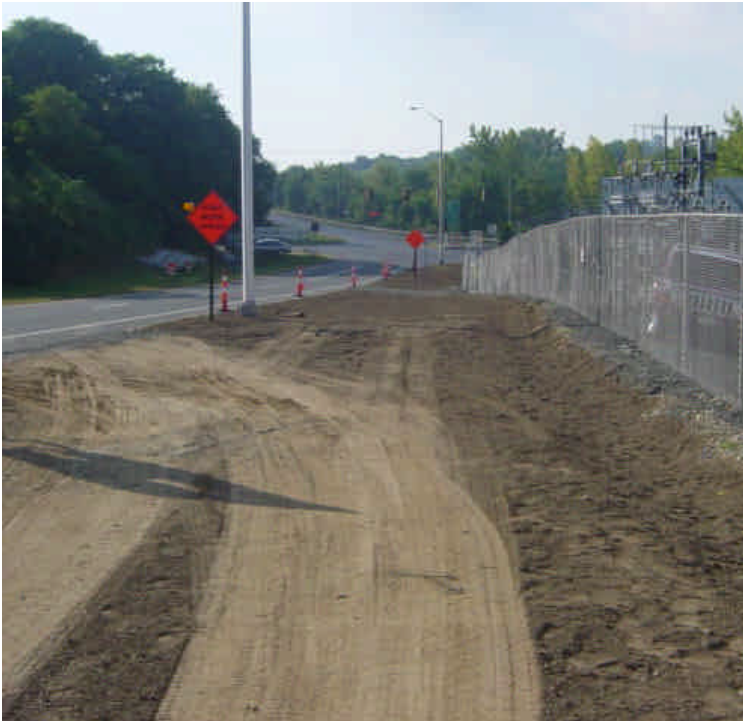
**Area between sta #2-9 has been re-graded to restore the drainage swale along the side of the substation. Exposed topsoil will need to be stabilized. The area around the drainage inlet at sta. #9+50 has also been re-graded. Temporary controls are needed until the area stabilizes.**
