Docket No. 272 – Development and Management Plan Inspection

Segment 4c Underground Line

Date: September 26, 2008

Location: Westport Avenue to the Norwalk Substation in the City of Norwalk

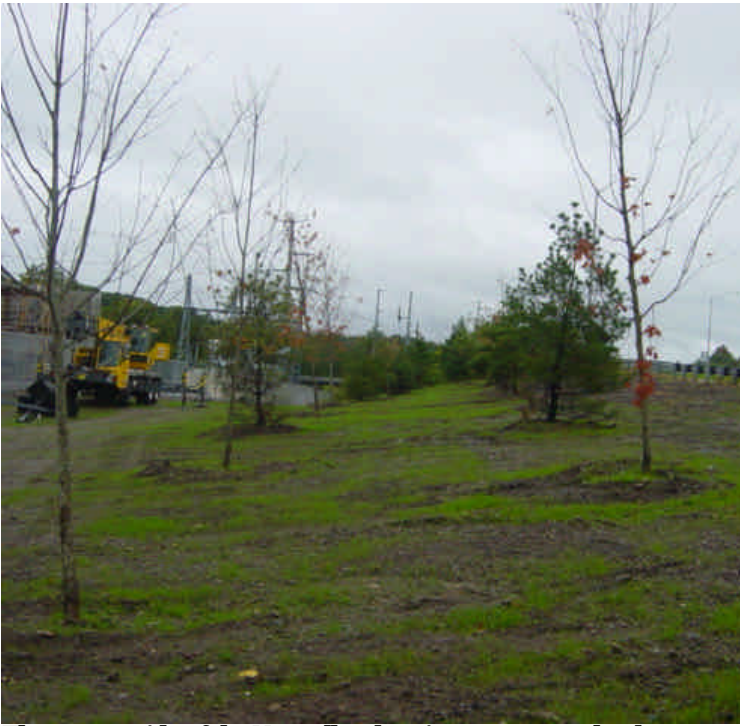
The area outside of the Norwalk substation near sta. #0 has been (including hydroseed) and the area is beginning to vegetate.

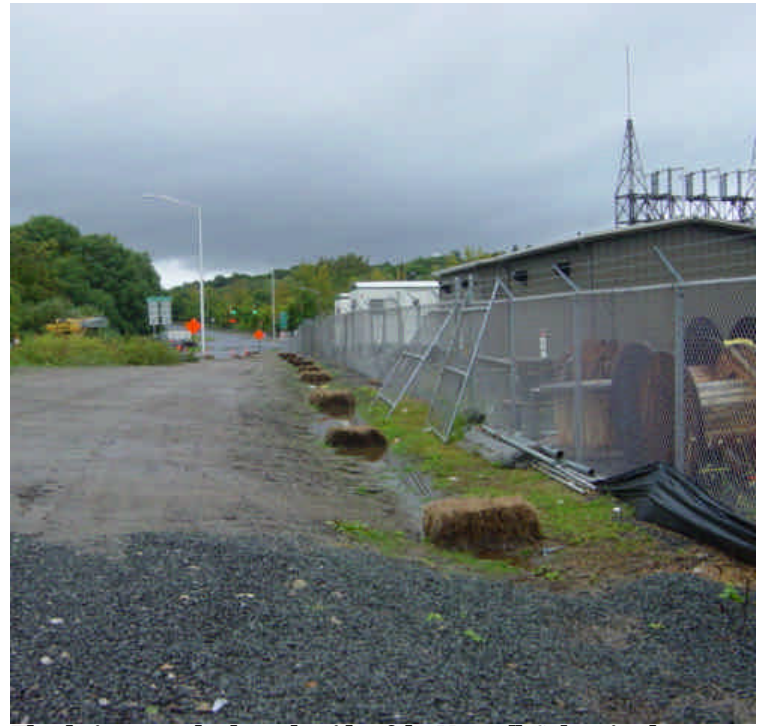
The drainage swale along the side of the Norwalk Substation has been restored. Haybale check dams are in place. However, heavy rains caused portions of the swale to fill with sediment. Exposed soil needs mulch and seed.

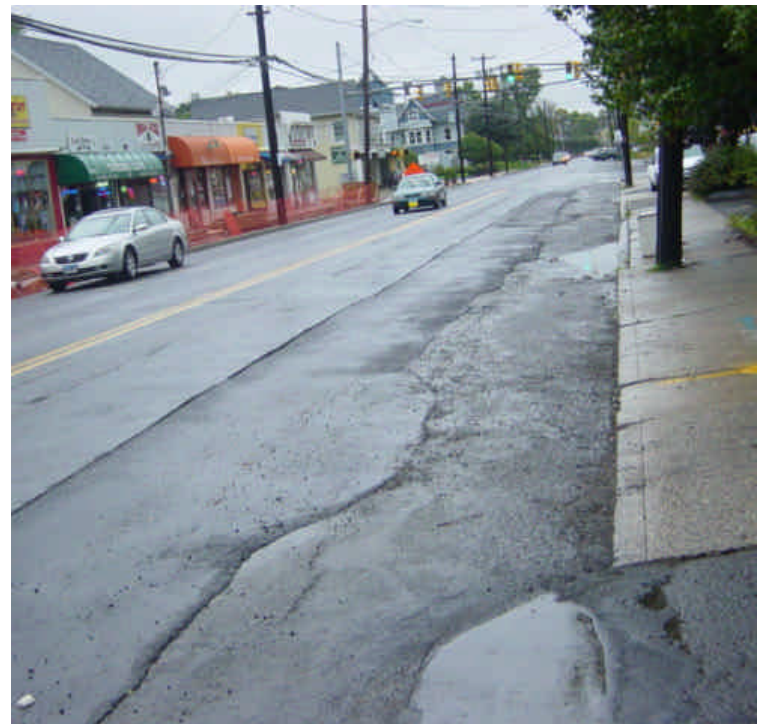
Trenching is complete along Main Street. A minor amount of cold mix remains along the edge of the roadway. Sweep roadways when feasible.

Areas of Inspection	Observation	Recommended Action	Corrected Action
Access Roads and Adjacent Roadways	All work is within existing paved roadways and parking lots at this time. Minor sediment/ cold mix accumulation was noted along the roadway at various locations through this segment. 8/1-9/26/08	Sweep roadways on a regular basis. 9/26/08	Needs regular attention
Vault Openings and Trench Construction Norwalk	Some restoration efforts were observed at sta. #0-4 & #14-16 but additional attention is needed. Steel road plates were observed near sta. #33, & #46-48. 9/26/08	Continue to monitor areas. Mulch/ temporarily stabilize areas as they are completed. Continue to sweep roadways as soon as feasible. See erosion control section. 9/26/08	NA (Not applicable)
Erosion and Sediment Controls	Controls were removed from catch basins on state routes per the request of ConnDOT to improve drainage during winter conditions. Contractor plans to discontinue use of controls for the duration of the project and clean basins as necessary. 9/26/08	Since controls are no longer in place in the catch basins, attend to all sediment at the source and stabilize exposed soils as quickly as possible. Clean catch basins as necessary. Consider installing controls when work is immediately adjacent. 9/26/08	Needs regular attention.
