Docket No. 272 – Development and Management Plan Inspection

Segment 4c Underground Line

Date: October 3, 2008

Location: Westport Avenue to the Norwalk Substation in the City of Norwalk

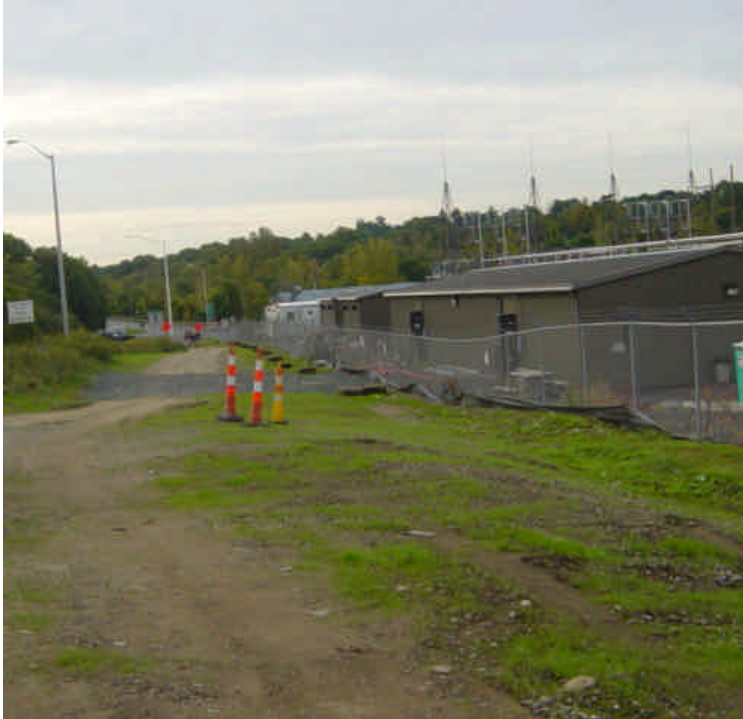
The area outside of the Norwalk substation near sta. #0-4 has been seeded and the area is beginning to vegetate. The drainage swale has been restored however, heavy rain has caused portions of the swale to fill in with sediment.

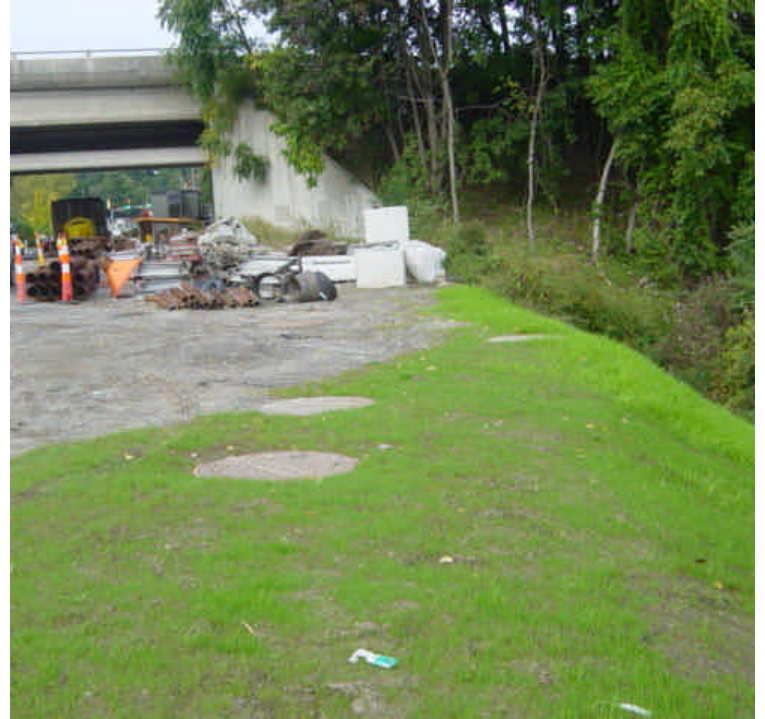
The slope at sta. #14-18 has been re-graded and is approximately 65% vegetated. Silt fence and hay bale barrier remains along the graded slope. Construction materials noted here are not related to the M/N project.

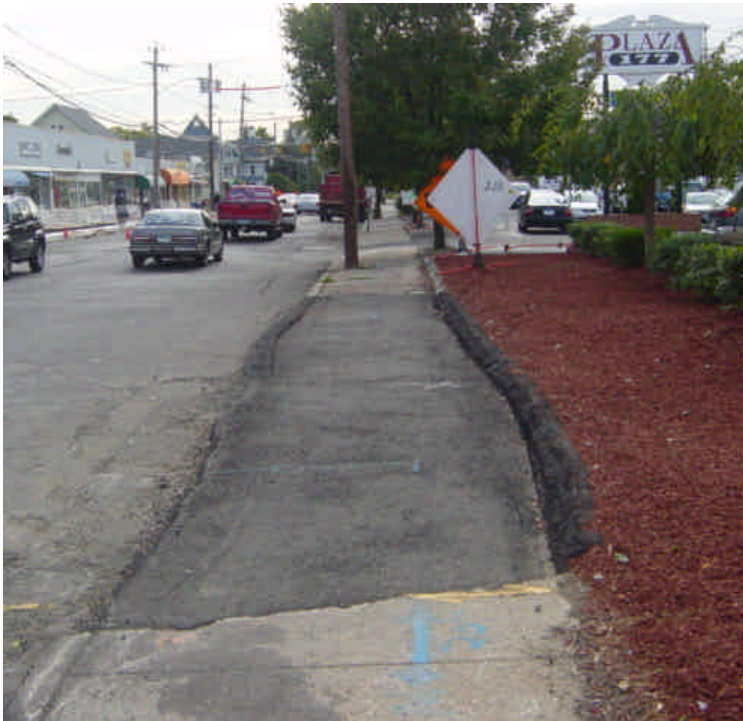
The median area near sta. #31+50 has been restored. Additional restoration to the curb and sidewalk is still required.

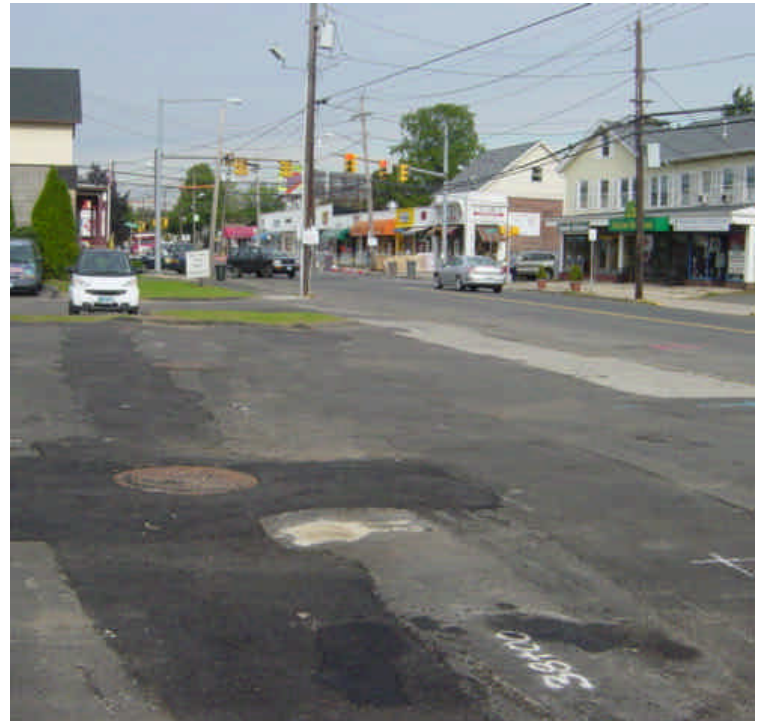
Tie-in work has been completed near sta. #38 and the area has been temporarily paved.
