Docket No. 272 – Development and Management Plan Inspection

Segment 4c Underground Line

Date: October 16, 2008

Location: Westport Avenue to the Norwalk Substation in the City of Norwalk

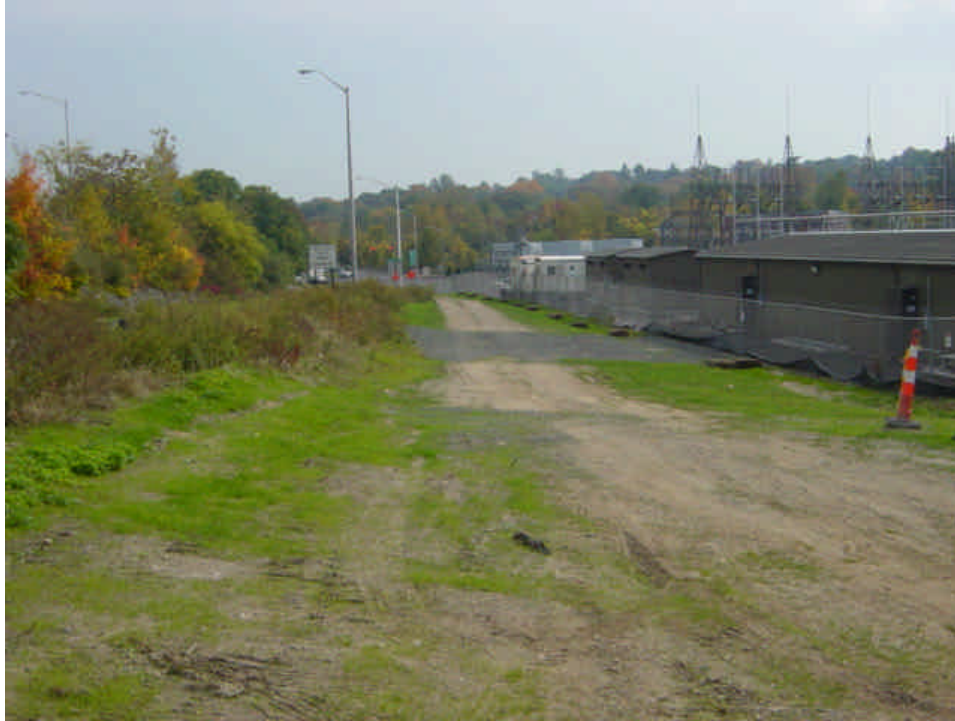
The area adjacent to the Norwalk substation near sta. #4-8 has been seeded and the area is beginning to vegetate, except in some areas where construction traffic is impeding vegetation growth. The drainage swale has been restored, but sediment has washed out and accumulated in portions of the swale.

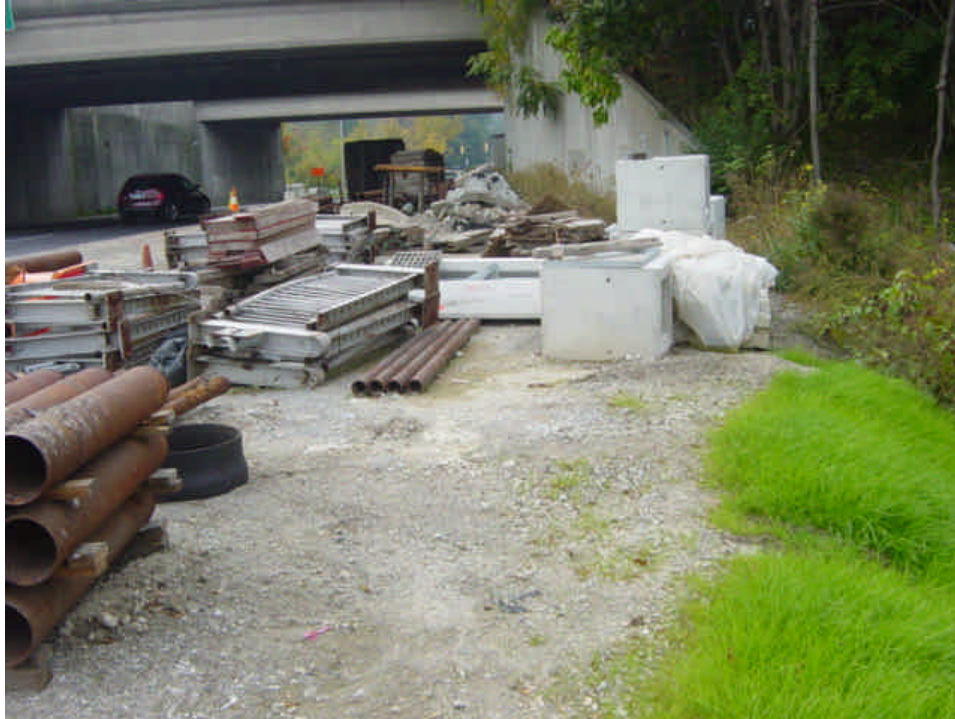
The slope at sta. #14-18 has been re-graded and is stabilized, except for a portion near the road where exposed soil remains. Material for the adjacent bridge project is also being staged in this area.
