Docket No. 272 – Development and Management Plan Inspection

Segment 4c Underground Line

Date: October 24, 2008

Location: Westport Avenue to the Norwalk Substation in the City of Norwalk

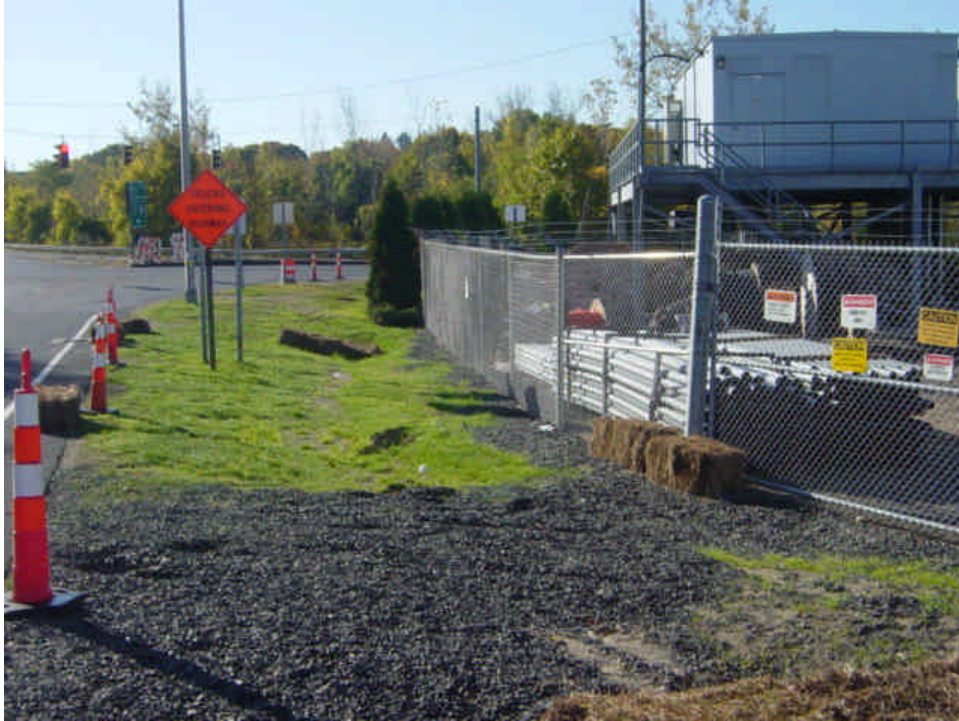
The area outside of the Norwalk substation near sta. #8 has been seeded and the area is beginning to vegetate. The drainage swale has been restored, but sediment has eroded and accumulated in portions of the swale. The receiving catch basin will need to be cleaned.

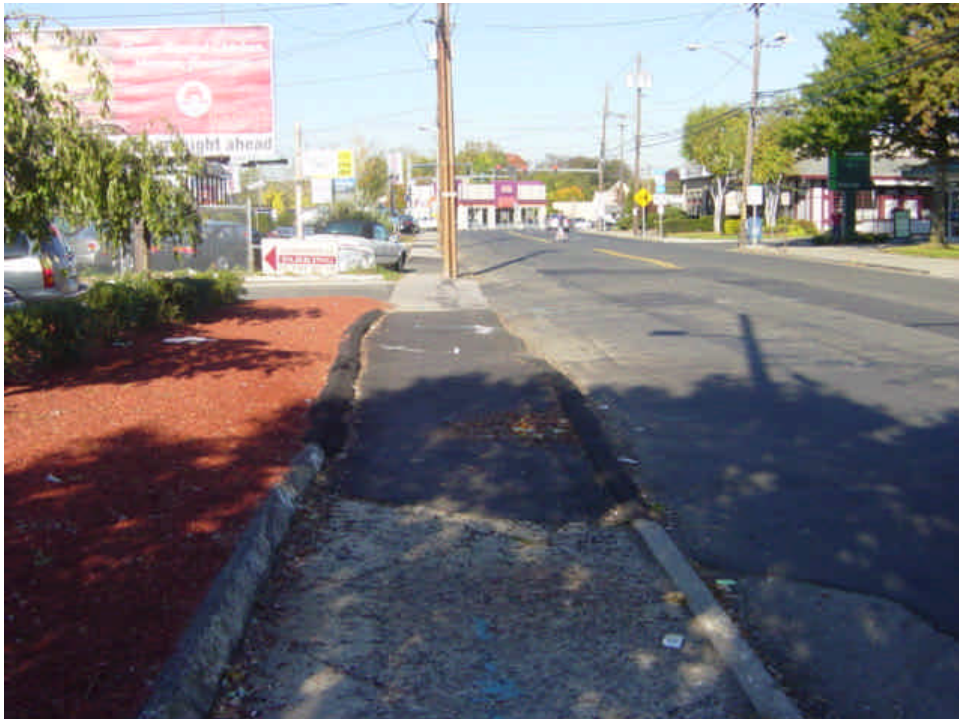
Landscaped area near sta. #31 - 32 has been restored, but curb and sidewalk restoration is still required.
