**Docket No. 272 – Development and Management Plan Inspection**

**Segment 4c Underground Line**

**Date:** October 30, 2008

**Location:** Westport Avenue to the Norwalk Substation in the City of Norwalk

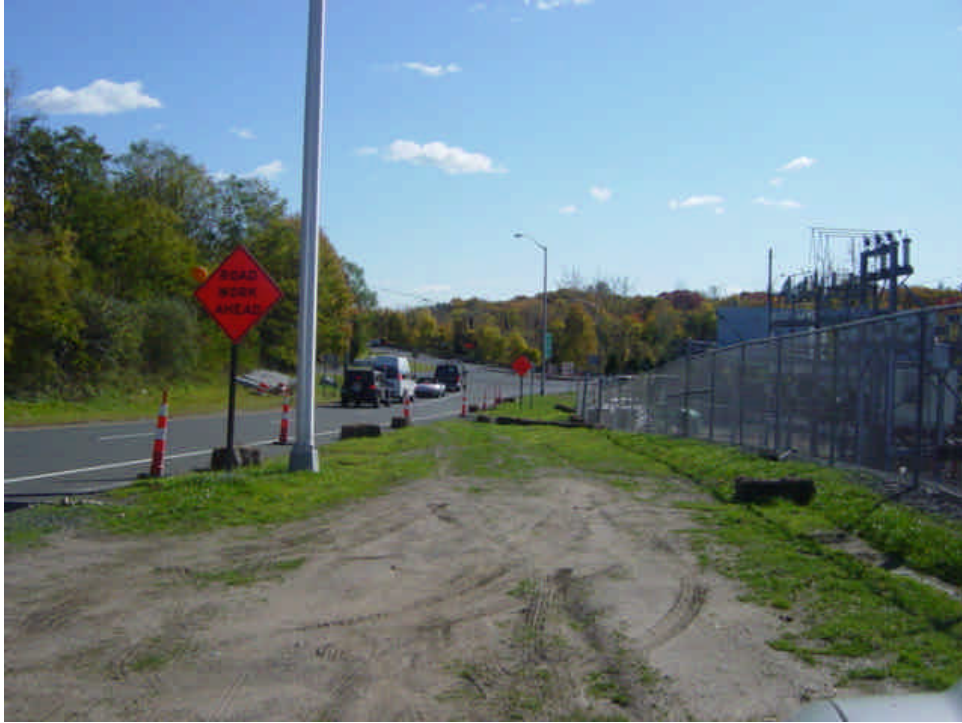
**The area outside of the Norwalk substation near sta. #8 has been seeded and the area is beginning to vegetate. The drainage swale has been restored, but sediment has eroded and accumulated in portions of the swale. The receiving catch basin will need to be cleaned.**

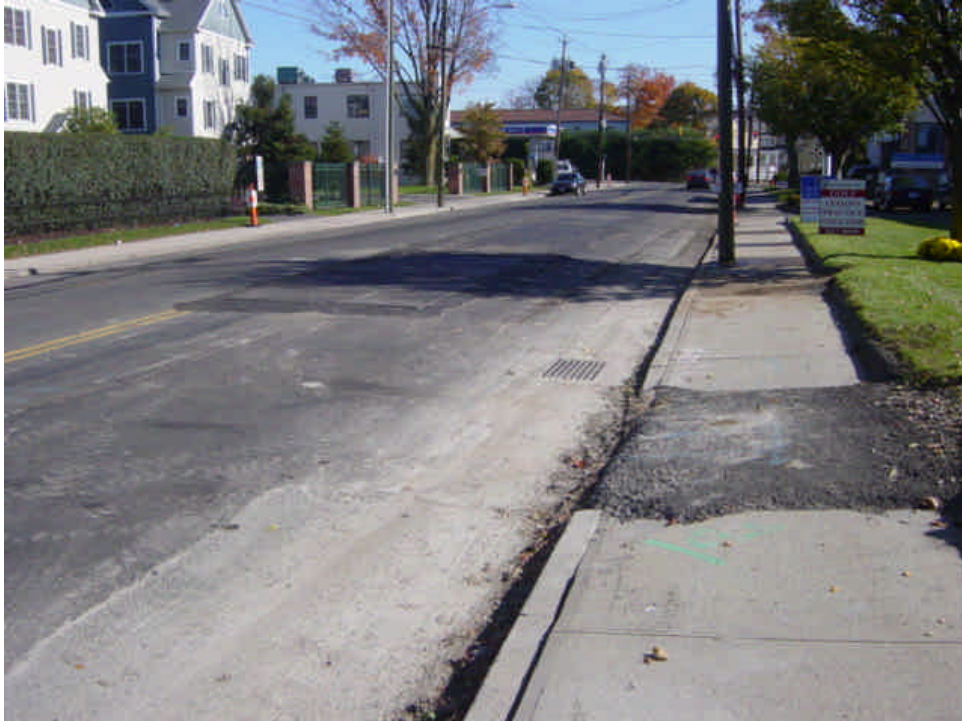
**Sediment and granular material has accumulated along the edge of the roadway near sta. #43-45.**
