Docket No. 272 – Development and Management Plan Inspection

Beseck Switching Station Inspection

Date: April 24, 2007

Location: Beseck Switching Station

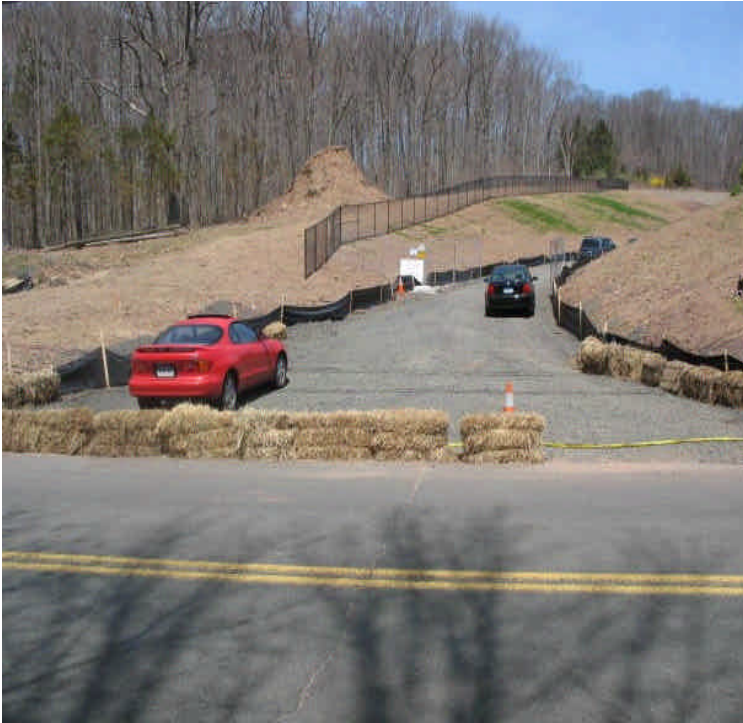
Site entrance off Carpenter Lane is well controlled; the area is being used for temporary parking of personal vehicles.

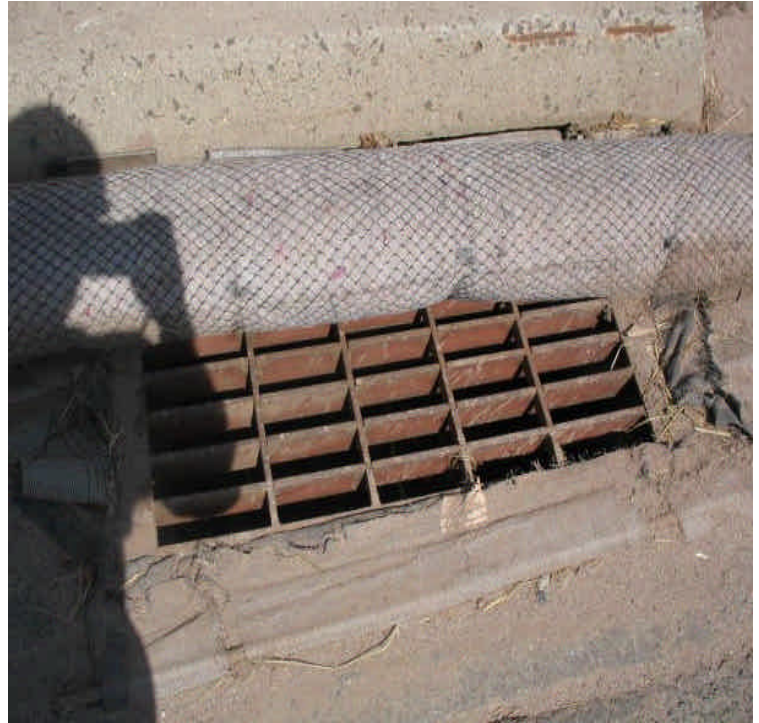
Carpenter Lane was recently swept and gutter buddies were cleaned and replaced in the catch basin.

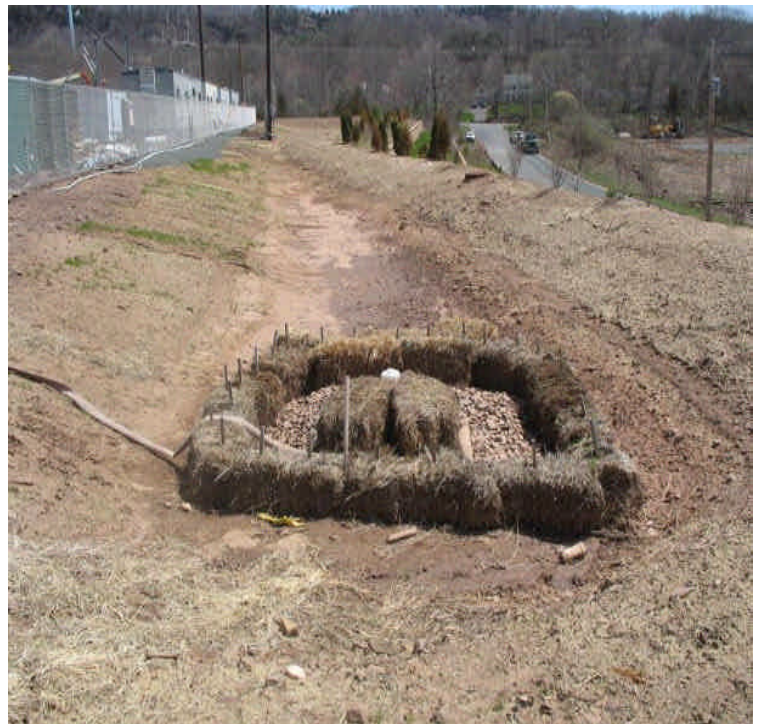
Haybales and controls remain in place at the inlet of the detention basin. Sediment from the stormwater run-off has settled in the basin.

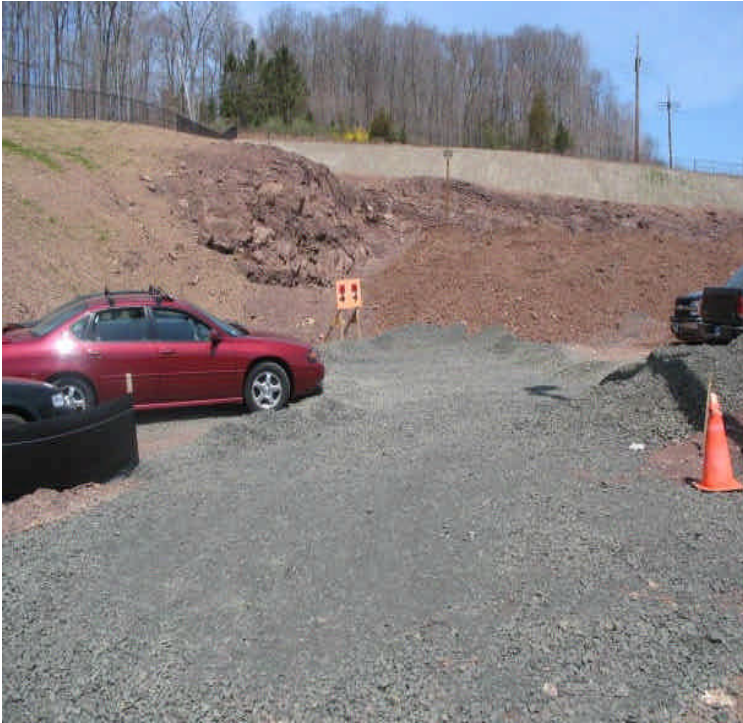
Stone and stone check dams remain in place along the site entrance.

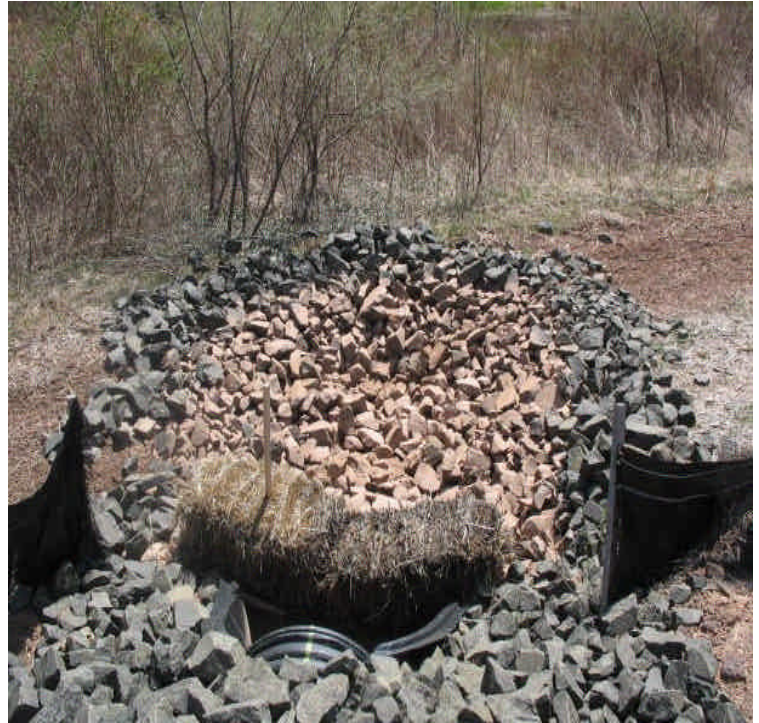
The sediment trap at the culvert under the ROW access road is dry and contains some filtered sediment. Haybales are in place at the inlet and outlet. 4/24/07	This control works well for smaller storms but was overwhelmed by the heavy rain last week. For future rain events, slow and filter water within the drainage ditch before it flows into the basin. 4/24/07	Needs additional controls in anticipation of larger storm events
	Gutters along Carpenter Lane have recently been	Clean/sweep roadway regularly, including the	Gutters have recently been cleaned.

View of the culvert and sediment trap under the access road to the ROW. This control works well for smaller storms but needs reinforcement during the larger rain events.

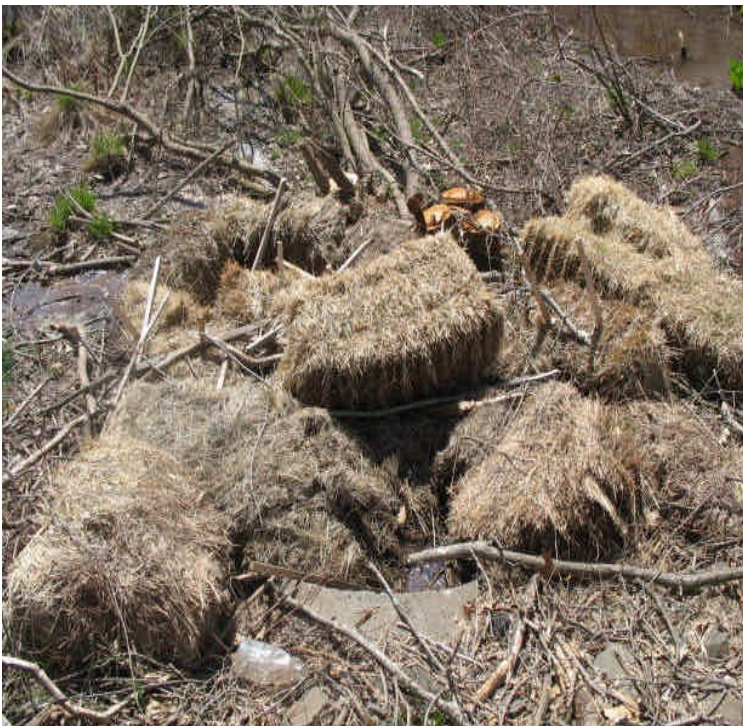
Storm drain outlet across Carpenter Lane has clear water flowing through the haybales.

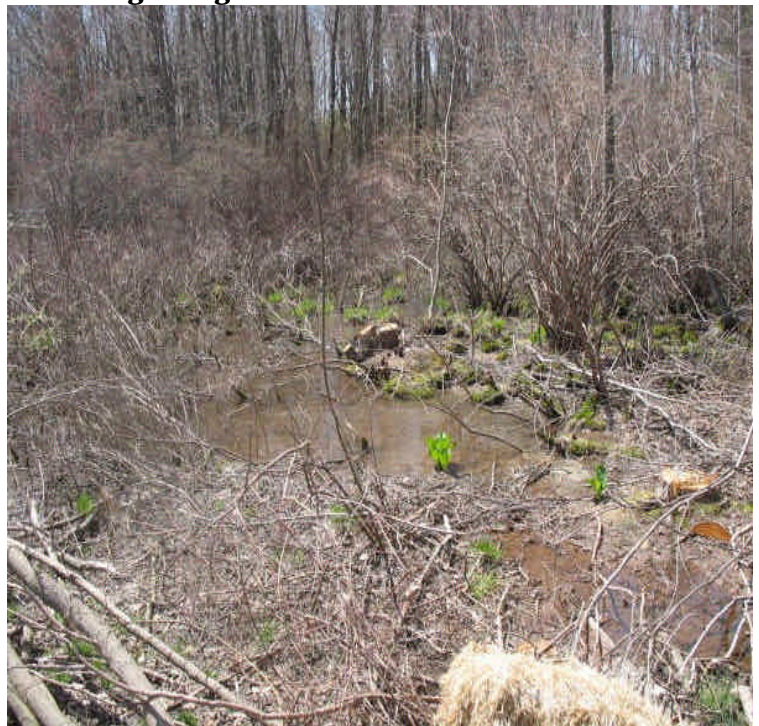
Clear water was observed leaving the haybales and entering the wetlands. Evaluate whether the amount of sediment accumulation justifies the minor disturbance needed to remove it, once the water subsides.
