Docket No. 272 – Development and Management Plan Inspection

Scovill Rock Switching Station Inspection

Date: April 2, 2007

Location: Scovill Rock Switching Station

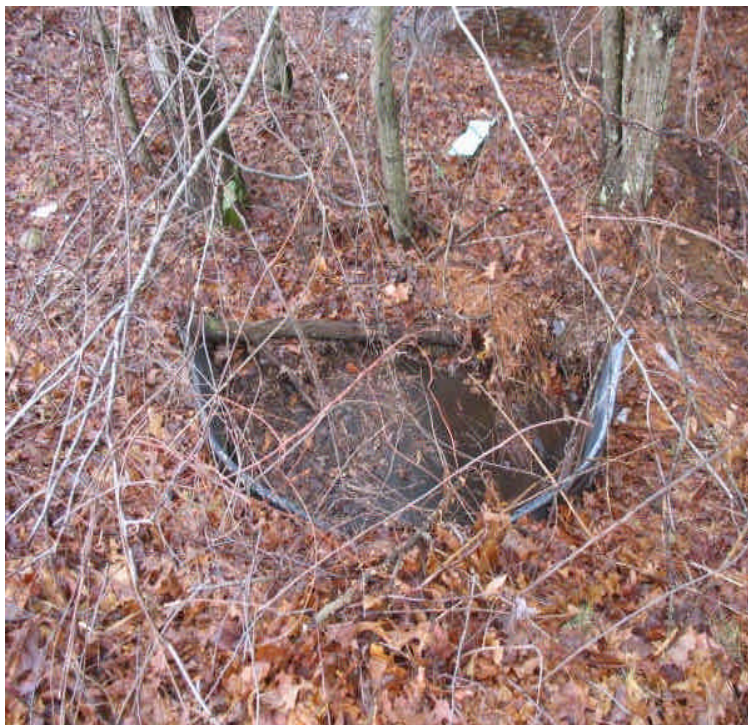
View of the culvert under the access drive. No sediment issues have been observed.

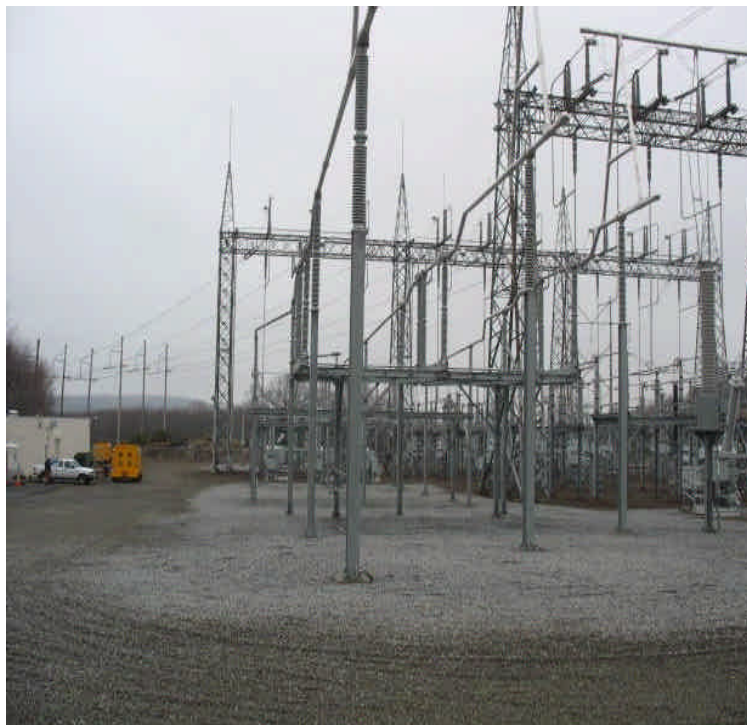
The site is stable and civil and structural work in the yard appears to be complete.

Areas of Inspection	Observation	Recommended Action	Corrected Action
	noted along the site fence. 4/2/07	recommended as routine maintenance or “housekeeping”. 4/2/07	
Additional Observations	Once the soil stockpile is removed, we anticipate that this site will be removed from the inspection route and reports will no longer be necessary. All earth disturbing work and structural work appear complete.	Remove stockpile, remaining erosion controls and finalize site	NA

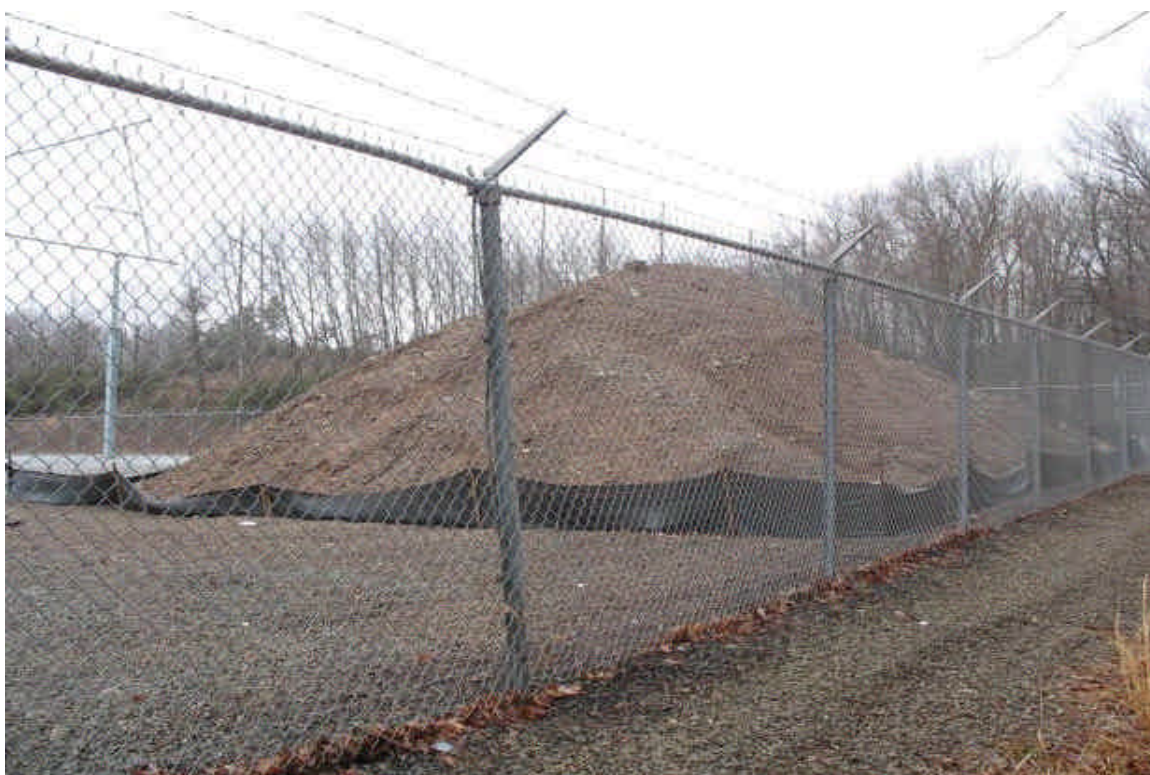
One stockpile remains in the yard, surrounded by intact silt fence and a flat crushed stone surface. It will be removed after soil	Once soil analysis is complete, remove soil and dispose of properly. Soils are contained within the yard. 11/21/06-4/2/07	NA

Soil stockpile to be removed. Controls are intact and sediment issues have not been observed.
