Docket No. 272 – Development and Management Plan Inspection

Segment 1a Inspection

Date: April 9, 2007

Location: Segment 1a – Scovill Rock Switching Station to Chestnut Junction, Oxbow Junction to Beseck Switching Station (excluding Royal Oak Bypass), and Black Pond Junction to Beseck Switching Station

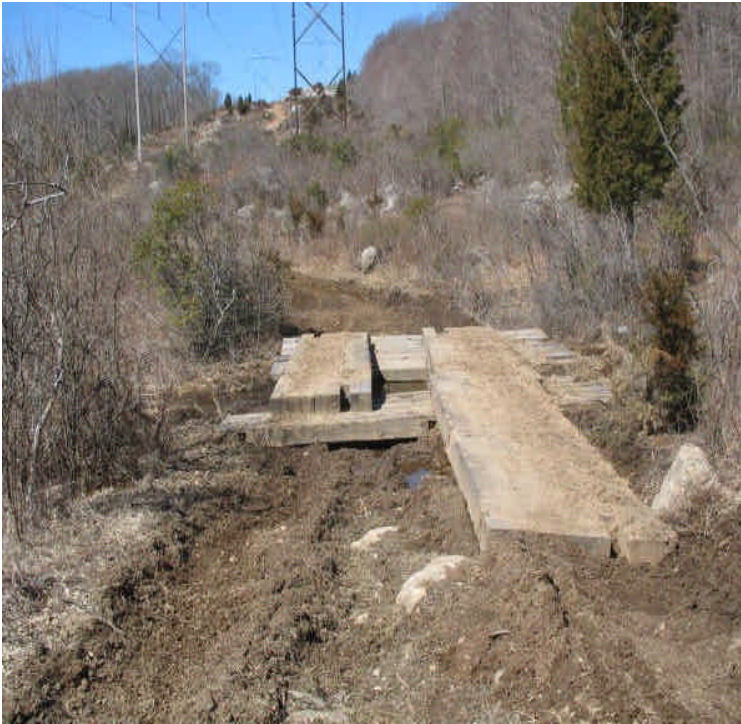
Timber mat crossing within the ROW west of Scovill Rock SS. This was installed for clearing crews access. Crews should work to stabilize soil or place controls after vehicles cause disturbance via tracking

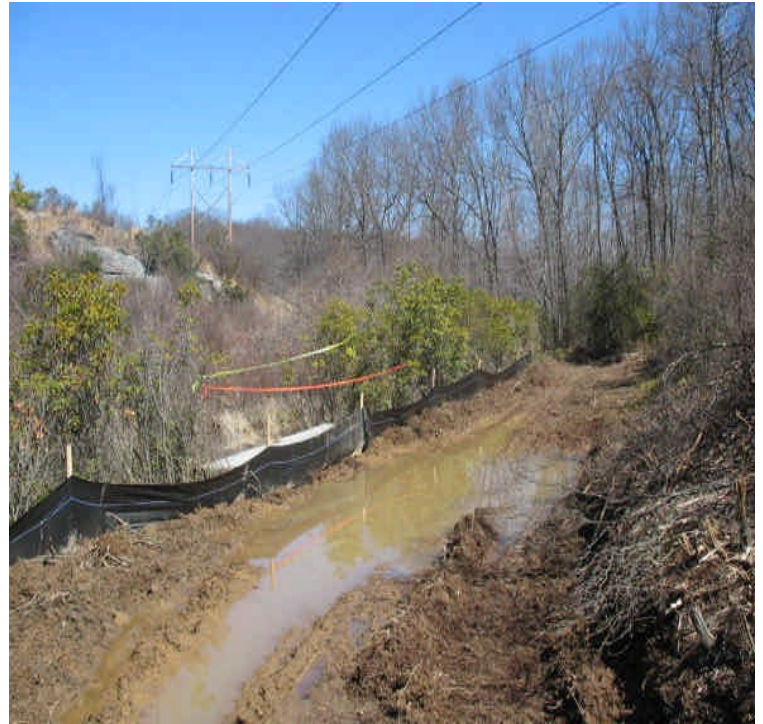
Water has ponded up along the access road in several locations west of Scovill Rock. Disturbance from vehicle tracking could result in turbid run-off. Good controls were installed.

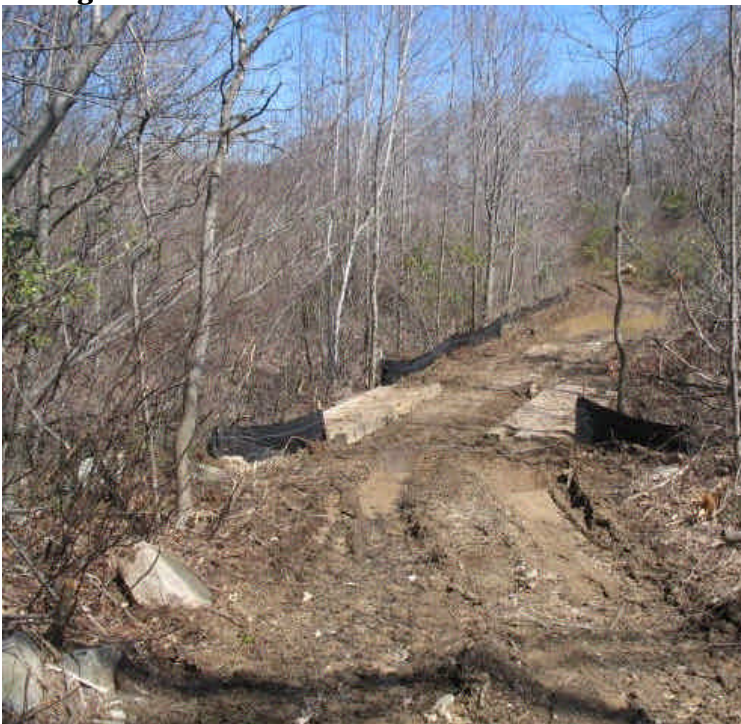
An additional area with controls installed along one of the access roads west of Scovill Rock. The area appears to be well contained.

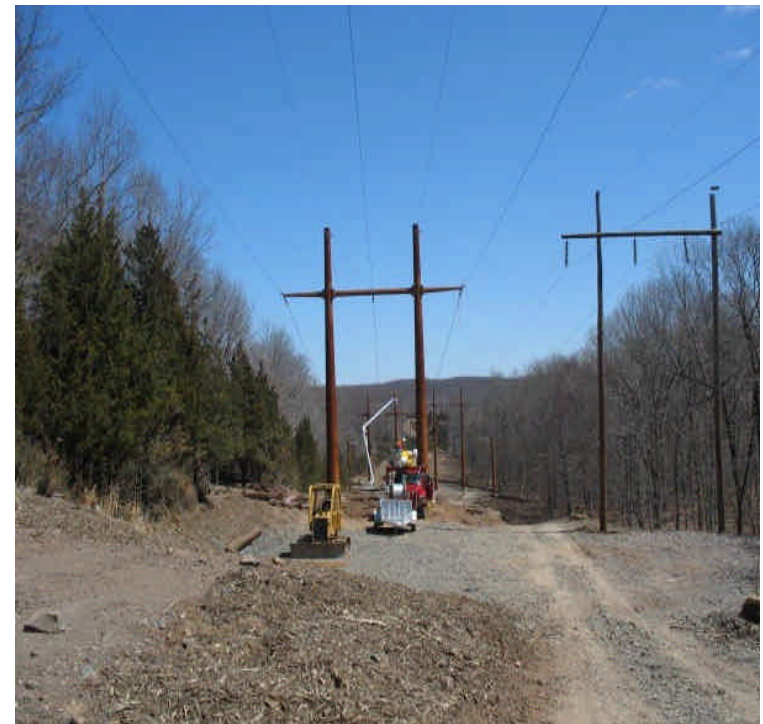
Line removal/installation continue off Black Walnut Dr.

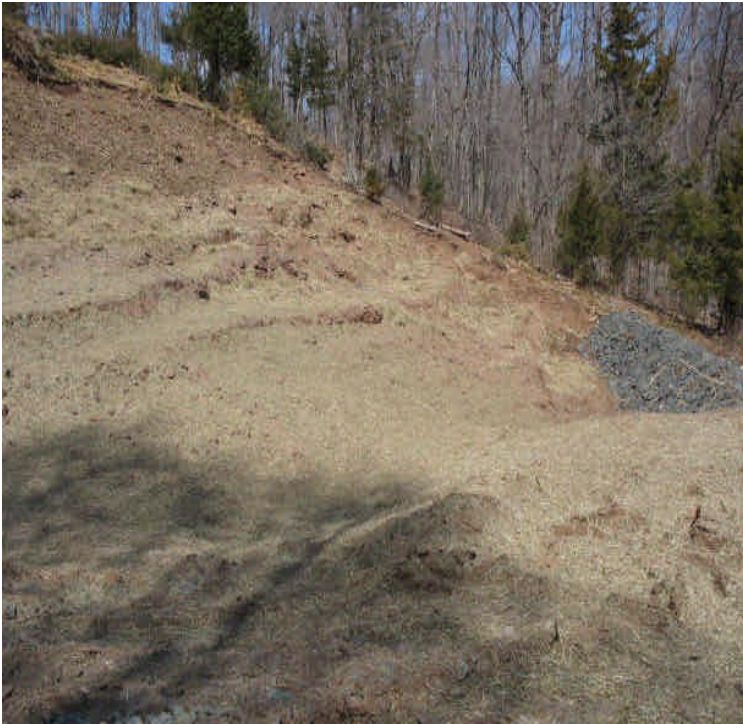
Mulch was placed along slopes off Arbutus St. Stone check dam were also installed to filter run-off.

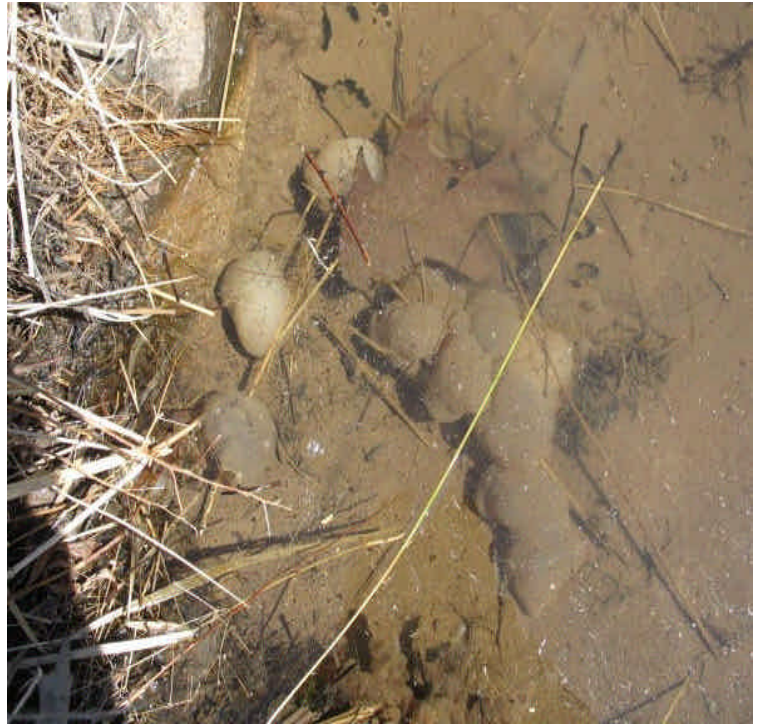
Ambystoma egg masses were noted in the ponded water adjacent to a timber mat crossing off Johnson Ln. Several wood frogs were also noted. Continue to prevent turbidity or sedimentation in this area.

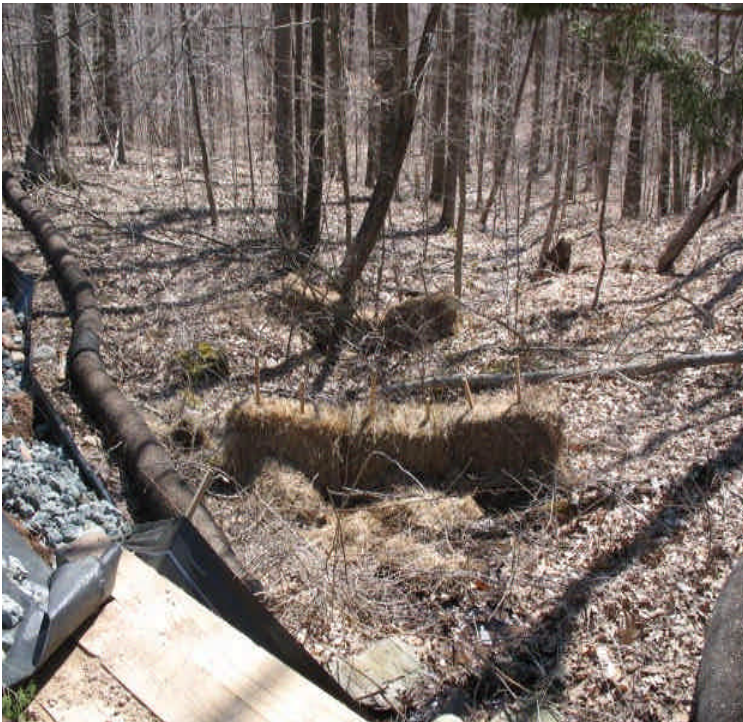
Timber mat wetland crossings have controls, including haybale check dams, installed downgradient off Johnson Lane

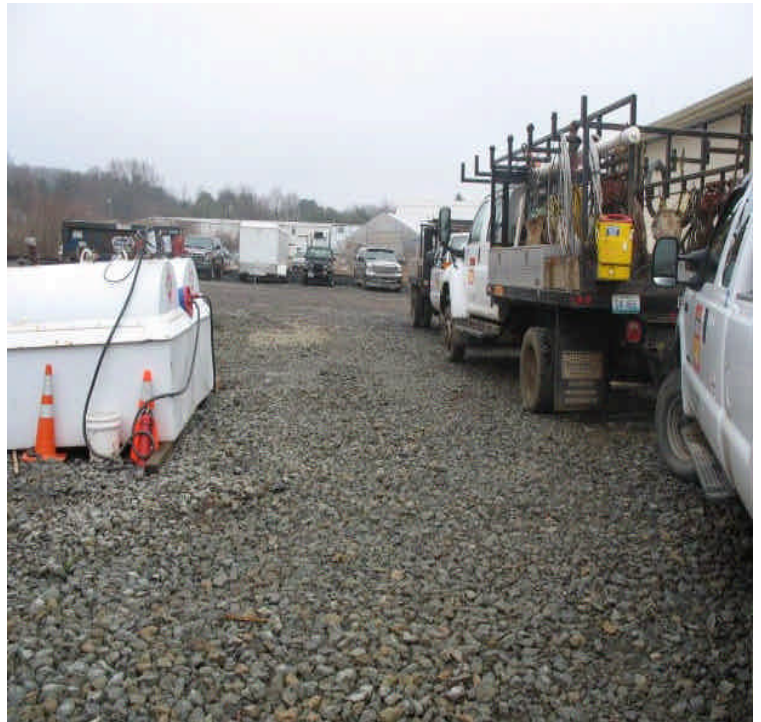
Both nozzles were contained at the fuel tanks within the contractor receiving yard. No spills were noted during this inspection.

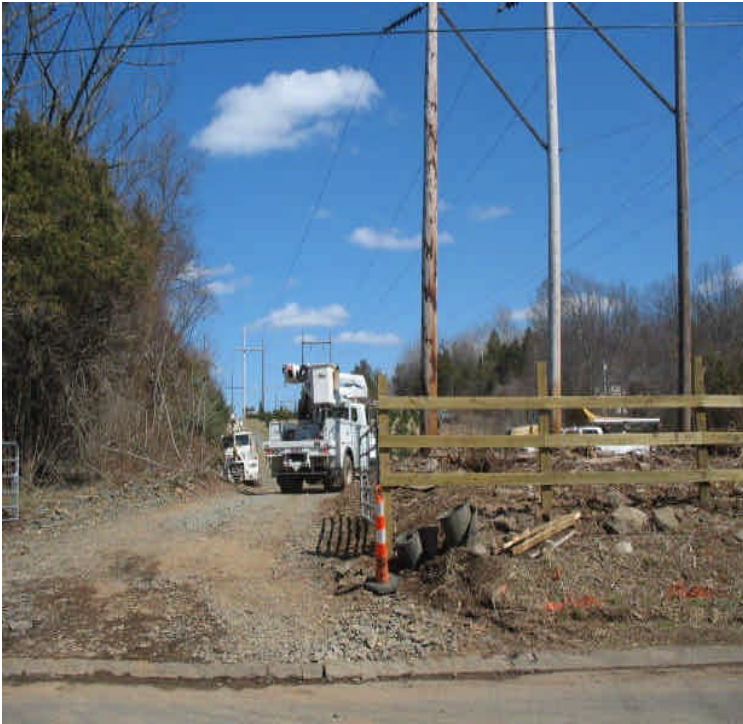
Line removal underway off Powder Hill Road.

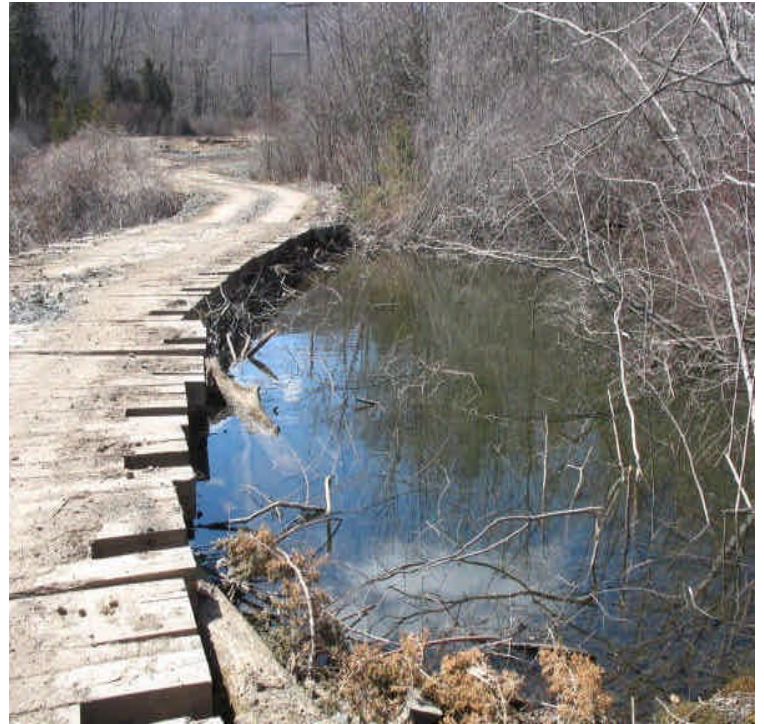
Wetland crossing off Powder Hill Road. Turbidity was not observed within the wetlands at this inspection. Felled trees were removed from the wetlands,

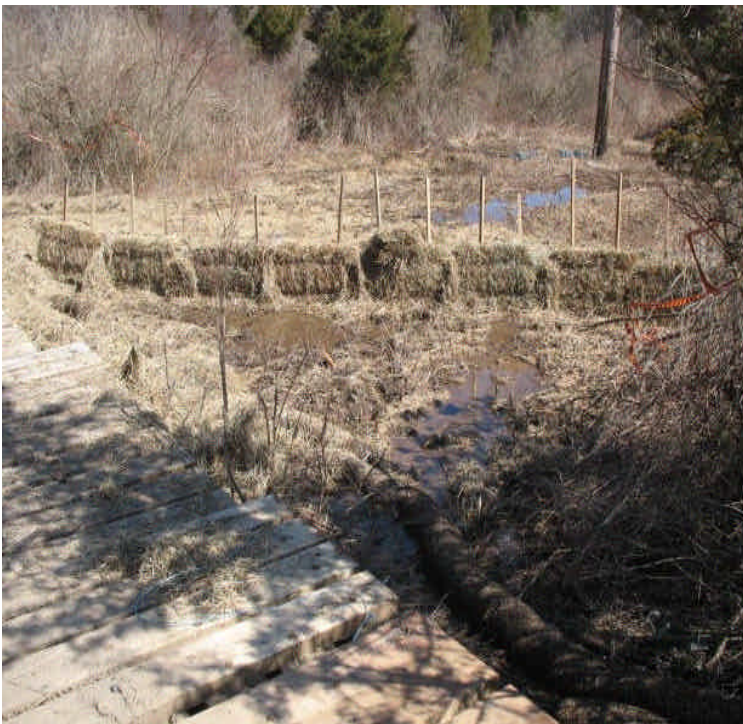
View of newly installed haybales and fiber rolls at the base of the slope off Powder Hill Rd. Sediment is filtered from the run-off before it flows off-site

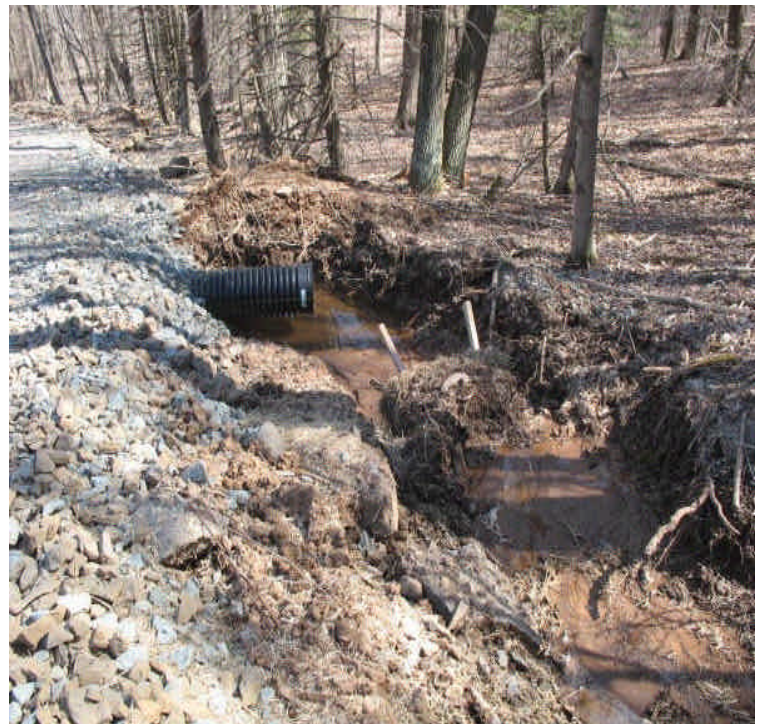
View of the drainage swale with haybale check dams installed along the access road off Powder Hill Rd. Run-off is diverted and filtered prior to leaving the site.

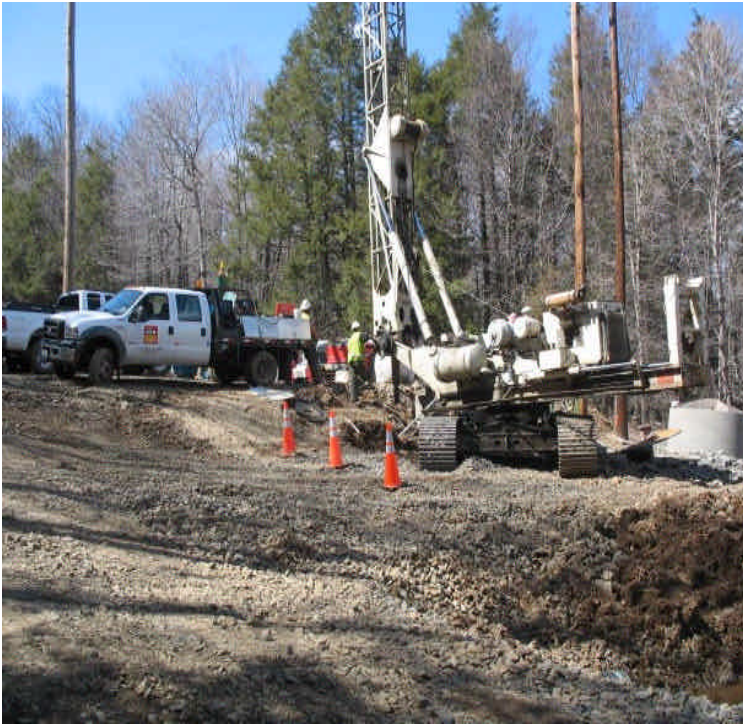
Foundations were being drilled off Powder Hill Rd.

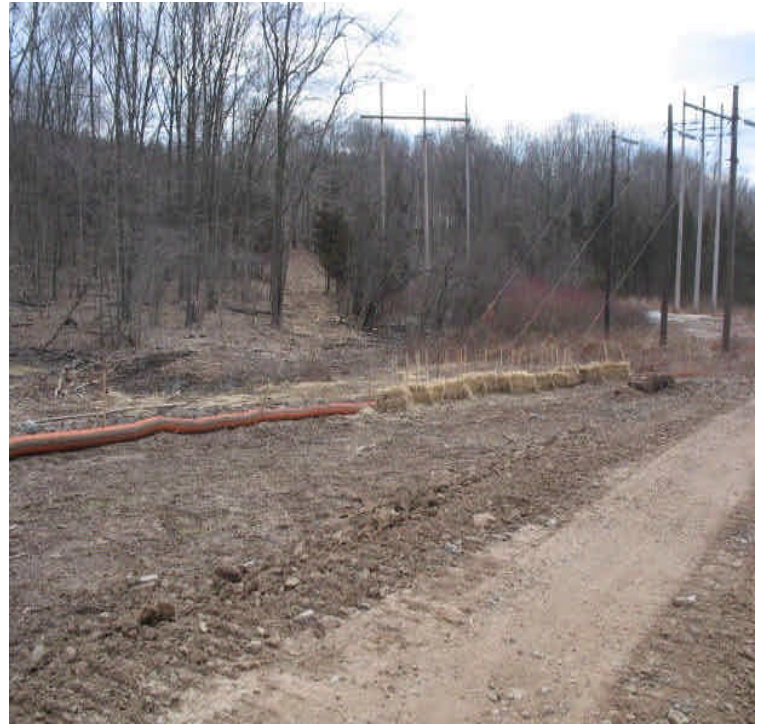
Access road north of Beseck SS has been regraded and stone was added as needed to stabilize the soils and reduce run-off. Haybale and filter sock barriers are in place to slow and contain run-off.

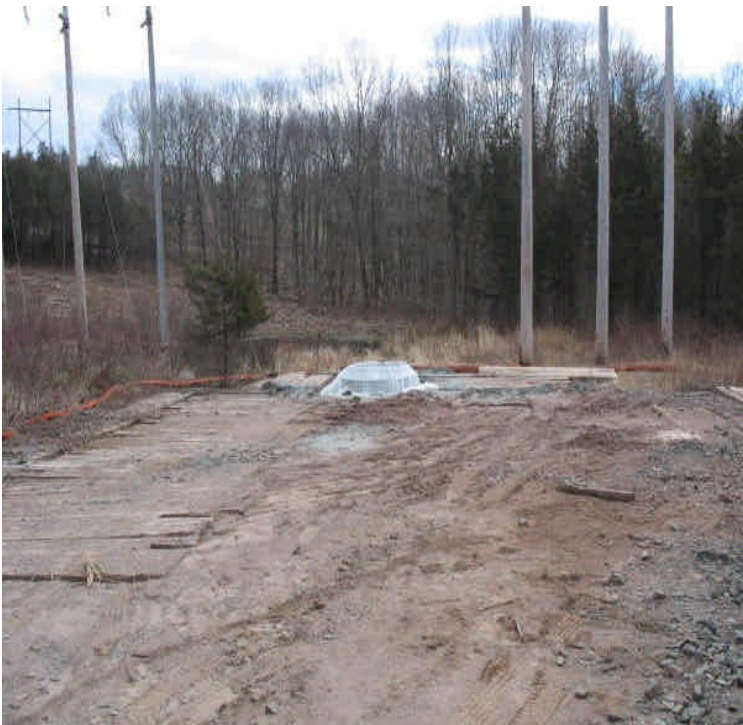
Areas of Inspection	Observation	Recommended Action	Corrected Action
<p>Black Pond Junction to Beseck SS ROW, North of Beseck SS to East Meriden Substation</p>	<p>Beseck SS, fiber rolls (filter socks) remain adjacent to the timber mat pads but sediment (likely from snow clearing) has been piled on and over the socks. 4/2-4/9/07</p>	<p>Continue to monitor run-off and ensure it does not reach wetlands. Add more controls and remove sediment from existing controls to restore capacity as necessary. 4/9/07</p>	<p>NA</p>
<p>Fleming Road</p>	<p>Water bars and haybales remain in place along the access road. Stone was used at saturated areas to stabilize the access road and pads. 4/9/07</p>	<p>Monitor controls and ensure that all dewatering slurry be adequately contained away from the wetlands. 4/9/07</p>	<p>NA</p>
<p>South of High Hill Rd. (vicinity of East Meriden Substation)</p>	<p>Haybales and silt fence remain adjacent to the pond north of Beseck. 4/9/07</p>	<p>Controls look good. Monitor, adjust, and extend controls as needed. 4/9/07</p>	<p>Foundation installed with no apparent sediment issues.</p>

Sediment (likely from snow clearing in past weeks) was noted on and beyond the filter sock at the matted pad near Beseck SS. Sediment in the wetland needs to be carefully removed by hand.

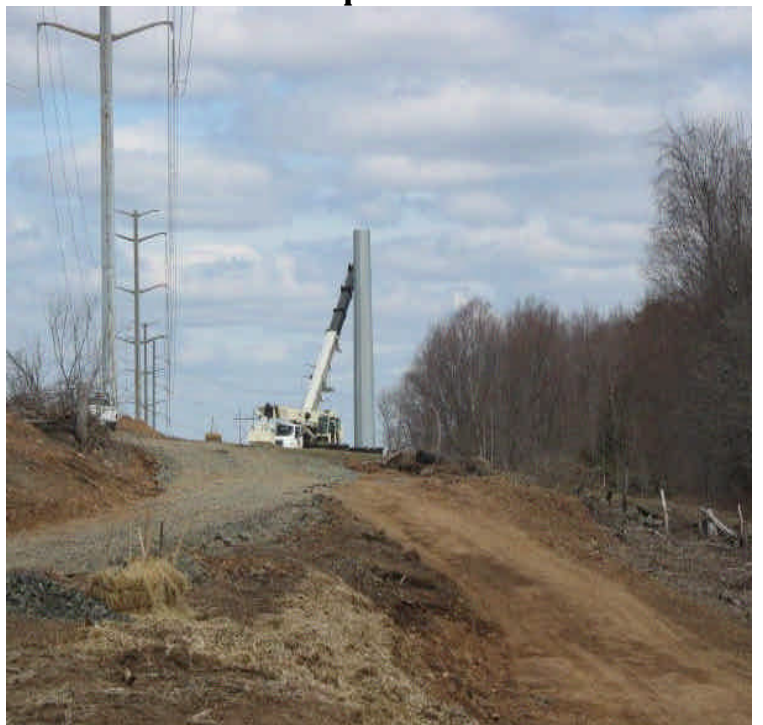
New pole construction was occurring just north of the Beseck SS.

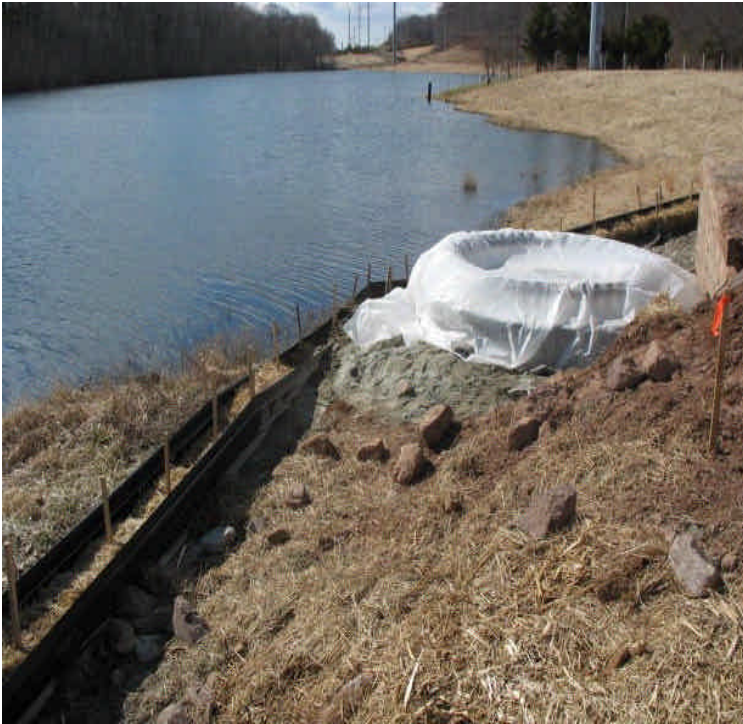
Black Pond Junction to Beseck SS Fleming Rd.	Foundation work is complete adjacent to the edge of the pond. The limits of the controls were maintained well during the work. 4/9/07	Continue to monitor the work along wetlands. 4/9/07	NA
High Hill Rd. South to East Meriden Substation and north to Black Pond	Pad site/work area is in place within a stream. The flow is being re-routed through a riprap channel and culvert. Erosion control mats are in place at the top of bank. 4/9/07	Continue to stabilize soils and adjust controls as necessary to protect wetlands and filter turbid run-off. See erosion control section for more details. 4/9/07	Clear water was flowing from the site.
	The root system and stumps were retained along the stream and within the wetland. 4/9/07	Continue to monitor and adjust controls as needed. 4/9/07	Low impact/careful clearing was noted in this area.
Black Pond	Foundation drilling is underway within the wetlands at the edge of a small stream. Controls were in place and no sediment was noted entering the stream. 4/9/07	Monitor controls closely and add more as needed. Contain and remove sediment during slurry production. 4/9/07	NA at this time. Controls are in place.

Controls remain in place along the pond north of Beseck SS to E. Meriden SS off Fleming Rd. The foundation at the edge of the pond was installed. Slopes were mulched for temporary stabilization.

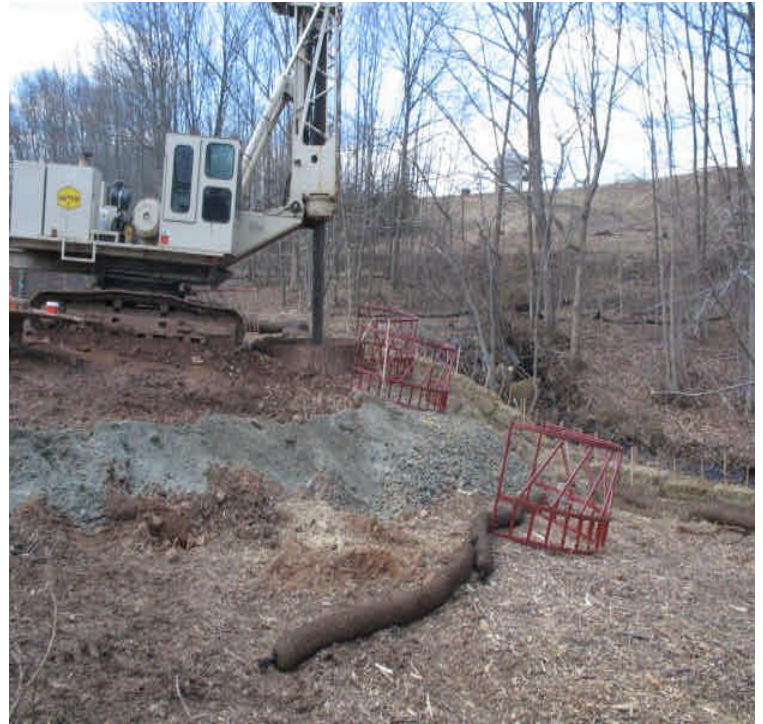
Foundation drilling just north of E. Meriden SS. A slurry pit has been established and will be used as needed. Filter socks are in place around the work. Continue to monitor controls carefully.

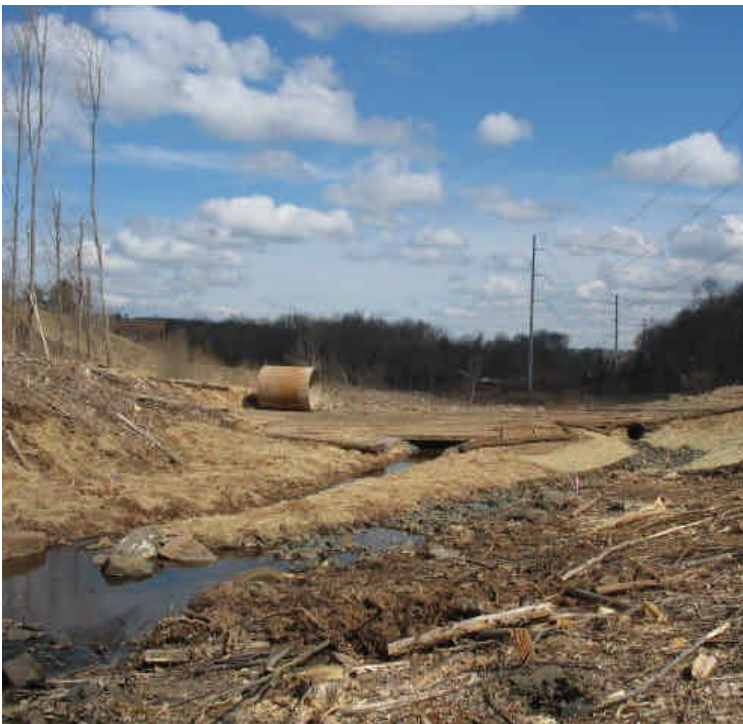
View of the channel banks and adjacent soil temporarily stabilized. in the ROW between E. Meriden SS to Black Pond. Timber mats are in place for workspace and access.

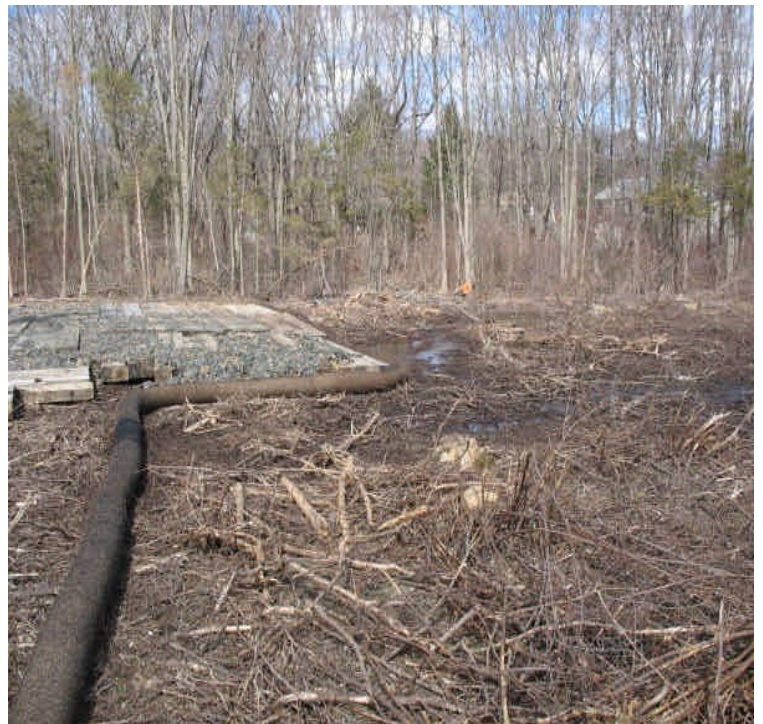
Pad area and controls installed above the stream south of High Hill Road. No run-off noted. Reduce tracking to the timber mat pad to the extent feasible.
