Docket No. 272 - Development and Management Plan Inspection

Segment 1b (Royal Oaks Bypass) Inspection

Date: April 2, 2007

Location: Segment 1b (Royal Oaks Bypass)

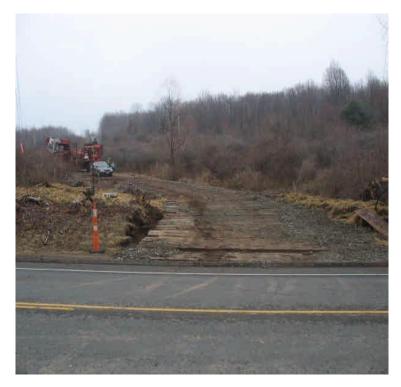
View from the contractor yard, looking across Rte. 17 at the access to the 1b ROW. The access is matted and sediment tracking was not an issue on the roadway.

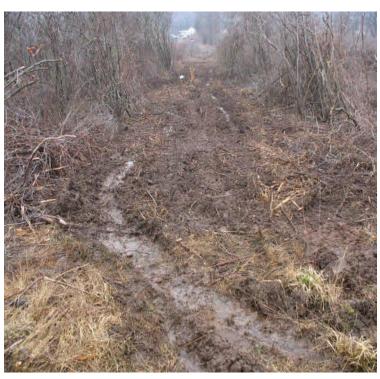
Areas of Inspection	Observation	Recommended Action	Corrected Action
	stabilize the soil. 4/2/07	install controls where applicable. 4/2/07	
	Ruts from equipment access were noted in the wetland near Rte 17. Mats were not in place in this location to support the equipment. 4/2/07	Add controls at the wetland crossings and extend timber mats into the area to prevent impacts from the equipment. 4/2/07	Needs attention.
	Timber mats were installed to reduce tracking and for equipment storage off Rte. 17 and haybales were placed to filter run-off from the mats. 4/2/07	Continue to monitor and stabilize adjacent areas to avoid sediment tracking and accumulation on the mats. 4/2/07	Haybales and timber mats were installed off Rte. 17.
Inland Wetland and Watercourse encroachment and mitigation	Cutting, skidding, and equipment movement within the ROW has occurred, compacting soils and causing ruts and disturbance in some areas. 4/2/07	Continue to monitor wetlands and add controls as needed when soil is first disturbed. Install/extend mats into the wetlands for vehicle access. 4/2/07	Needs attention.

Ruts were observed from equipment through wetlands near Rte 17. Mats should be installed to support vehicles before they access saturated/wetland areas.

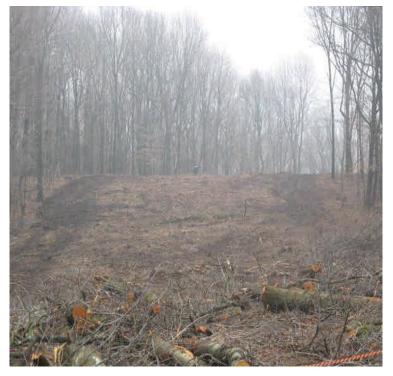
View of the newly cleared ROW looking toward the Black Walnut Dr. area. $\,$

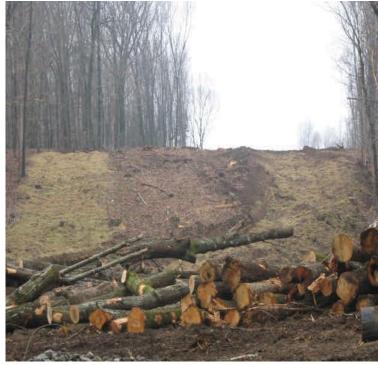
Erosion and sediment controls	Clearing is complete; Mulch was added to the steeper slope and much of the root system remains in place to stabilize the soil. 4/2/07	As construction and soil disturbance progress, add controls where needed. 4/2/07	Mulch was added to the steeper slopes.
	Controls were not in place at the pond but the remaining root system	Continue to minimize impacts to the ponds/wetlands and	NA

View from the ROW off Black Walnut Dr. Slopes have been mulched to temporarily stabilize the soils.
