**Docket No. 272 – Development and Management Plan Inspection**

**Segment 1b (Royal Oaks Bypass) Inspection**

**Date:** April 16, 2007

**Location:** Segment 1b (Royal Oaks Bypass)

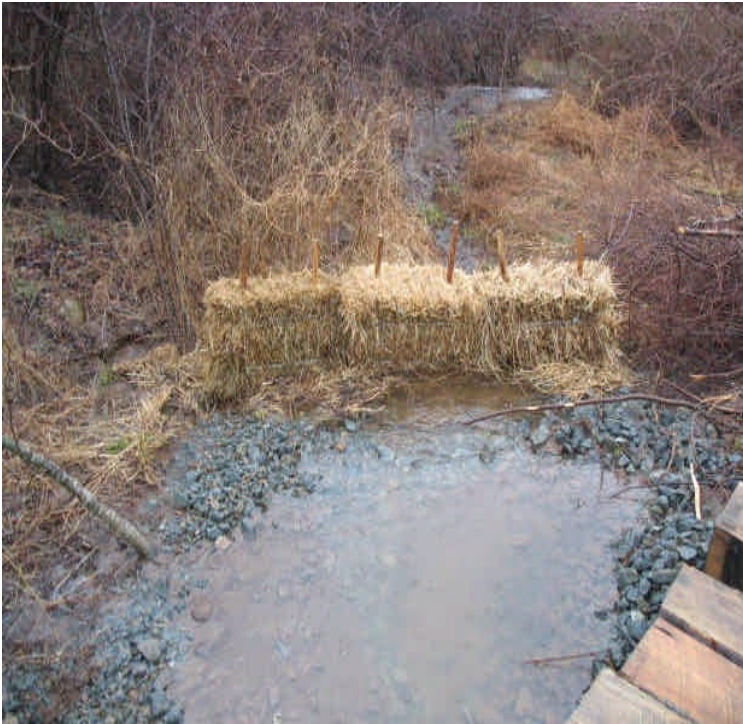
**Stormwater controls installed adjacent to the timber mat crossing off Rte 17. Clear water was flowing off site.**

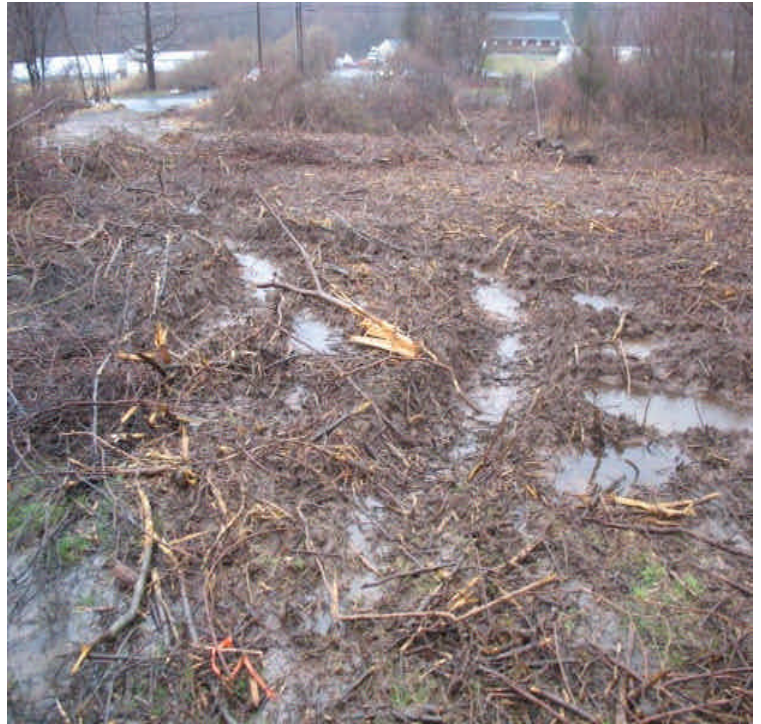
Areas of Inspection	Observation	Recommended Action	Corrected Action
	<p><b>Controls were not in place at the ponded area within the ROW but roots stabilize the soil. 4/16/07</b></p> <p><b>Ruts from equipment access remain in the wetland near Rte 17. Mats were not placed in this location to support the equipment. 4/2-4/16/07</b></p> <p><b>Timber mats are in place for equipment storage off Rte. 17. Haybales and stone sediment traps were used to filter water flowing from the timber mats. Water leaving the site was clear. 4/16/07</b></p>	<p><b>Continue to minimize impacts to the ponds and install controls where applicable. 4/16/07</b></p> <p><b>Add controls at the wetland crossings and extend timber mats into the area to prevent impacts from the equipment. Restore contours as necessary. 4/2-4/16/07</b></p> <p><b>Continue to monitor and stabilize adjacent areas to avoid sediment tracking and accumulation on the mats. 4/16/07</b></p>	<p><b>NA</b></p> <p><b>Needs attention.</b></p> <p><b>Run-off filtering through the controls was clear as it left the site.</b></p>

**Ruts were observed due to equipment tracking through wetlands near Rte 17. Mats should be installed to support vehicles before they access saturated/wetland areas.**

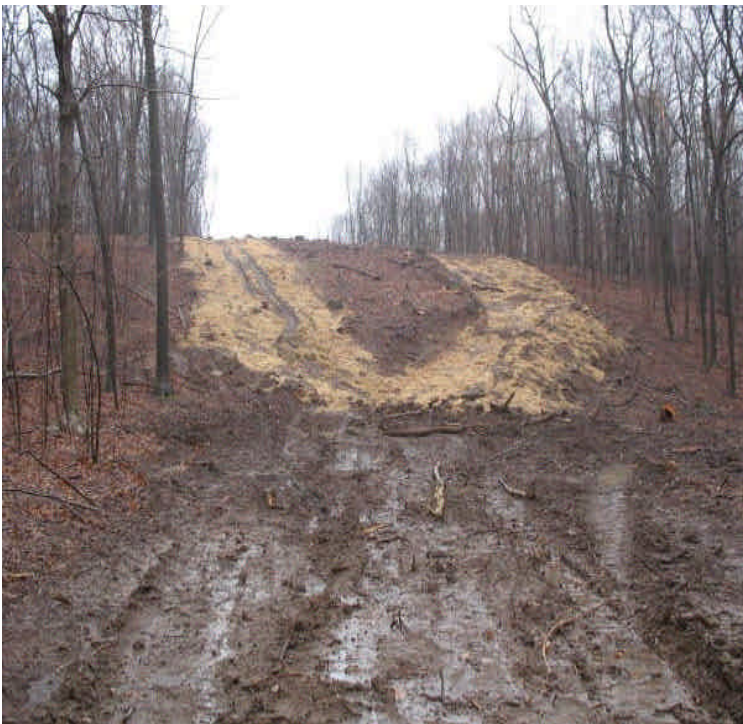
<b>Erosion and sediment controls</b>	<p>Clearing is complete; Mulch remains along a steep slope and much of the root system remains in place to stabilize the soil. Some washouts/gullies were noted on the steep slope as a result of heavy rains. 4/16/07</p>	<p>As clearing construction and soil disturbance progress, add controls where needed. Regrade and seed steep slopes for further stabilization as soon as feasible. 4/16/07</p>	<p>Needs to be monitored.</p>

**Minor washouts/gullies were noted on the steep slope due to heavy rains.**

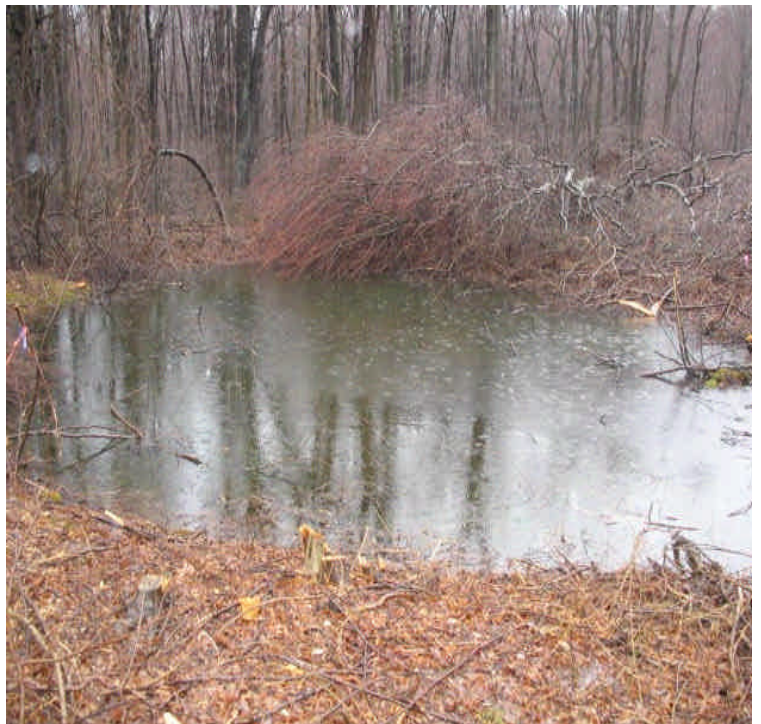
**View of the ponded area within the ROW. This was protected from direct impacts by using multiple access points into the ROW.**
