Docket No. 272 – Development and Management Plan Inspection

Segment 1b (Royal Oaks Bypass) Inspection

Date: April 23, 2007

Location: Segment 1b (Royal Oaks Bypass)

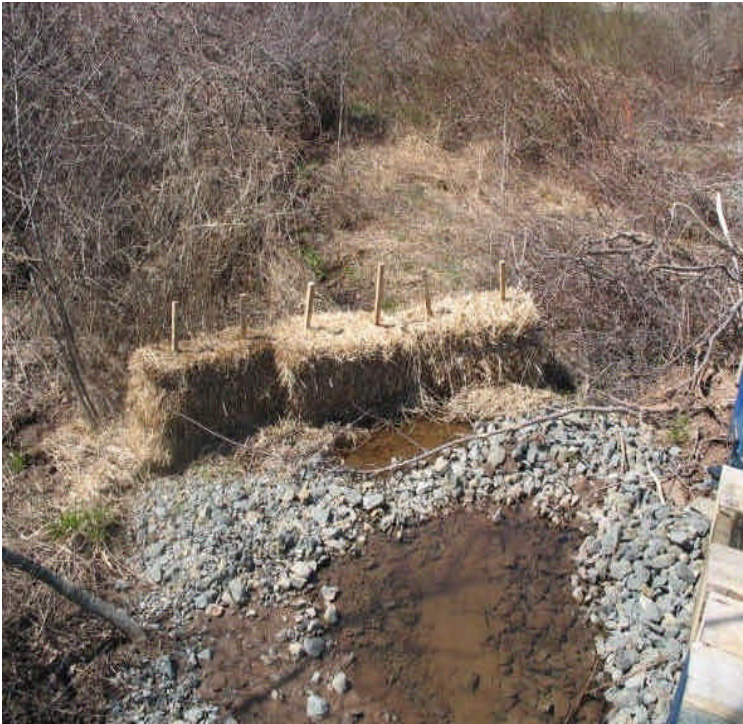
Stormwater controls installed adjacent to the timber mat crossing off Rte 17. Clear water was flowing off site.

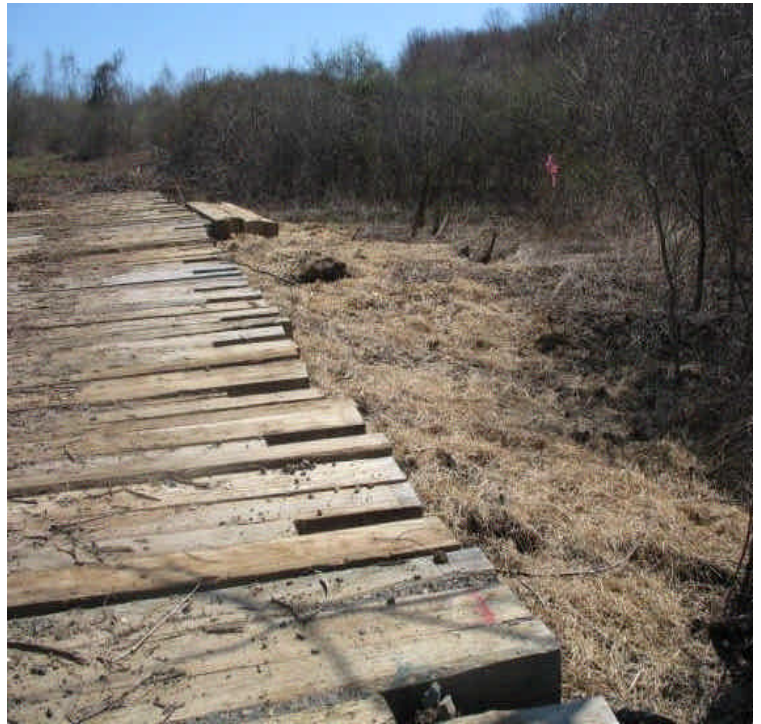
Hay mulch was used along the edge of mats and wetlands near Rte 17 to temporarily stabilize the exposed soil.

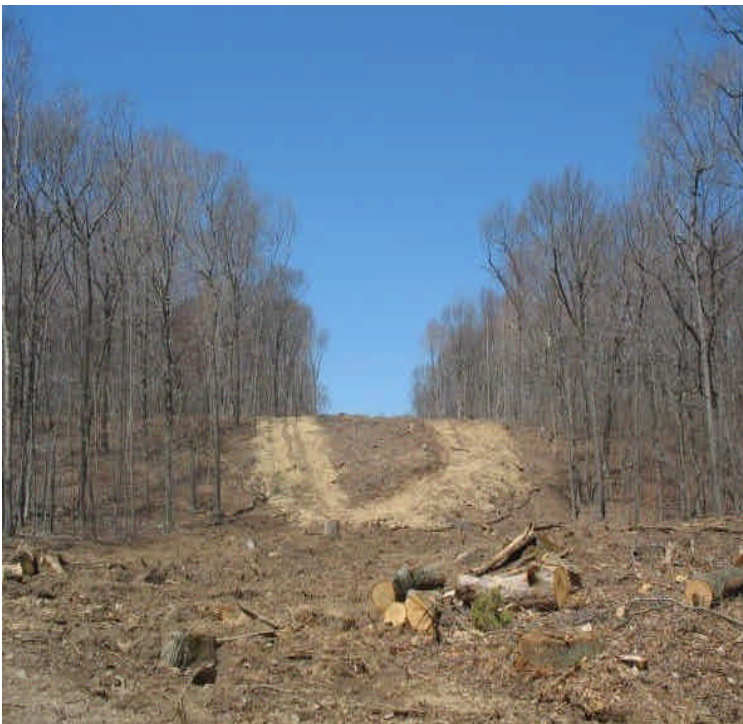
Erosion and sediment controls	Clearing is complete; Mulch remains along a steep slope and much of the root system remains in place to stabilize the soil. Some washouts/gullies were noted on the steep slope as a result of last week's heavy rains (noted 4/16). 4/23/07	As clearing construction and soil disturbance progress, add controls where needed. Regrade and seed steep slopes for further stabilization when feasible. 4/16-4/23/07	Needs to be monitored.
	Controls were not in	Continue to minimize	NA

Minor washouts/gullies were noted on the steep slope due to heavy rains last week. Mulch was in place prior to the rain.

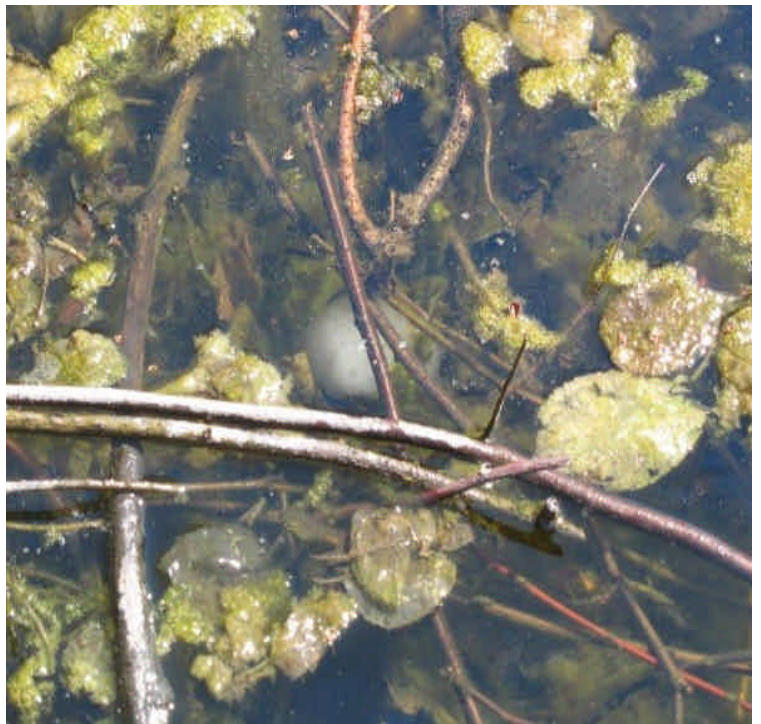
View of an *Ambystoma* egg mass in the ponded area within the ROW. This pond was protected from direct impacts by using multiple access points into the ROW.
