**Docket No. 272 – Development and Management Plan Inspection**

**Segment 2a Inspection**

**Date:** April 3, 2007

**Location:** Segment 2a – Beseck Switching Station to Cheshire/Hamden Town Line

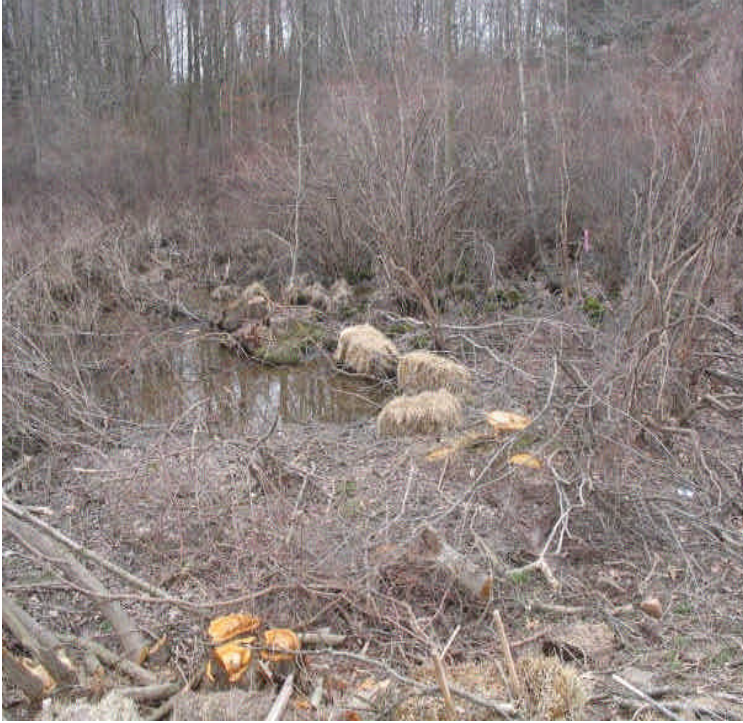
Area of the ROW that has been cleared south of Beseck SS off High Hill Rd. Low growing vegetation was retained in the wetlands here appropriately. Haybales left in wetlands for access should be removed.

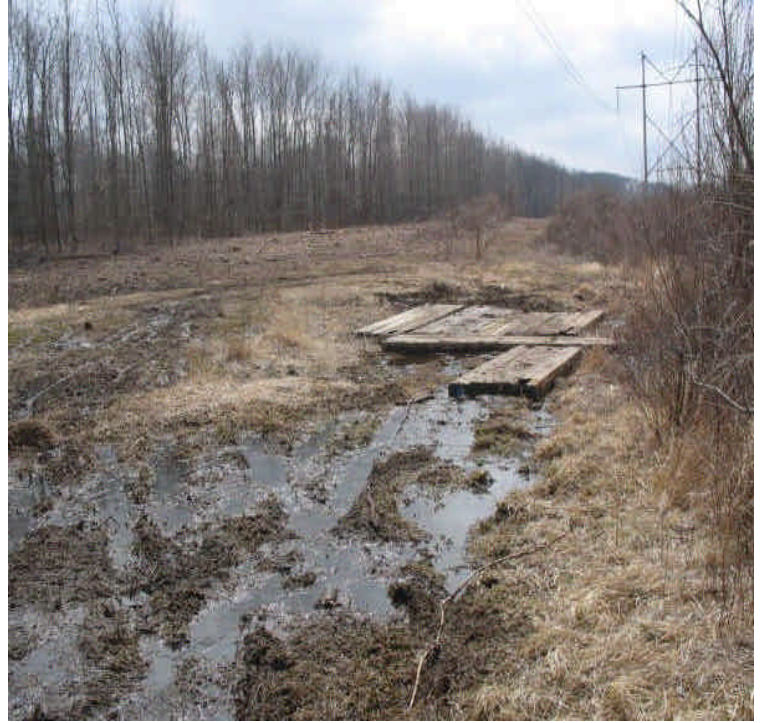
Partial timber mat crossing south of Carpenter Lane for clearing crew. Controls should be added as needed, when work continues.

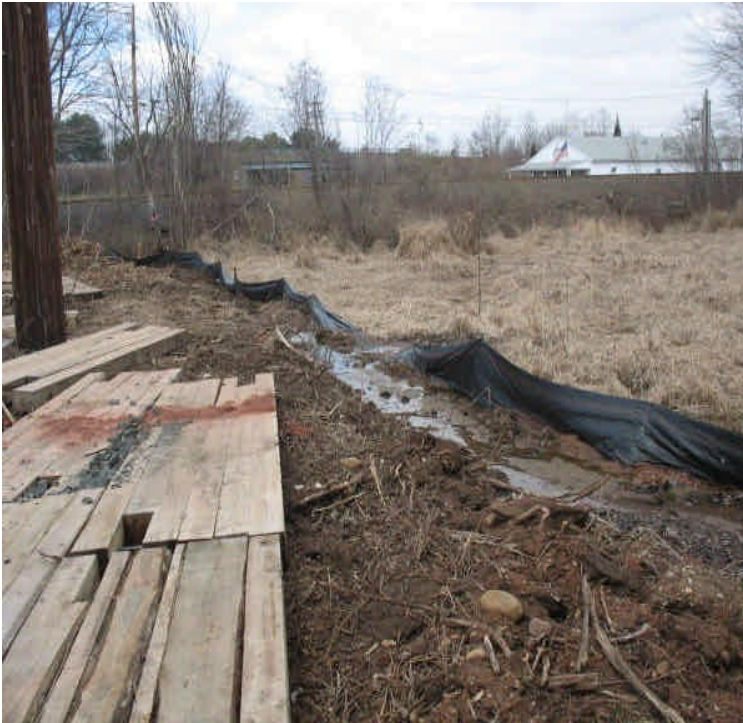
View of timber mats in place for pad construction and erosion controls off Powers Rd

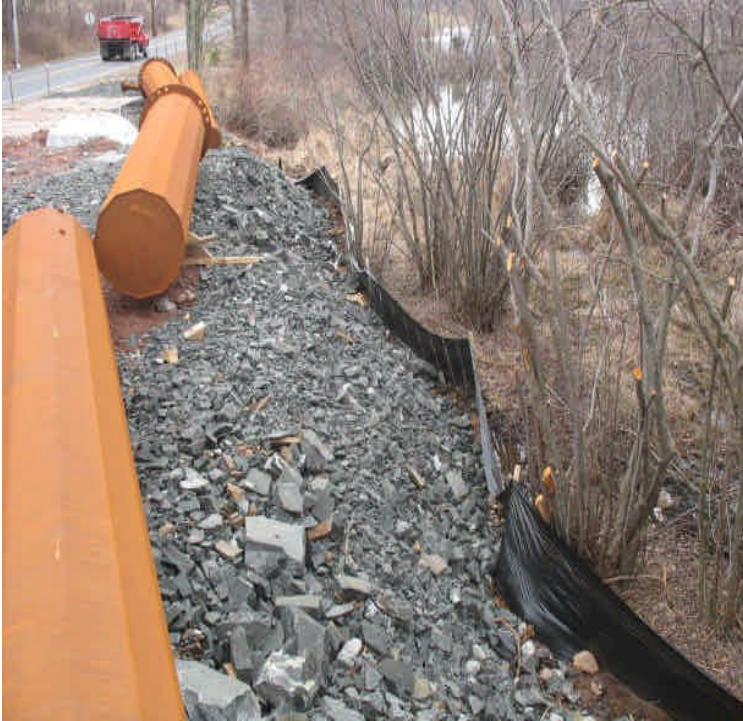
**Controls added along wetlands off Woodhouse Ave. Extend and reinforce controls as needed. The stone layers appear to be putting stress on the fence in some spots.**

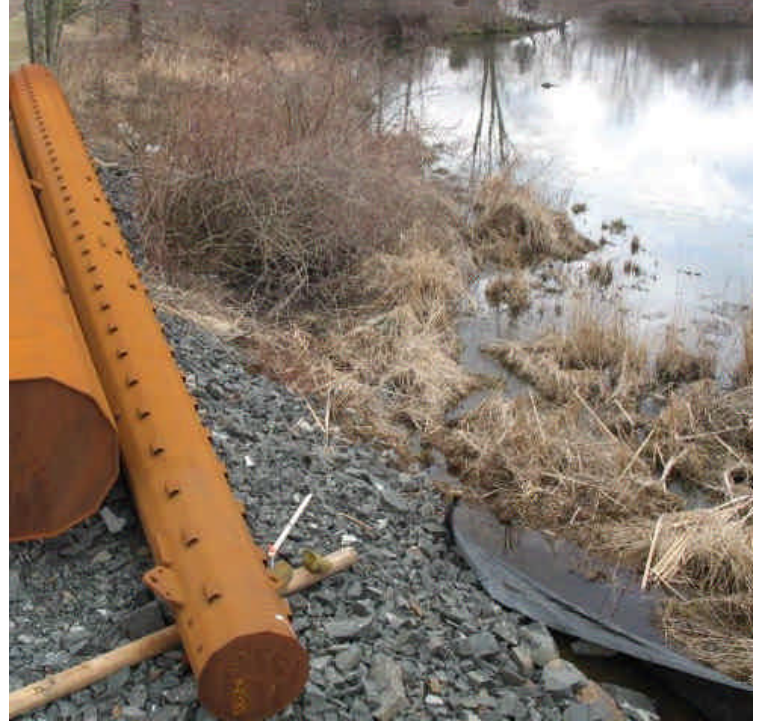
**Close-up view of an area where the fence was overwhelmed by the installed stone. Extend controls to keep an approved limit of work in the wetland here.**

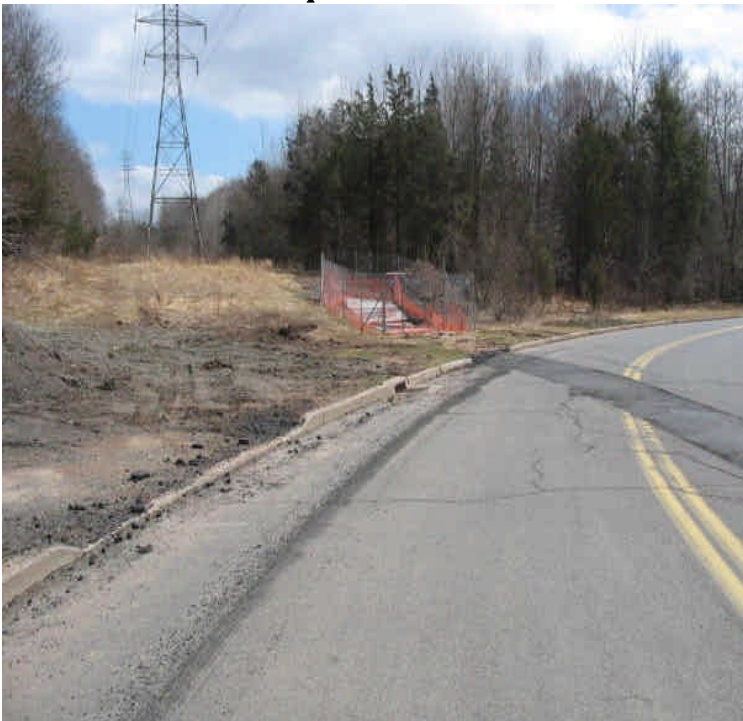
**Safety fence remains around the transition pit located off Old Farms Road. An area of adjacent exposed soil and leftover fill is located in the overhead ROW. Extra material should be removed and the area mulched/temporarily stabilized.**

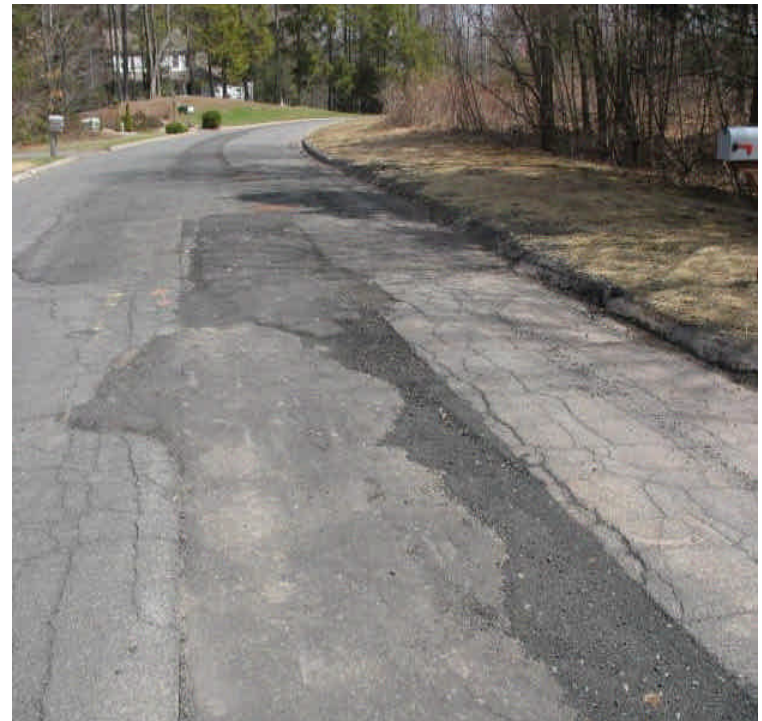
Old Farms Rd. (115kV Underground trench-work)	<p>Trenching is complete for now and area has been stabilized. Some loose asphalt “crumbling” was noted at the trench patch. 3/27-4/3/07</p>	<p>Add controls as needed if work resumes in this area. Continue to clean loose asphalt until area can be properly repaved. 3/27-4/3/07</p>	<p>Area is not currently active.</p>
Foundation and site construction	<p>Temporary/permanent pole installation, drilling access road construction</p>	<p>None. 4/3/07</p>	<p>NA</p>

**The trench was patched along Old Farms Rd. Some loose asphalt or "crumbling" was noted along the edge of the roadway.**
