Docket No. 272 – Development and Management Plan Inspection

Segment 2a Inspection

Date: April 10, 2007

Location: Segment 2a – Beseck Switching Station to Cheshire/Hamden Town Line

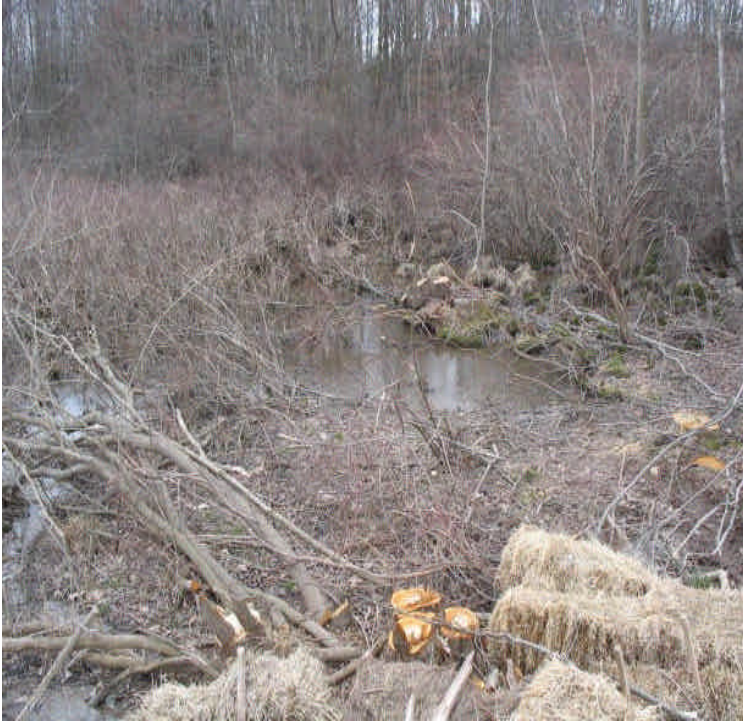
The haybales that had been used for clearing crew access and left in the wetland just south of Beseck SS and Carpenter Lane were removed. Most low growing shrubs and vegetation were retained appropriately.

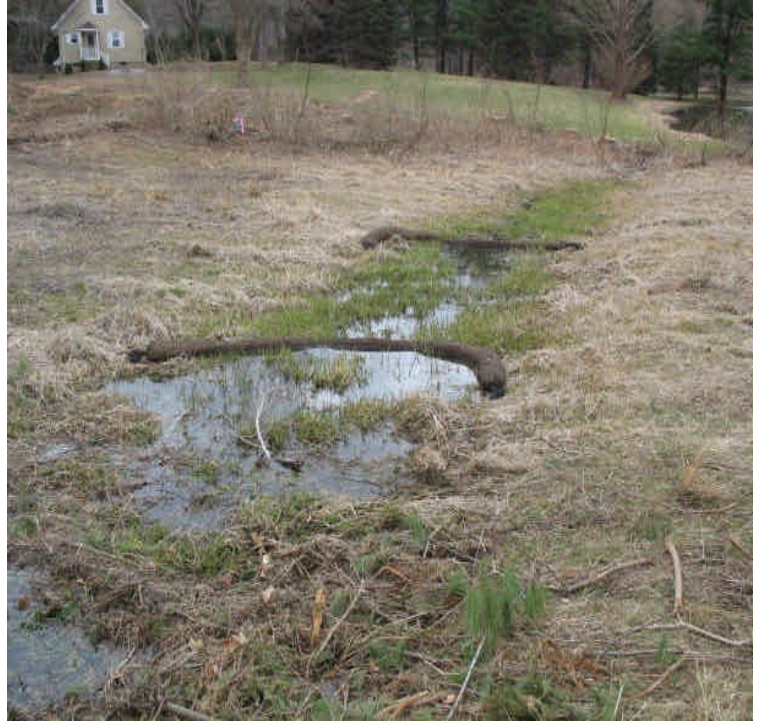
Filter socks were added downgradient of the work off Liney Hall Ln. No turbidity issues were noted.

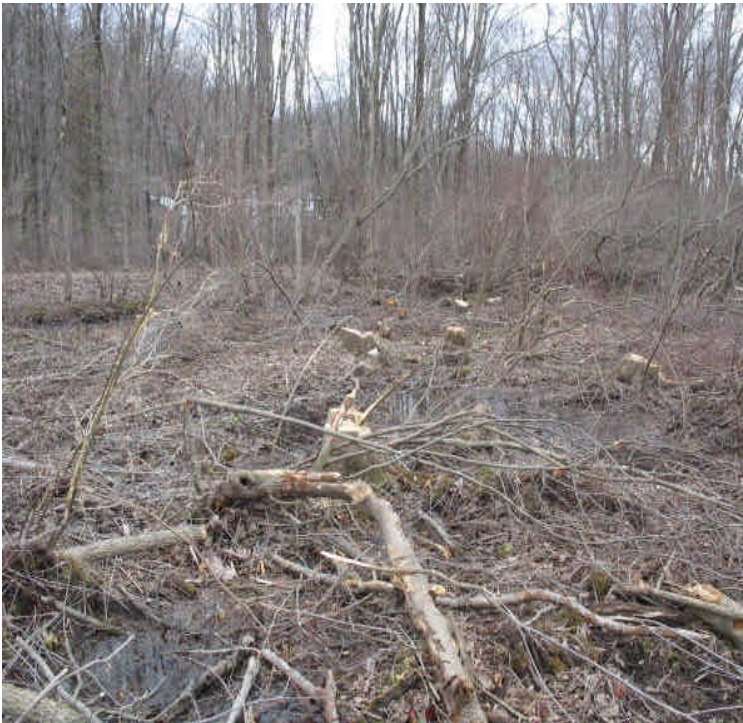
View of clearing within wetlands off Liney Hall Ln. Low impact techniques had been used to reduce direct disturbance to the wetland. Continue to preserve low growing shrubs.

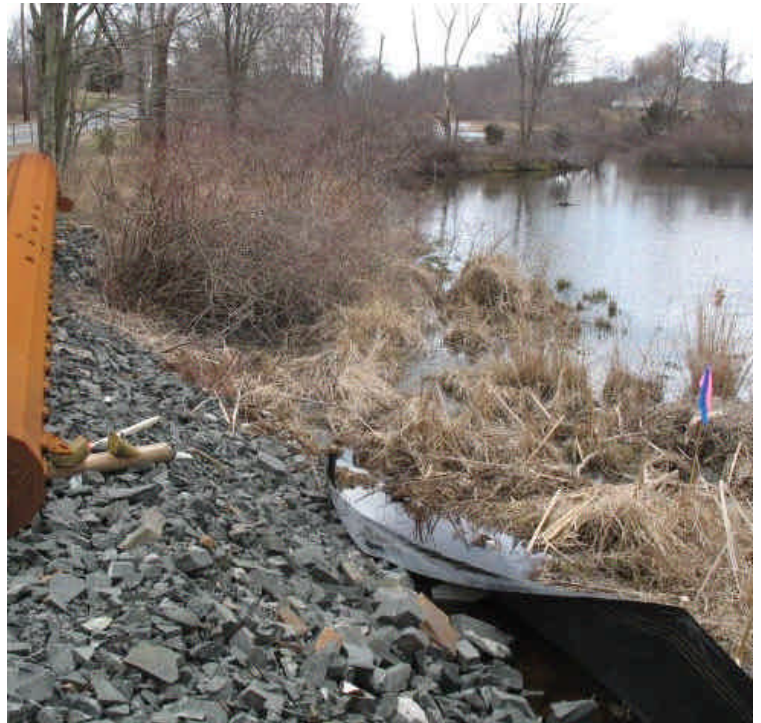
Close-up view of an area where the fence was overwhelmed by the installed stone. Extend controls to keep a visual limit of work in the wetland here.

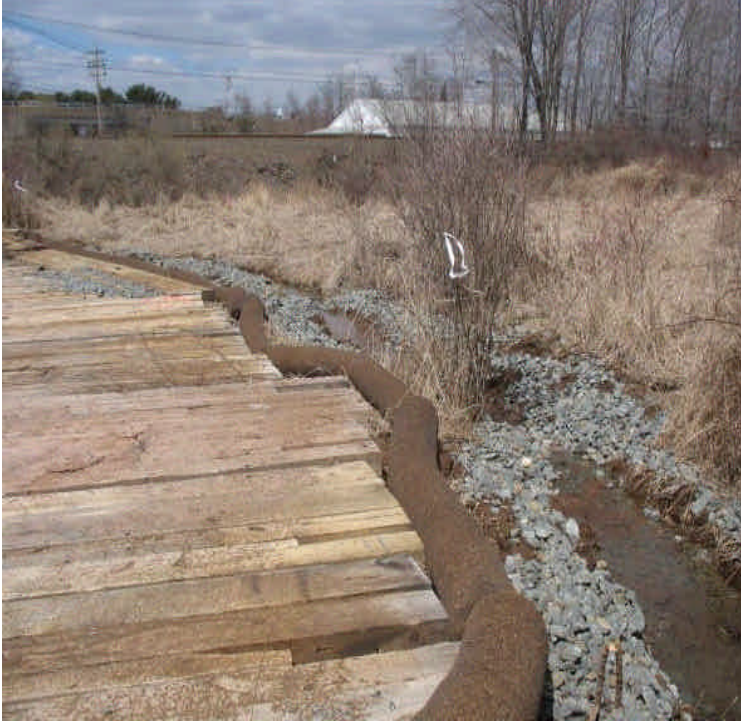
Silt fence removed, filter socks installed for erosion controls off Powers Rd.

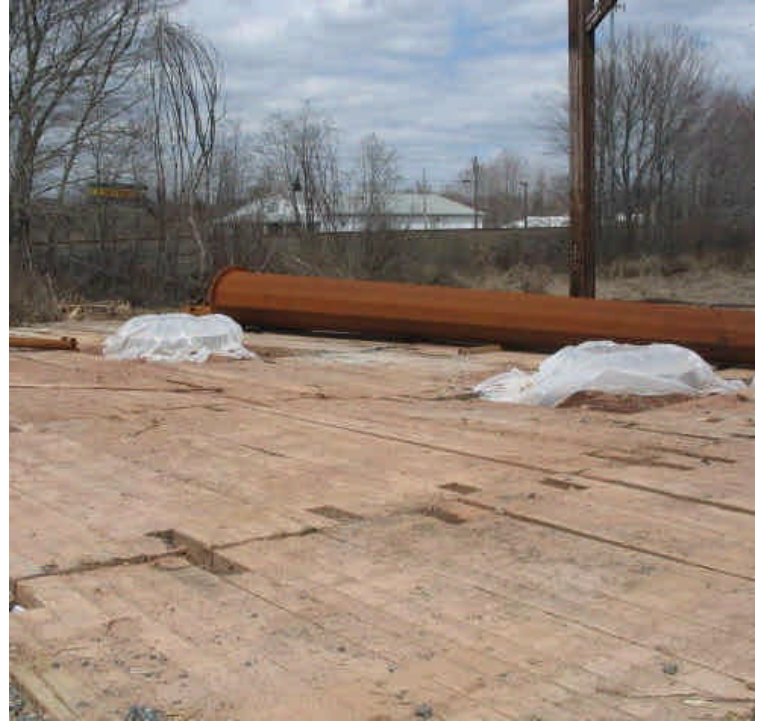
View of timber mat pad constructed off Powers Rd with several completed foundations.

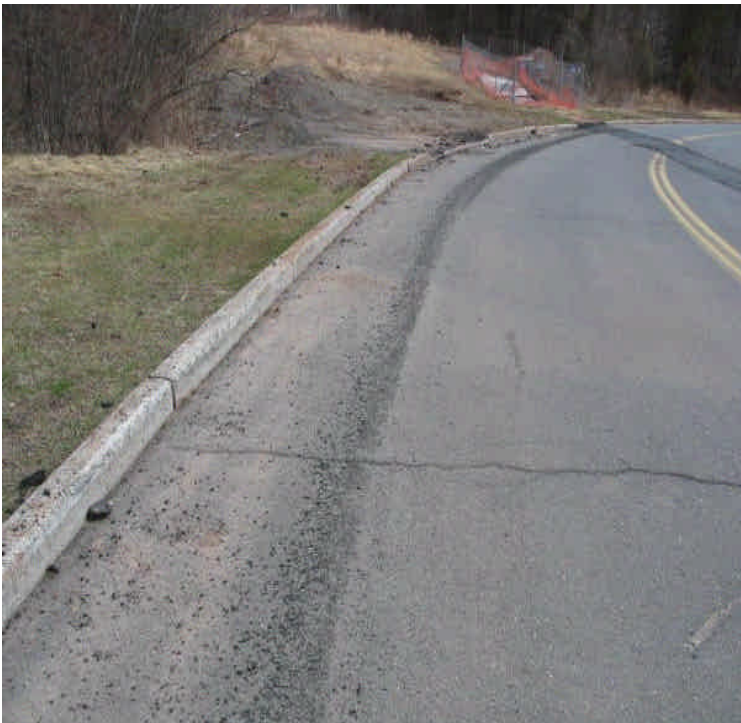
The trench was patched along Old Farms Rd. Some loose asphalt or "crumbling" was noted along the edge of the roadway. In the background, safety fence remains around the transition pit and an area of adjacent exposed soil and leftover fill is located in the overhead ROW. Extra material should be removed and the area should be mulched.

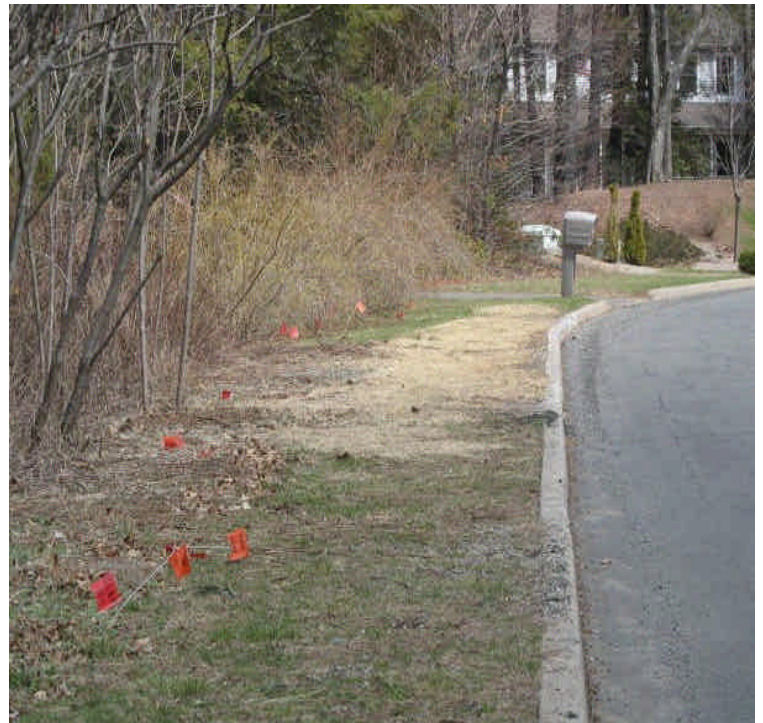
View of an area off Old Farms Rd. which was regraded, seeded, and mulched to provide temporary stabilization until grass establishes.
