**Docket No. 272 – Development and Management Plan Inspection**

**Segment 3 Underground Line**

**Date:** April 13, 2007

**Location:** East Devon Substation to the Housatonic River Crossing

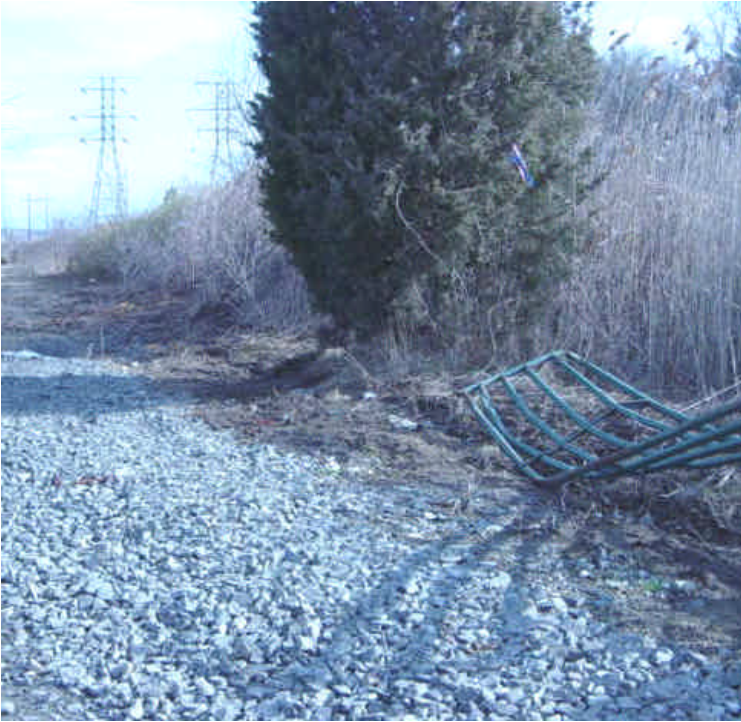
Areas of Inspection	Observation	Recommended Action	Corrected Action
<p><b>Milford (contractor yard)</b></p>	<p>to enter catch basins. 4/13/07</p> <p>The erosion controls adjacent to sta. #1053, which were previously in disrepair, have been removed as work in this area appears complete. The controls down gradient from here remain in place. 4/13/07</p> <p>Exposed slopes near sta. #1076 should be temporarily or permanently stabilized 4/13/07</p> <p>Silt fence was installed along the stone construction entrance at station #1080. 4/13/07</p> <p>Haybales remain in place proactively near station #1017 to prevent sediment migration. The silt fence in this area is in disrepair. 4/3 - 4/13/07</p> <p>Perimeter controls remain in place around the yard, however, the stone pile from snow plowing remains beyond the controls. 3/27-4/13/07</p>	<p>basins and sensitive areas, by quickly attending to it as it is generated. 4/13/07</p> <p>Protect resource areas until adjacent areas are stabilized either temporarily or permanently, and depending on whether Seg. 2b activities will disturb these areas again. 4/13/07</p> <p>Spread mulch and/or seed in the area to stabilize the slopes and prevent erosion. 4/13/07</p> <p>None. Silt fence is proactive and provides a limit of access. 4/13/07</p> <p>Re-establish compromised silt fence, or stabilize exposed soils and remove silt fence. 4/3 - 4/13/07</p> <p>See the storage and staging yard section of this report for more details. 4/13/07</p>	<p>Needs evaluation to determine if controls need to be re-established.</p> <p>Needs attention when feasible.</p> <p>Silt fence was installed (proactively).</p> <p>Needs attention</p> <p>NA</p>

**Photo taken of sta. #1053 where the silt fence in disrepair has been removed along with the materials previously noted in the wetland (including metal gate). It appears that Segment 3 work in the cross-country area is complete for now.**

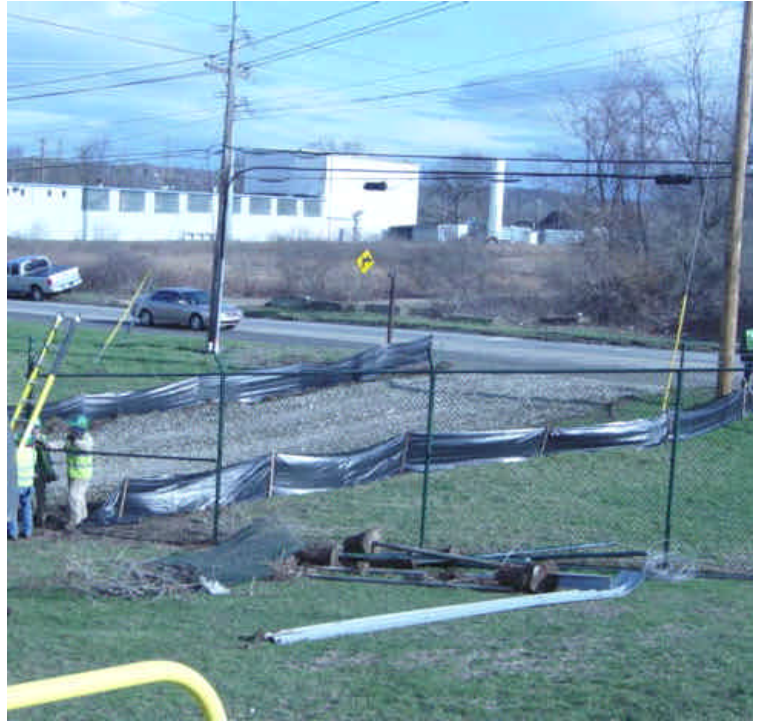
**Photo of the construction entrance located at sta. #1080.**

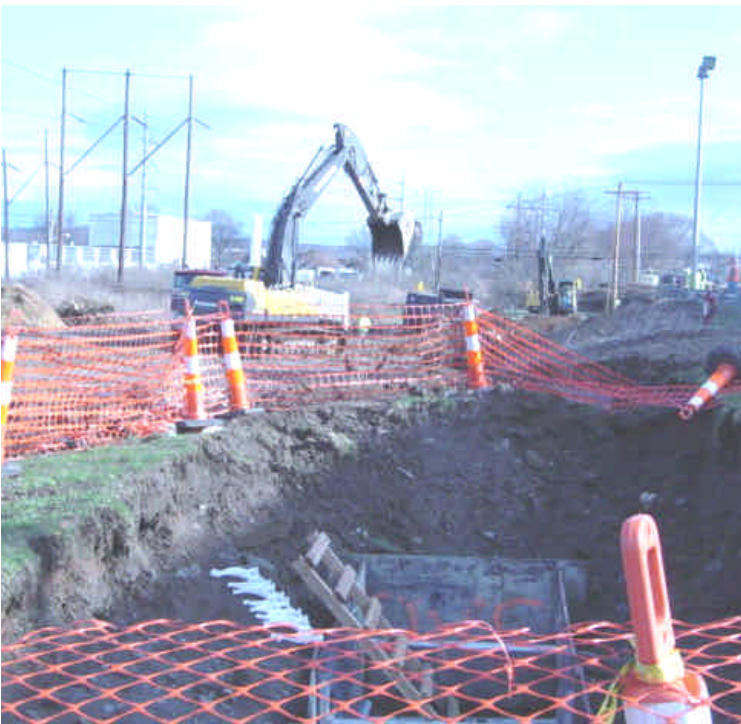
<p>Soils</p>	<p>Soils are exposed as part of the excavation for trench, vault, and utility work. 4/13/07</p> <p>Environmentally sensitive soil was being removed from the Vault #5 excavation and transported to an approved location. 4/13/07</p>	<p>Soils appear to be handled appropriately. 4/13/07</p> <p>Soils appear to be handled appropriately. 4/13/07</p>	<p>NA</p> <p>Soil was being removed to an approved location.</p>
<p>State species of concern, threatened and endangered species.</p>	<p>According to the D&amp;M plan, state-listed species are not located in this work area.</p>	<p>None</p>	<p>NA</p>
<p>Vegetative clearing (including trees to save or danger trees noted) or stabilization</p>	<p>Vegetated clearing is complete along the edge of the cross-country ROW from station #1064 to 1073 in order to accommodate the</p>	<p>Restore area as required by the D&amp;M Plan when feasible and as work is completed. Contractors understand that wood chips can be spread to a</p>	<p>Needs attention when work is complete.</p>

**Photo of excavation activities for vault #5. Crews were actively removing and transporting environmentally sensitive soil to an adjacent, exposed slope should be temporarily or permanently approved location.**

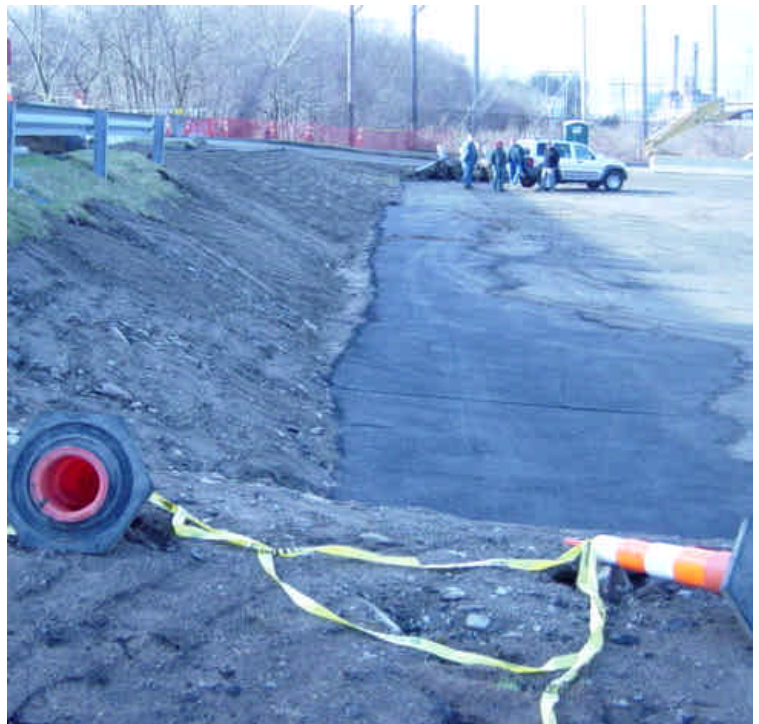
**Photo of completed trenching activities at sta. #1076. The removing and transporting environmentally sensitive soil to an adjacent, exposed slope should be temporarily or permanently approved location.**
