Docket No. 272 – Development and Management Plan Inspection

Segment 3 Underground Line

Date: April 19, 2007

Location: East Devon Substation to the Housatonic River Crossing

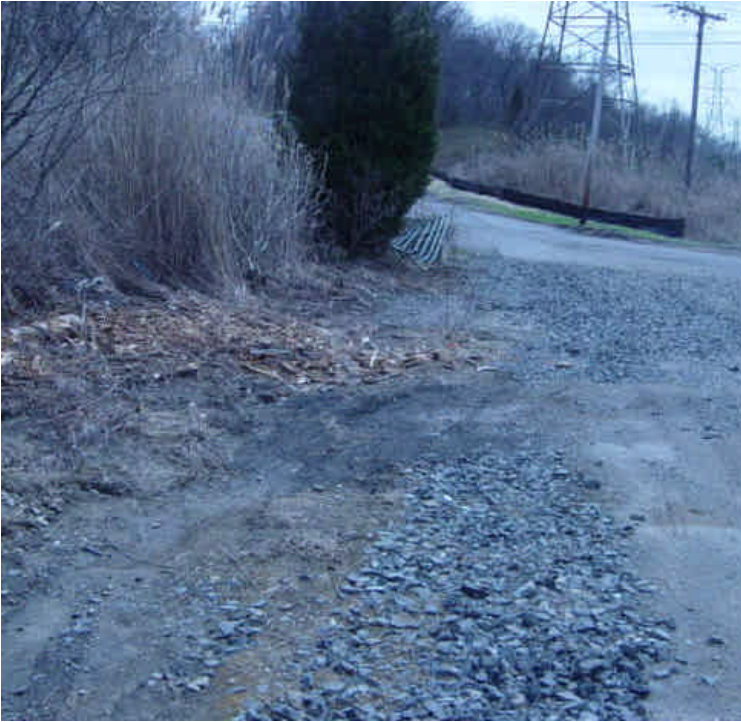
Areas of Inspection	Observation	Recommended Action	Corrected Action
	<p>adjacent to sta. #1053 have been removed as work in this area appears complete. The controls down gradient from here remain in place. The area appears stable as evidence of erosion was not observed even after heavy rains. 4/19/07</p> <p>Exposed slopes near sta. #1076 should be temporarily or permanently stabilized 4/13 - 4/19/07</p> <p>Haybales remain in place proactively near station #1017 to prevent sediment migration. The portion of silt fence in disrepair in this area has been maintained. 4/19/07</p>	<p>until adjacent areas are stabilized either temporarily or permanently, and depending on whether Seg. 2b activities will disturb these areas again. 4/19/07</p> <p>Spread mulch and/or seed in the area to stabilize the slopes and prevent erosion. 4/13-4/19/07</p> <p>Continue to stabilize exposed soils so that silt fence can eventually be removed. 4/19/07</p>	<p>signs of erosion even after heavy rains.</p> <p>Needs attention when feasible.</p> <p>Silt fence has been repaired.</p>

Photo of sta. #1053. The area appears stable even after heavy Rains, as there was no evidence of erosion.

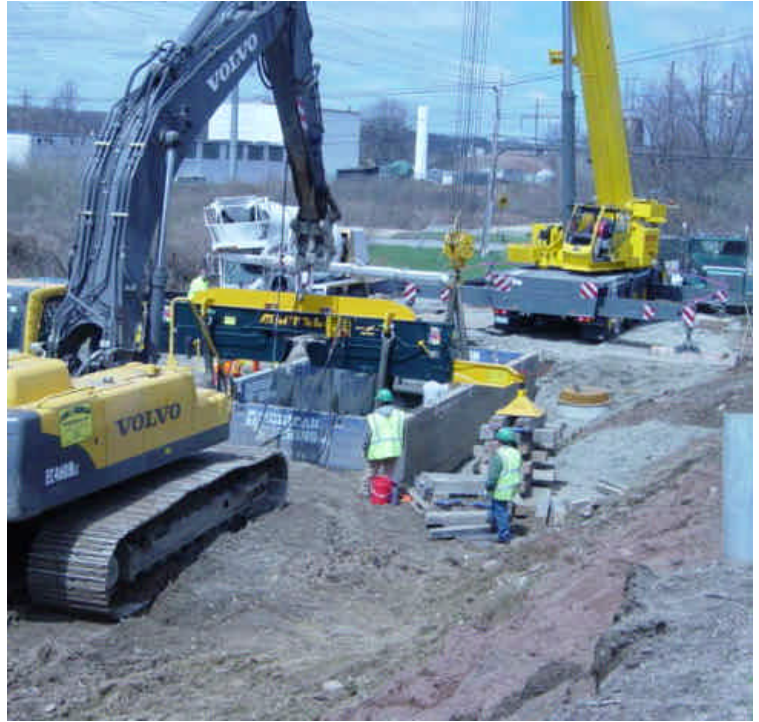
Photo of vault #5 construction activities.

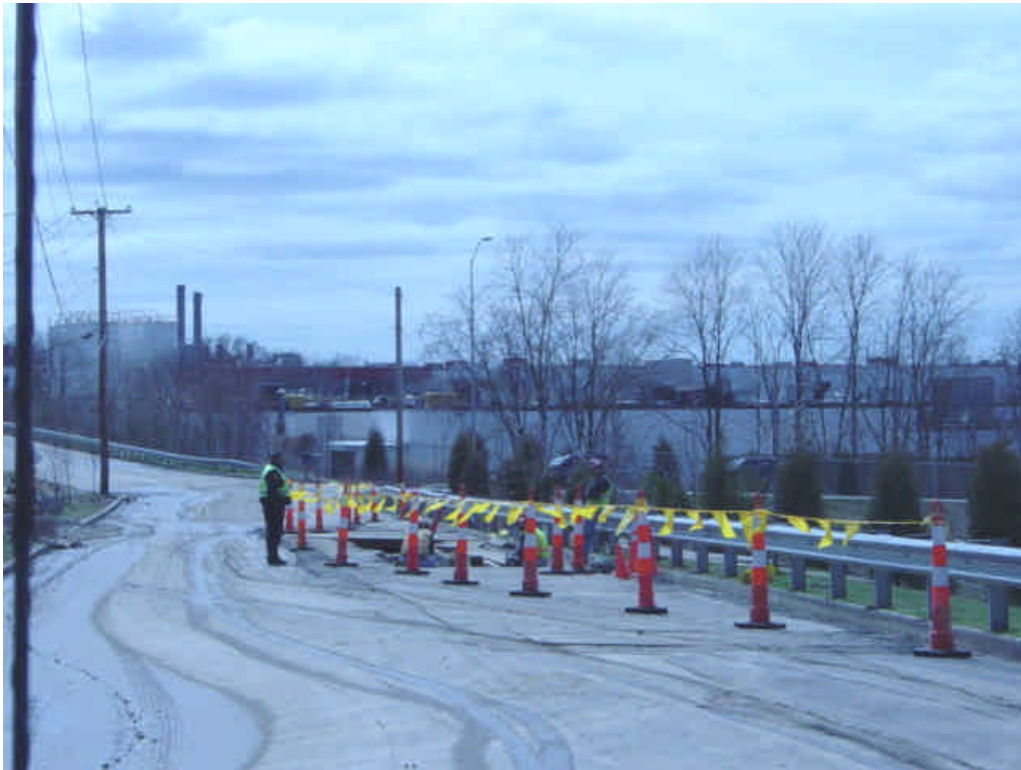
Photo of trenching activities at sta. #1096 near the Milford lay-down yard. The roadway appears to have been swept recently.
