Docket No. 272 – Development and Management Plan Inspection

Segment 4a Underground Line

Date: April 3, 2007 (night inspection)

Location: Singer Substation to Fairfield/Westport Town Line

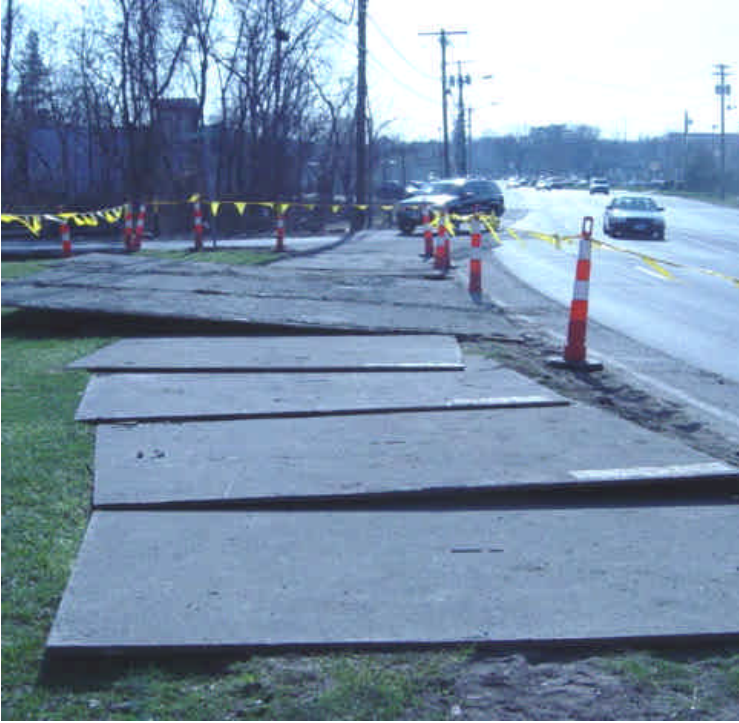
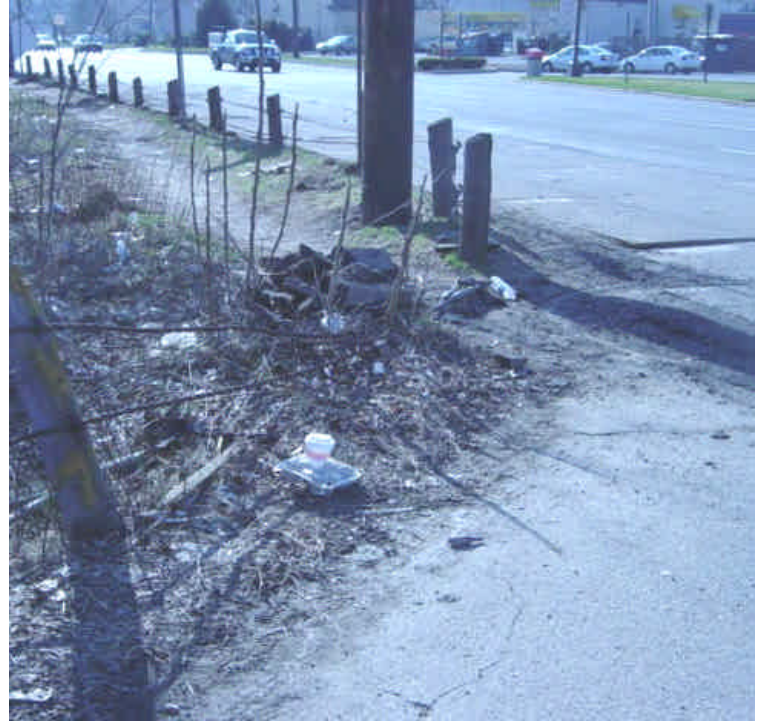
Both photos are of trenching activities at sta. #608 to #609. Right: A small amount of bituminous concrete has been piled along the edge of the trench work/roadway. When feasible, remove the excess construction materials/debris from the site.

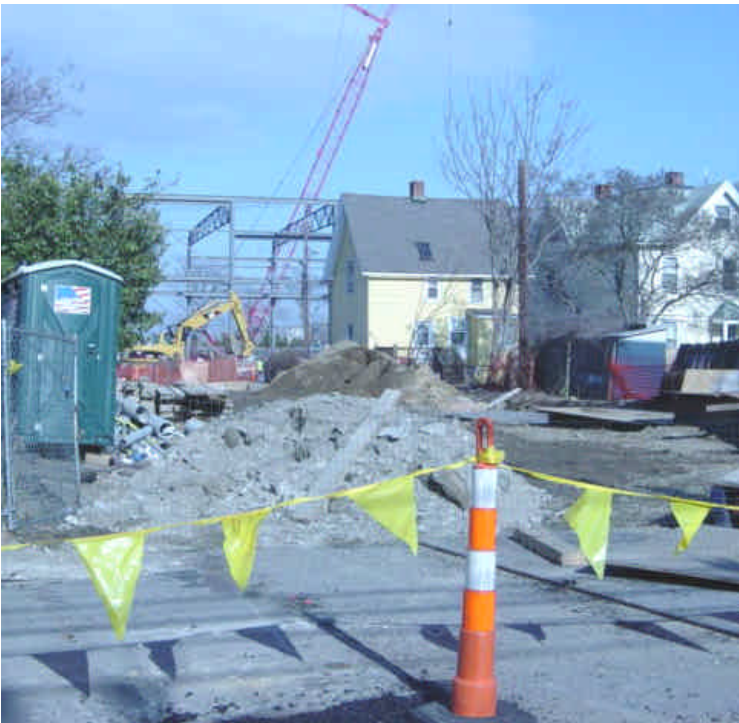
Photo of trenching activities between Broad St. and Main St. No issues were noted. Continue to keep soil contained to the work area.

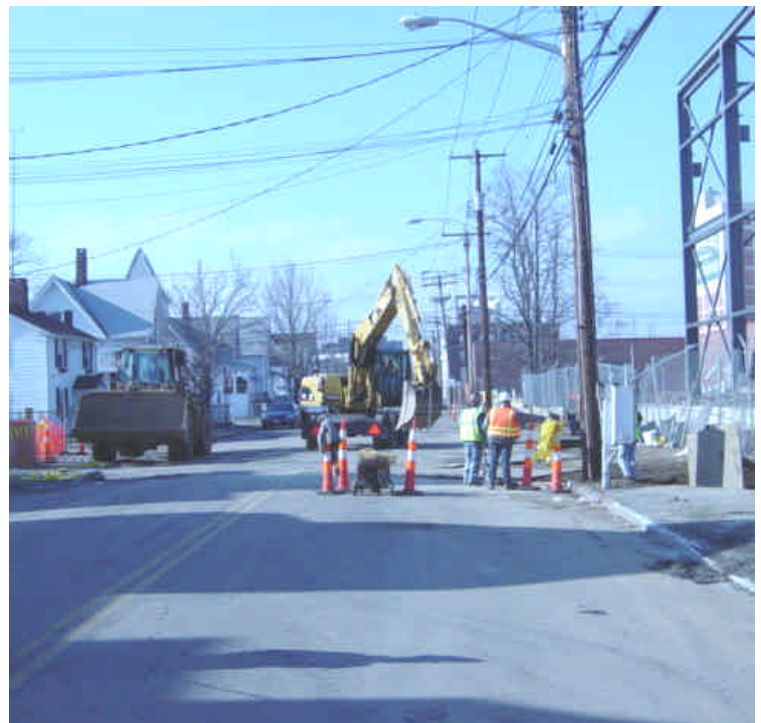
Trenching activities within Main St., located immediately adjacent to the fence at the Singer Substation yard. No issues were noted.
